GREY LOGS

CONSERVATION OF SERIOUSLY DETERIORATED LOGS

OVERLOOKING HIGHLANDS NC

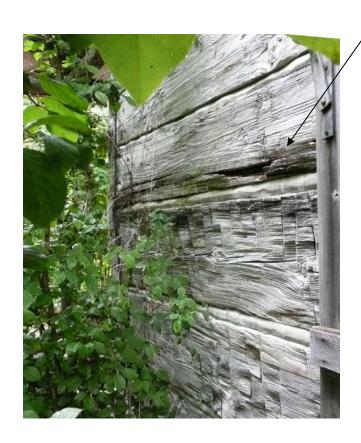
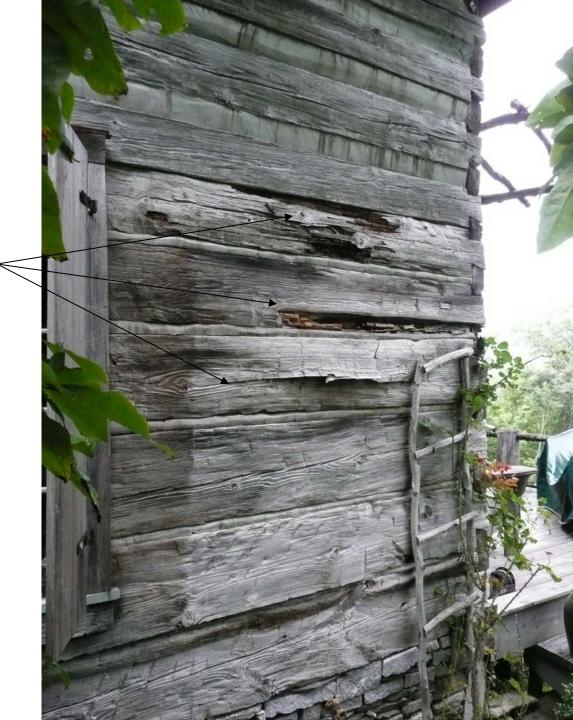
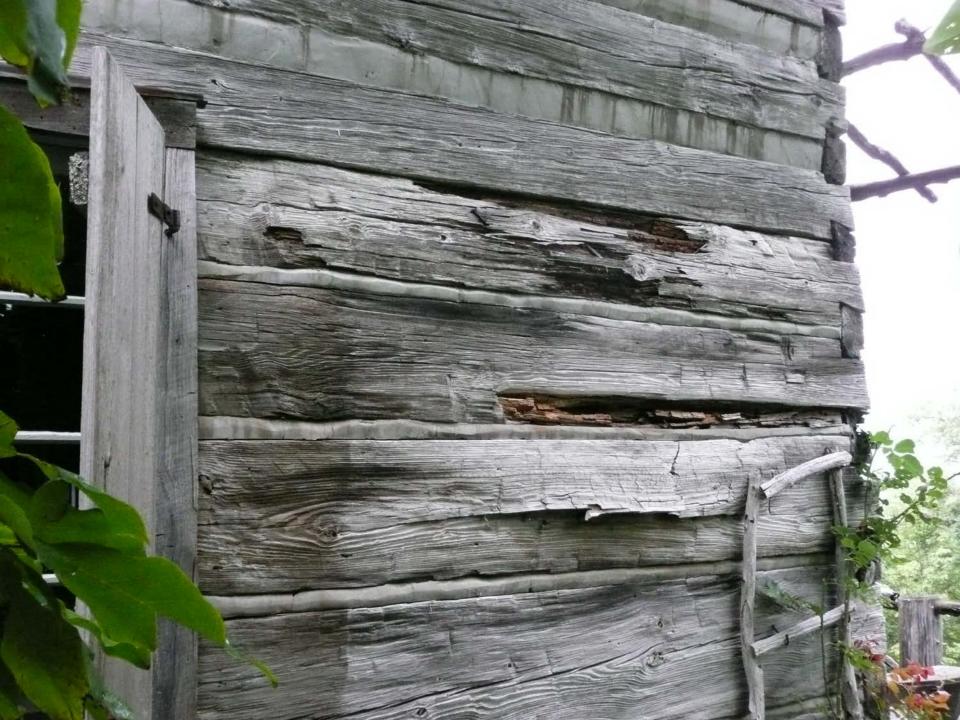
A BIT OF DETERIORATION

THE LOGS CANNOT BE REPAIRED IN PLACE

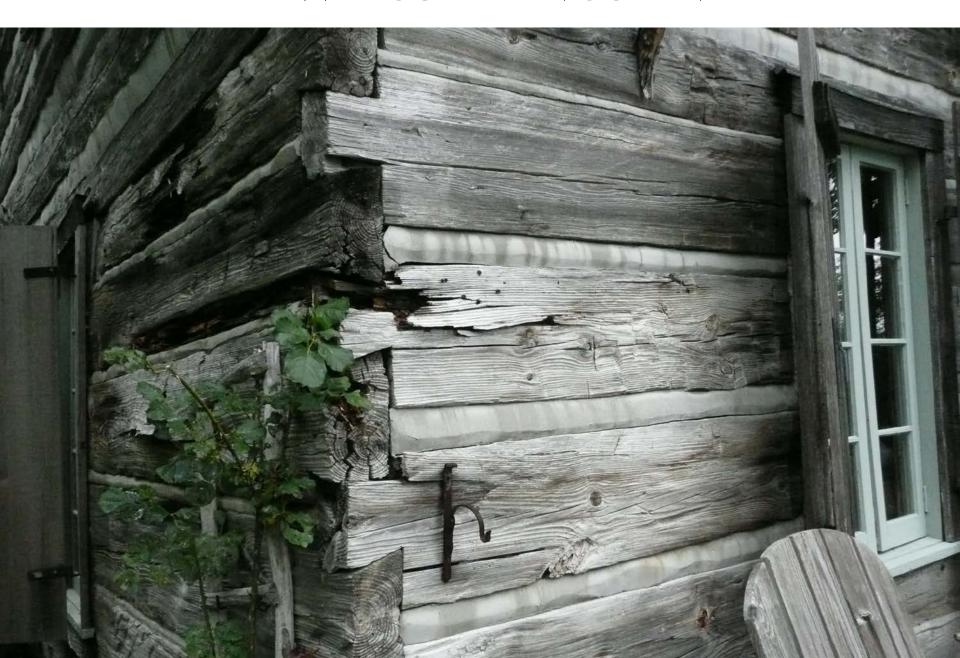
AND 2 AROUND THE CORNER

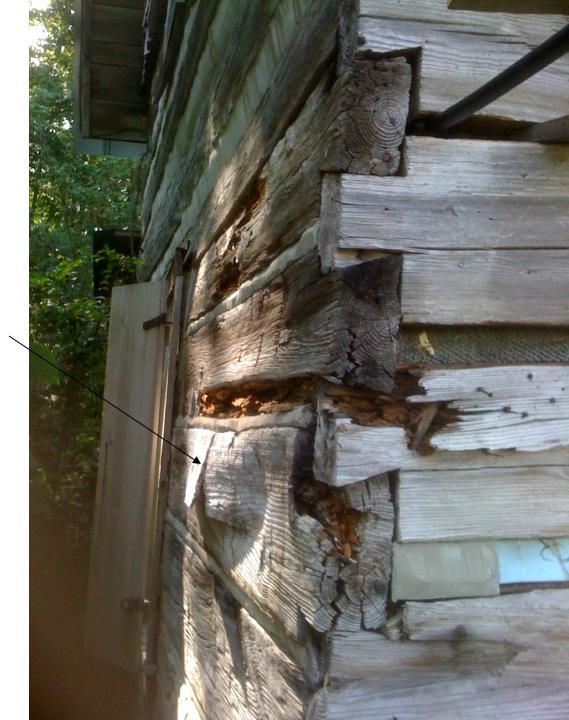
WE WILL FOLLOW THIS LOG

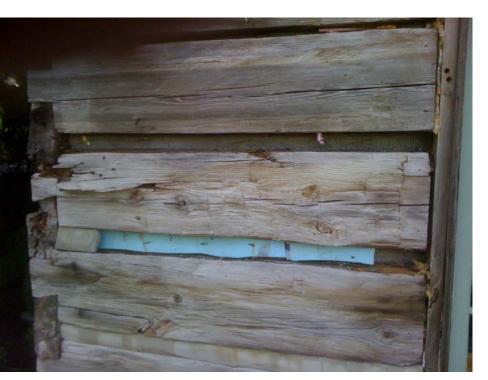
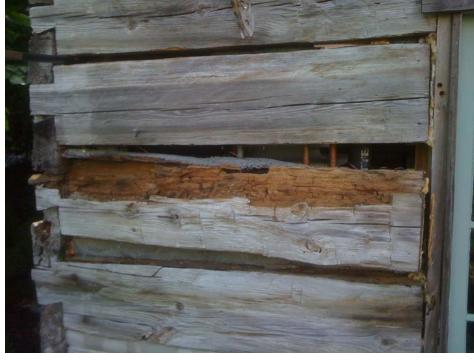
OTHER LOGS

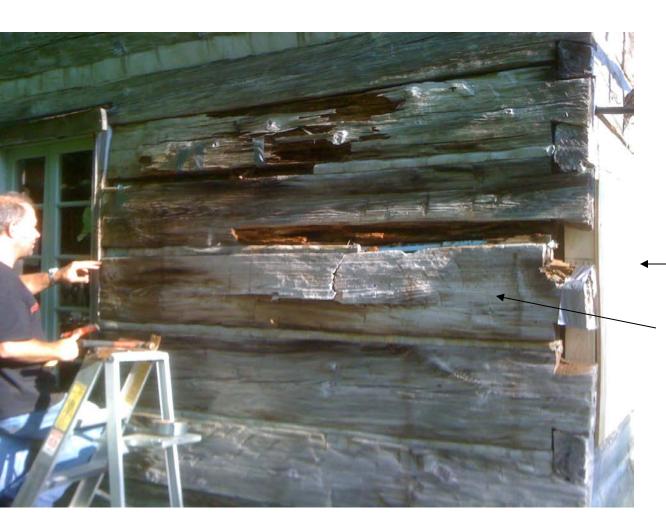
THESE LOGS HAVE BEEN REMOVED.

TEMP. STUD &
PLYWOOD INFILL

STUDY LOG

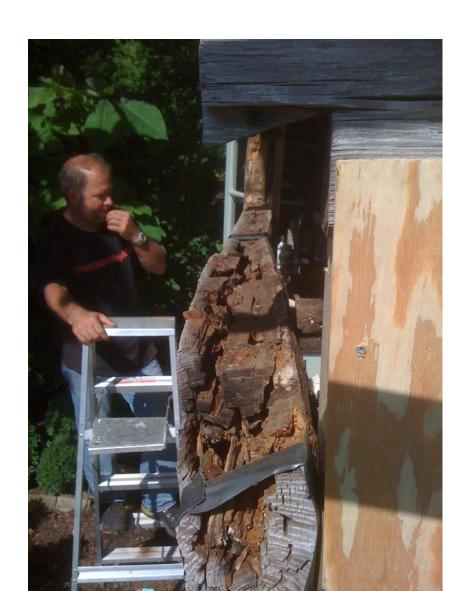
STUDY LOG FROM THE END SHOWING THE CONDITION OF THE CORE

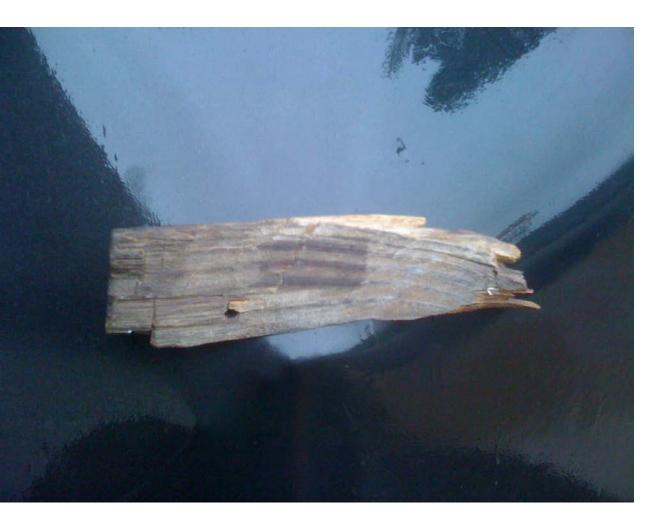
EPOXY SPILLED ON THE FACE STAINED THE CENTER.
BOTH ACRYLICS WHEN REMOVED WITH AMMONIA PROTECTED THE GREY. THE AREA ABOVE AND BELOW THE EPOXY STAIN HAD NO TREATMENT.

THE FUTURE FLOOR FINISH ON THE RIGHT SIDE WAS THE LEAST VISIBLE.

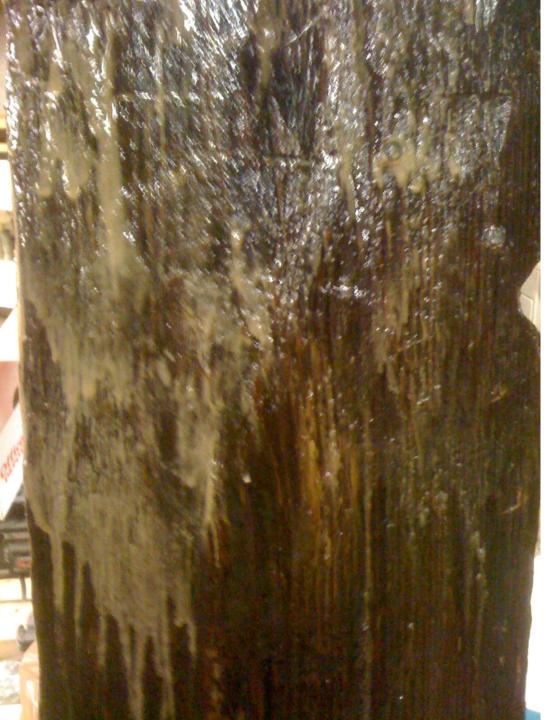
DARKNESS WAS DEFINITELY SCARY

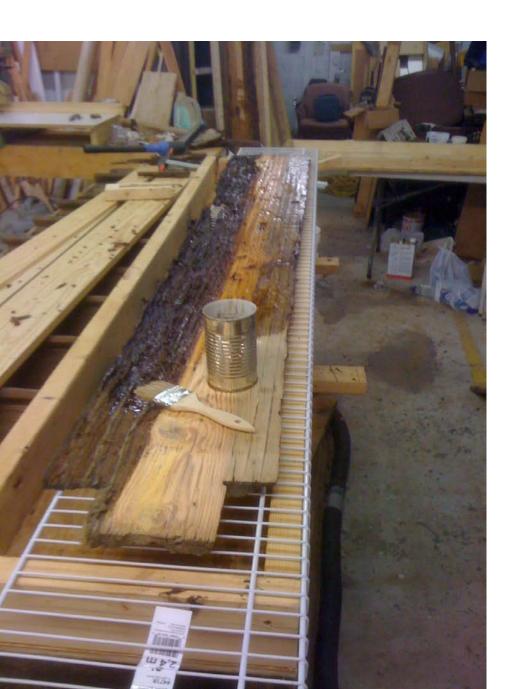
SOME AREAS WERE COATED
WITH A WHITE SCUM —
POSSIBLY BORATE LEACHING
AND INTERACTING WITH THE
ACRYLIC.

IT ALSO CAME OFF WITH AMMONIA.

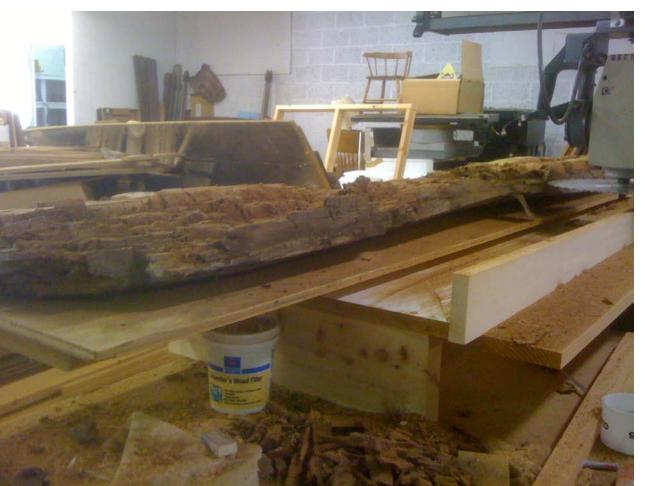
SOME FACES WERE MORE OF A PROBLEM

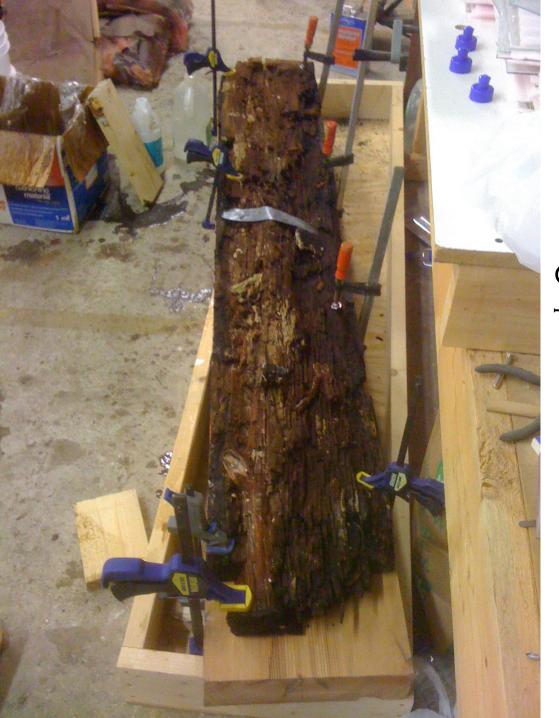
THIS ONE WAS SO
WARPED IT HAD TO BE
FLATTENED AFTER
SOAKING BEFORE IT
COULD BE CUT DOWN
TO A FACE

CLAMPED TO A CORE
TO DRY FLAT

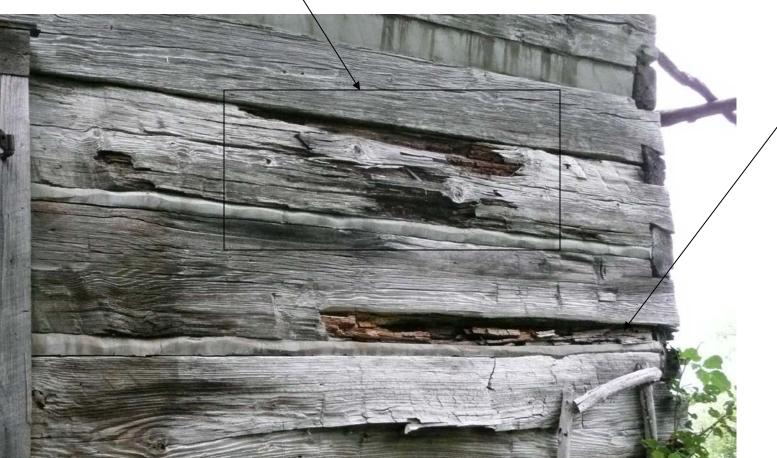
SOME WERE JUST MISSING PARTS OR SO THIN TO PRECLUDE REUSE IN THIS — EXTERIOR APPLICATION

THIS HAD BEEN SALVAGED BY
THE OWNER

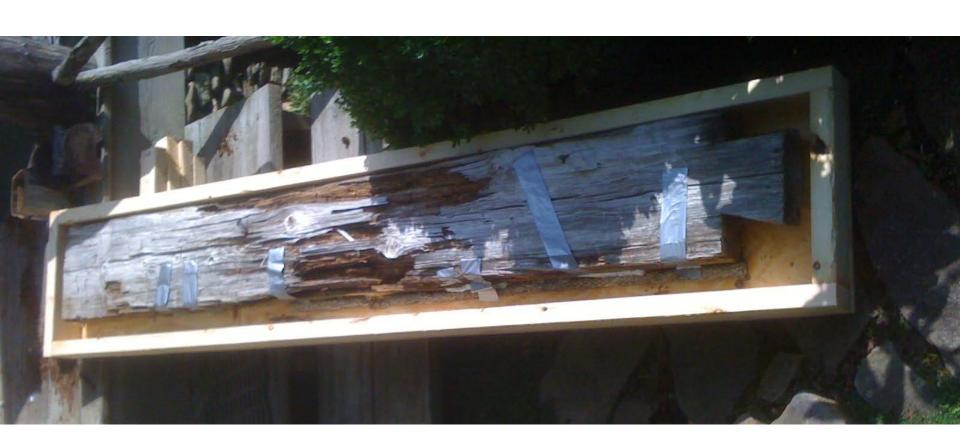
PROBABLY THE WORST

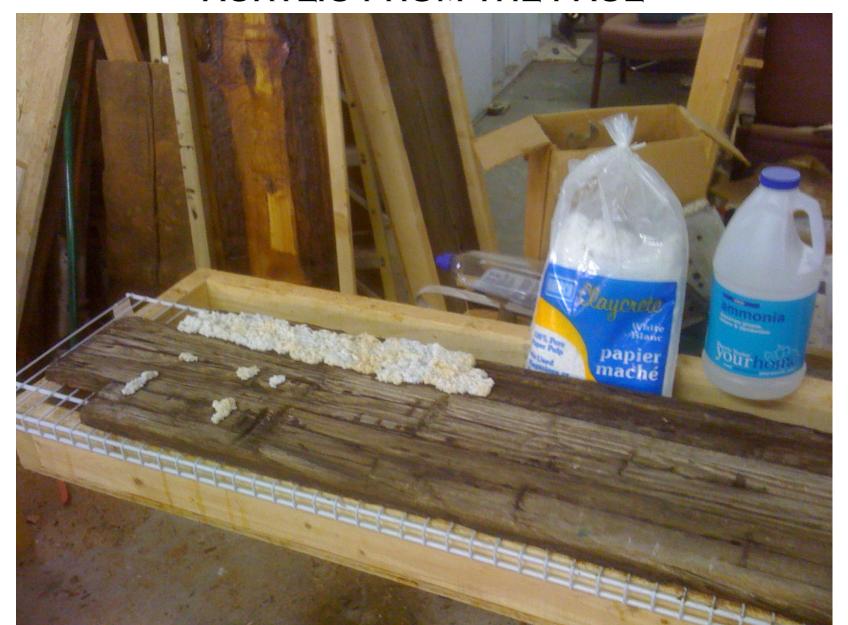
SOME NEEDED A POULTICE TO REMOVE EXCESS ACRYLIC FROM THE FACE

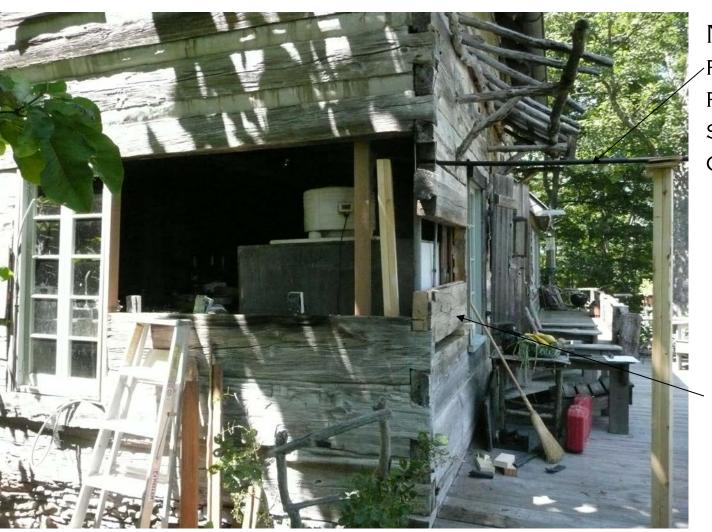
NOTE THE STEEL ROD ON THE 4X4 POSTS SUPPORTING THE CORNER
