# VIOLET BANK CEMETERY

STONE WALL CONSERVATION

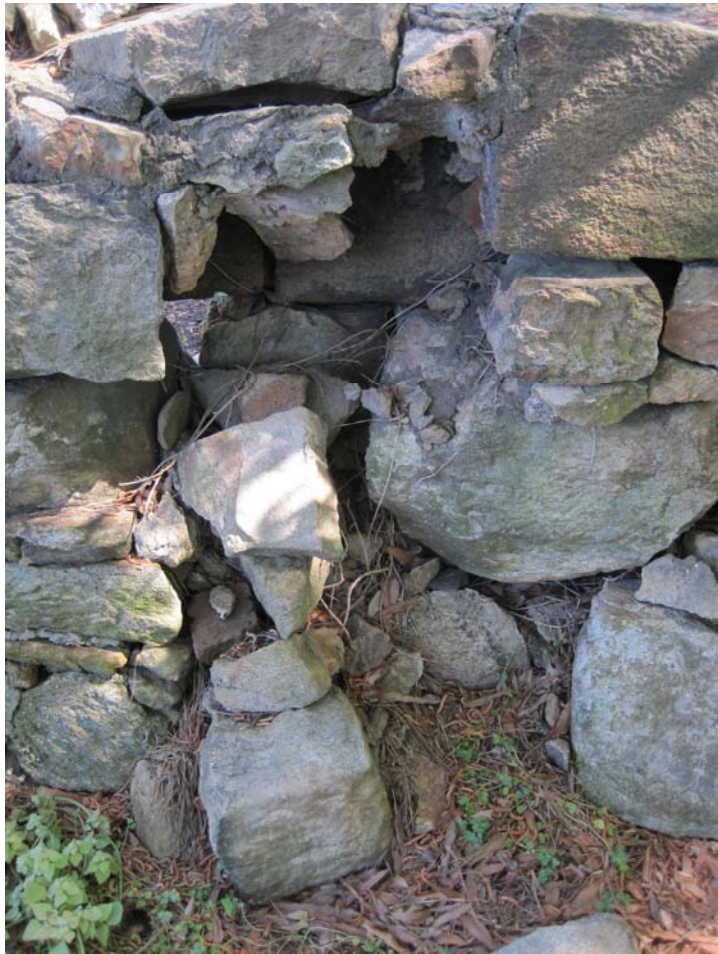
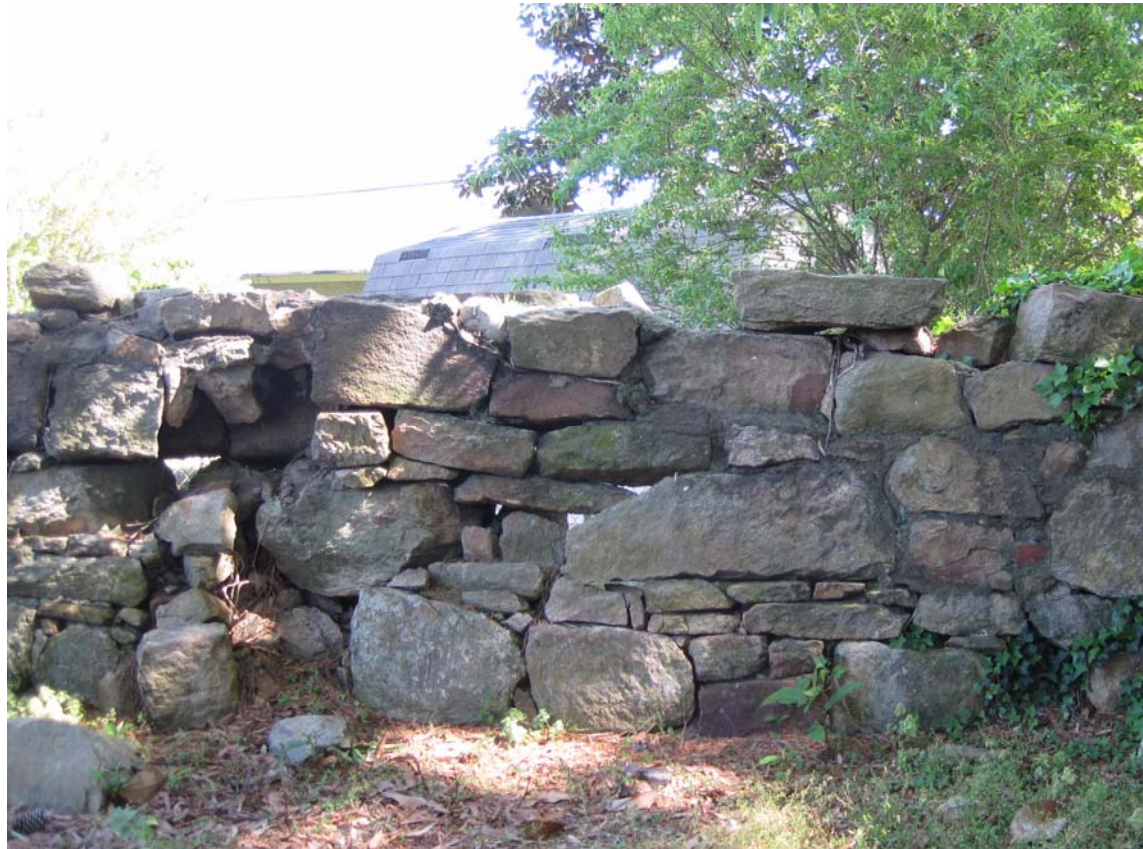
# UNFORTUNATELY THE NORTH WALL IS COLLAPSING

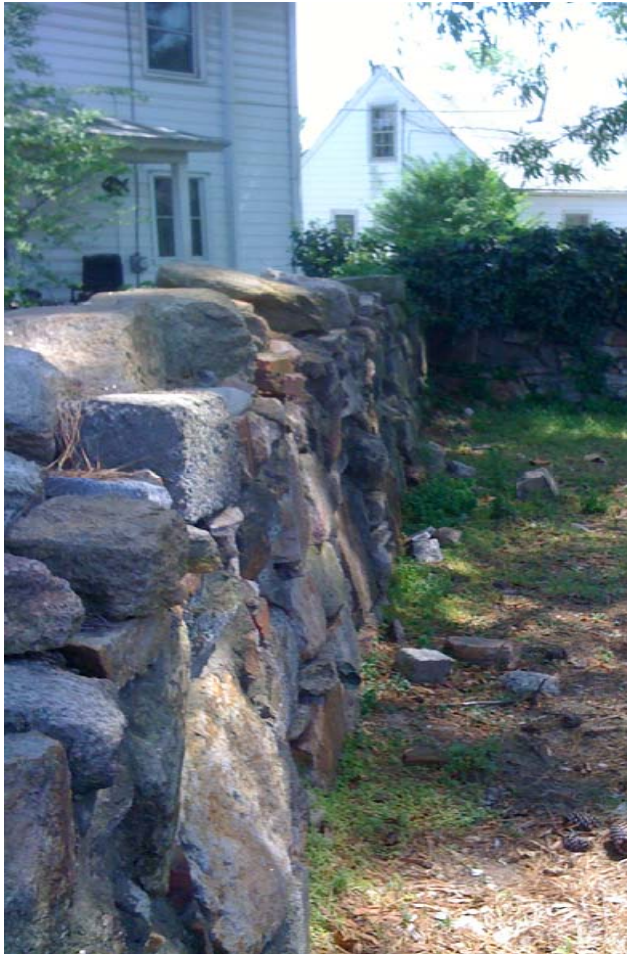
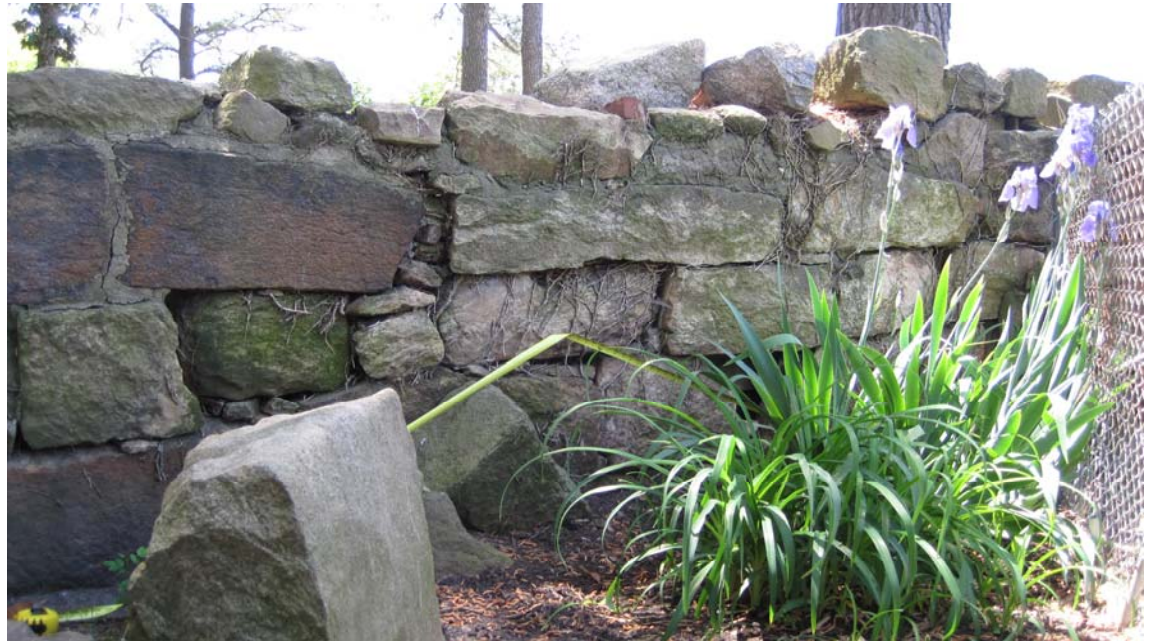
# BOWS AND LEANS

IN ADDITION TO THE WALL  
LEANING 8 INCHES,

THE BASE STONES ARE  
ROTATING, BUCKLING THE  
WALL AND DUMPING OUT  
MAJOR STONES

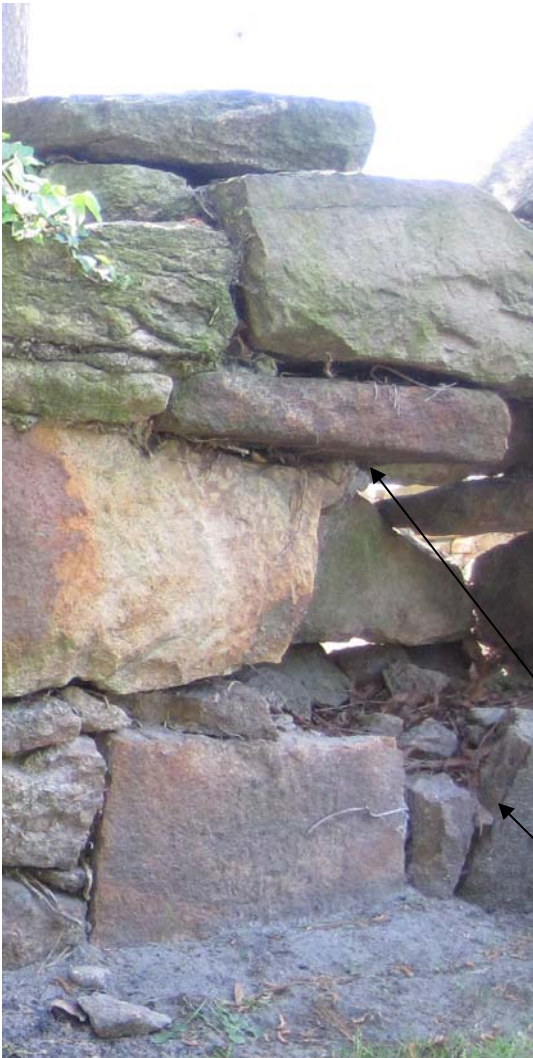
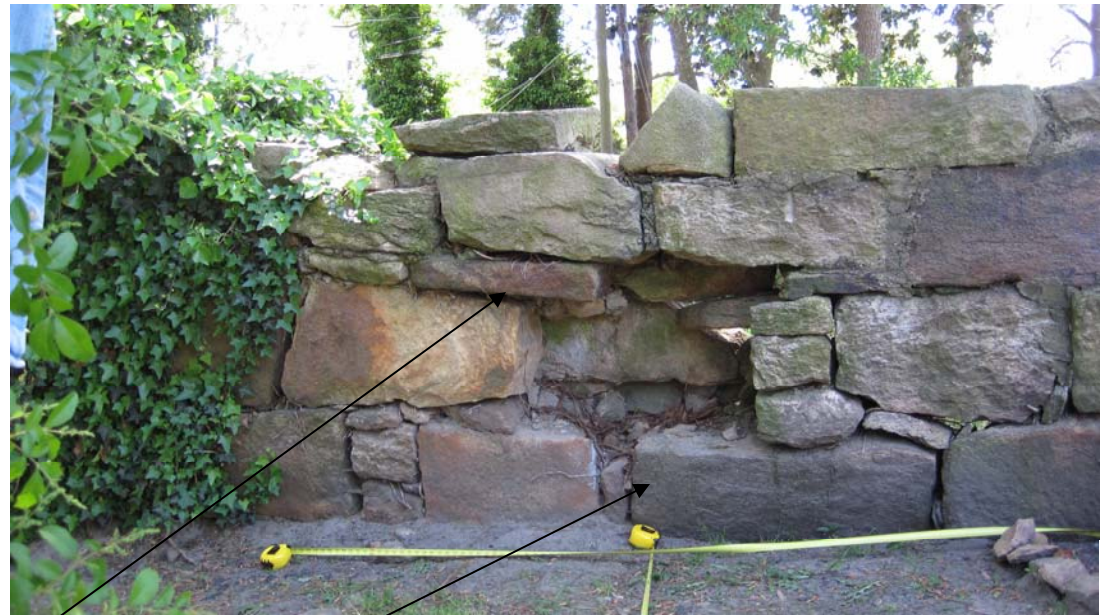
# NO ONE WANTED TO STAND NEXT TO THIS ONE

NOTE THE OVERHANG HERE  
AND  
THE ROTATION OF THIS STONE

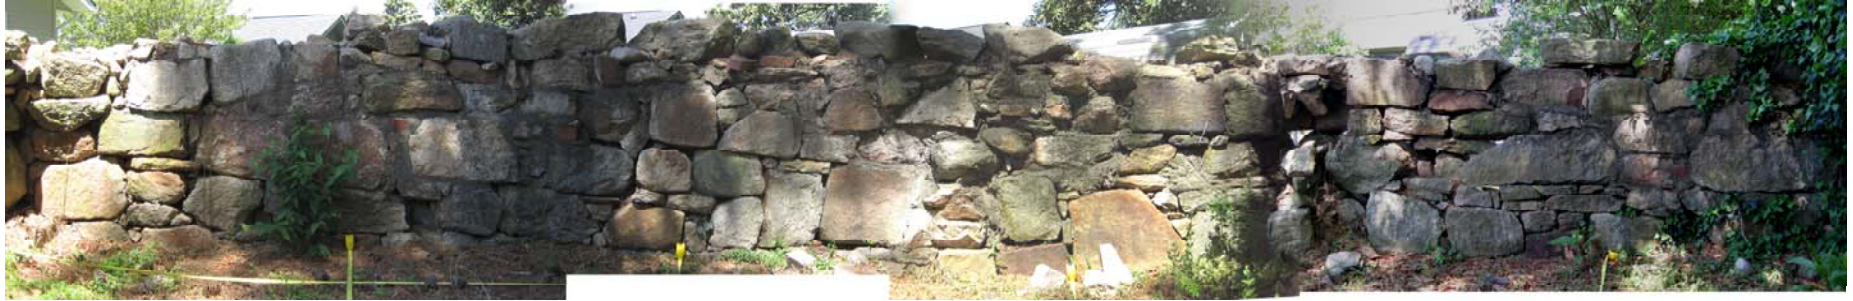
WALL VIEWED FROM INSIDE OF CEMETERY

# NORTH WALL BEFORE

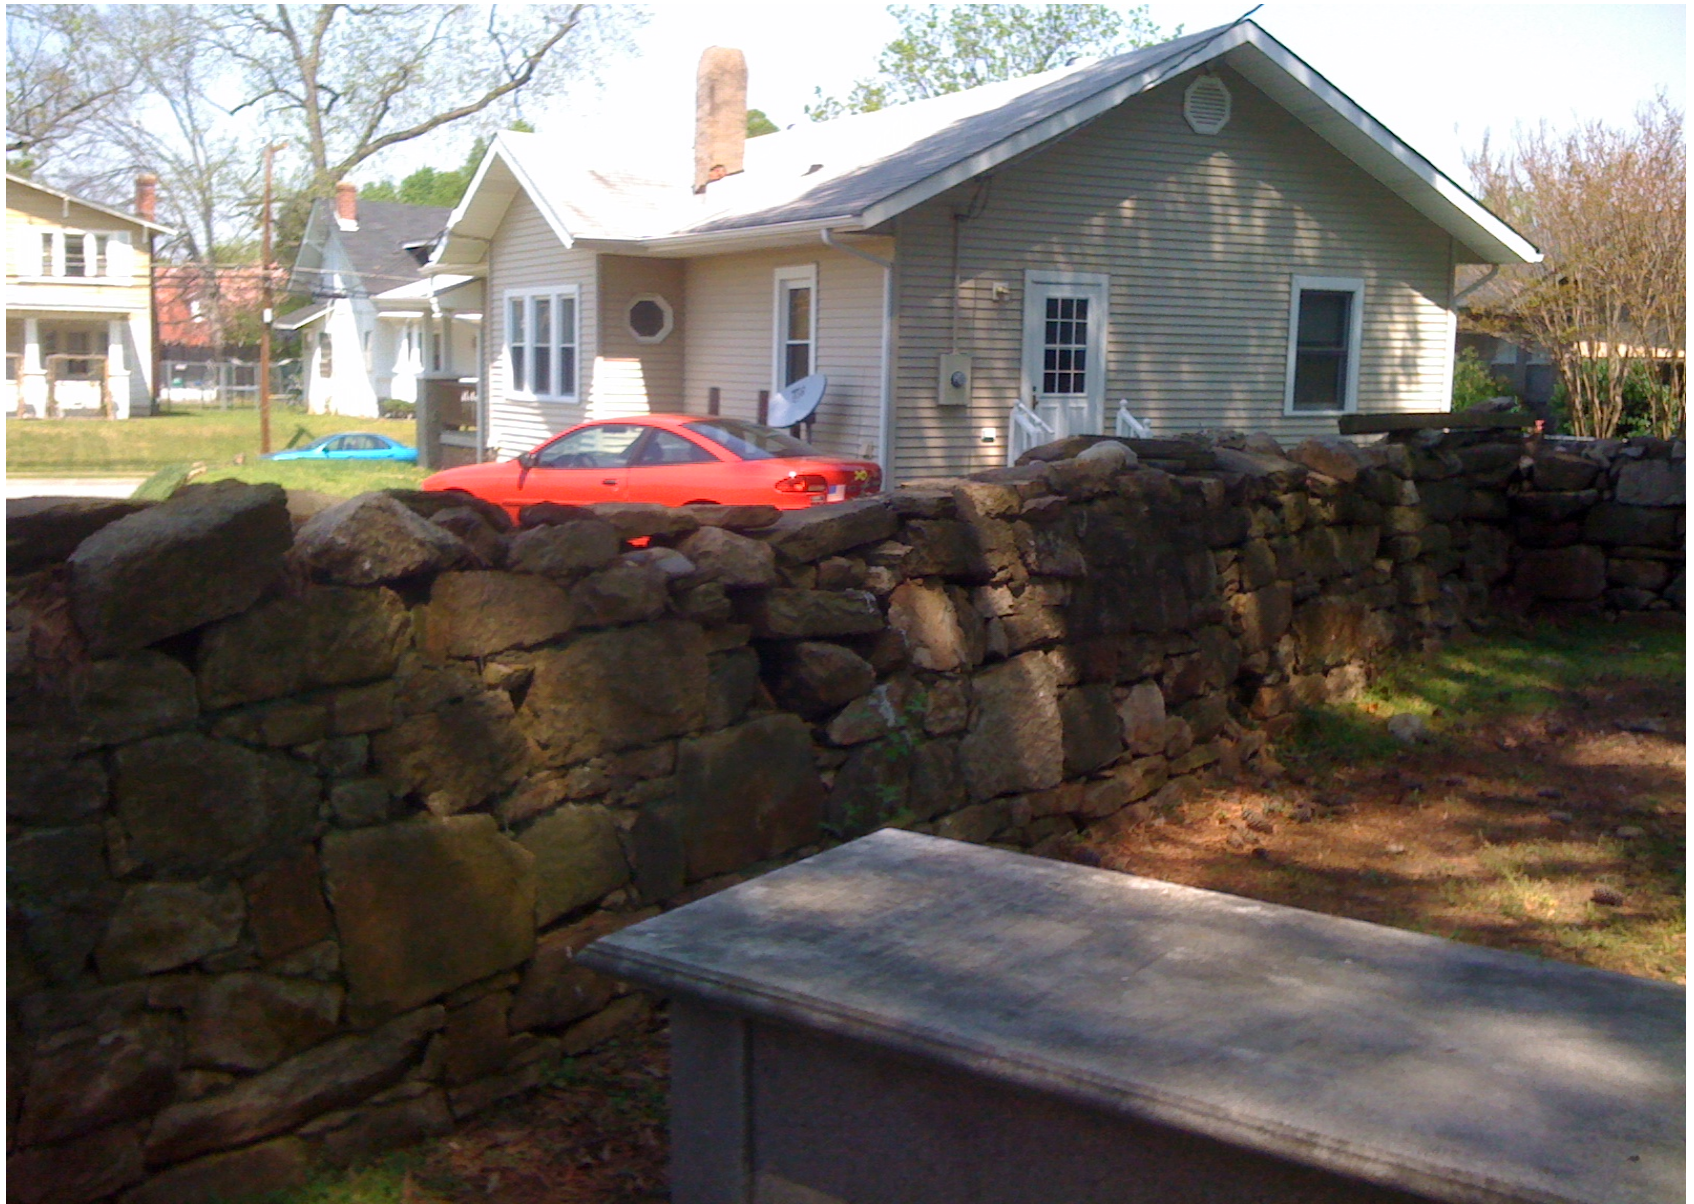
# WEST WALL LEANING

THE WEST WALL IS ALSO  
LEANING AND

APPEARS TO HAVE COLLAPSED  
IN TWO PLACES THAT HAVE BEEN  
POORLY REBUILT

ANOTHER SIGNIFICANT AREA IS  
BOUND UP IN PORTLAND  
CEMENT

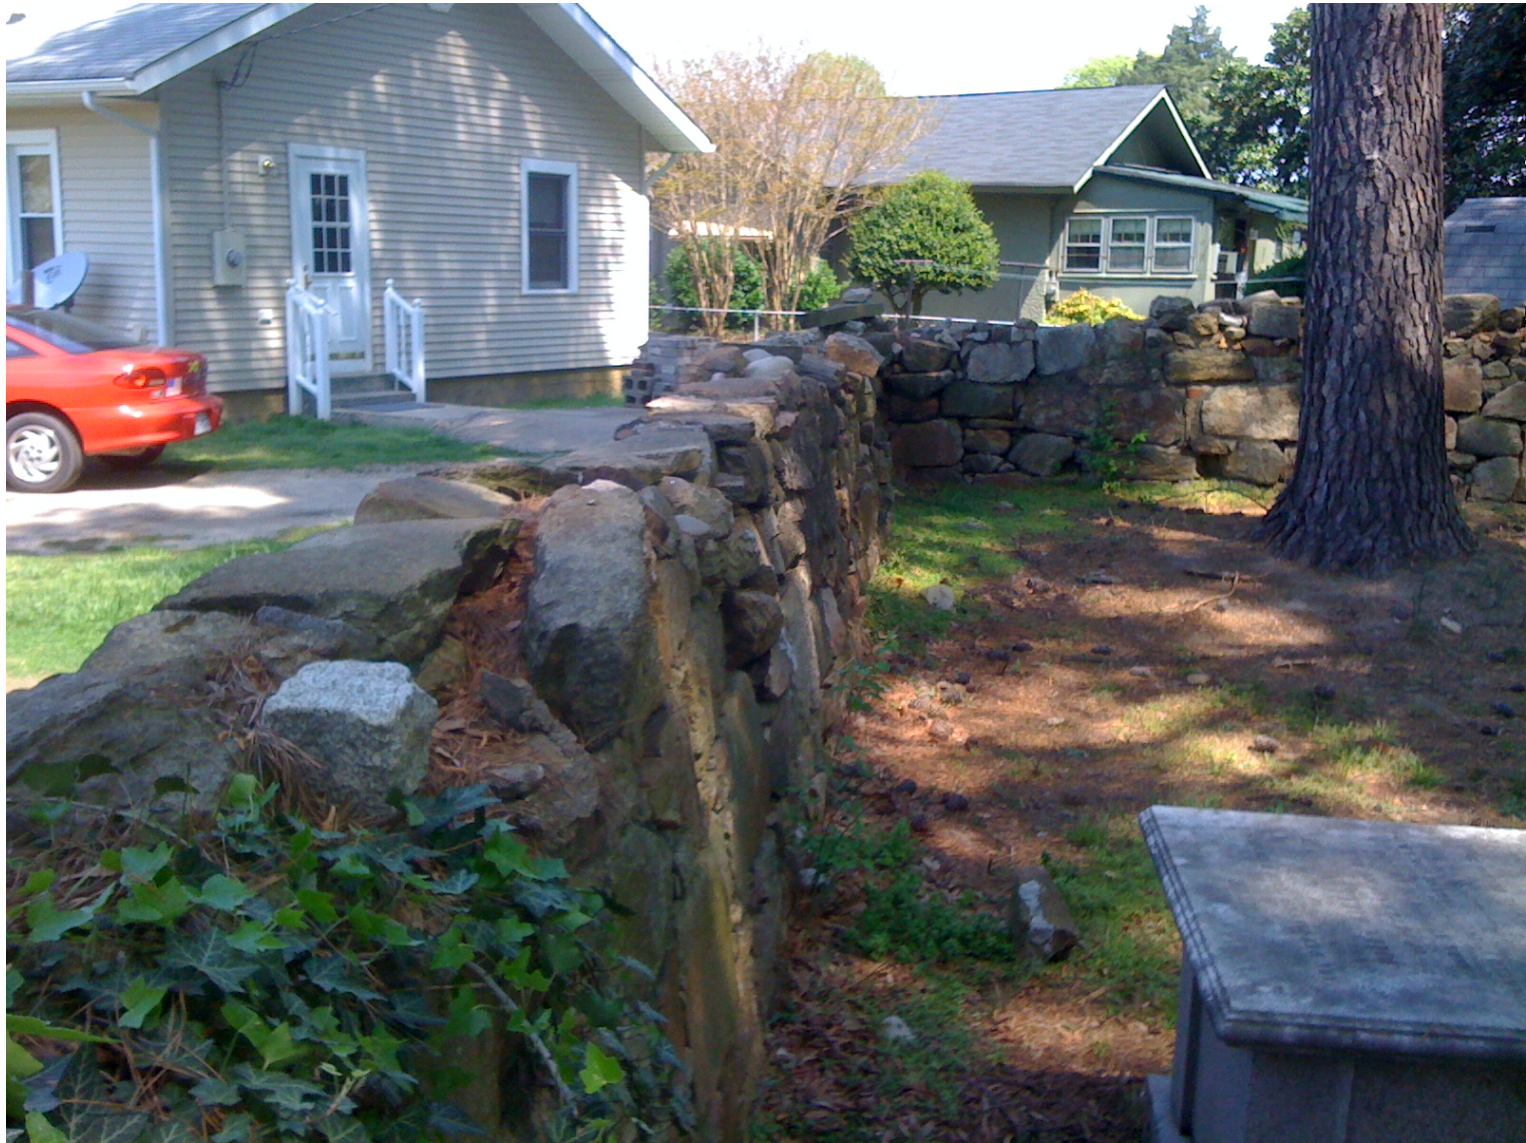
# WEST WALL LOOKING NORTH

PRIOR COLLAPSE  
UNSTABLY LAYED AS A LEANING  
JUMBLE OF STONE

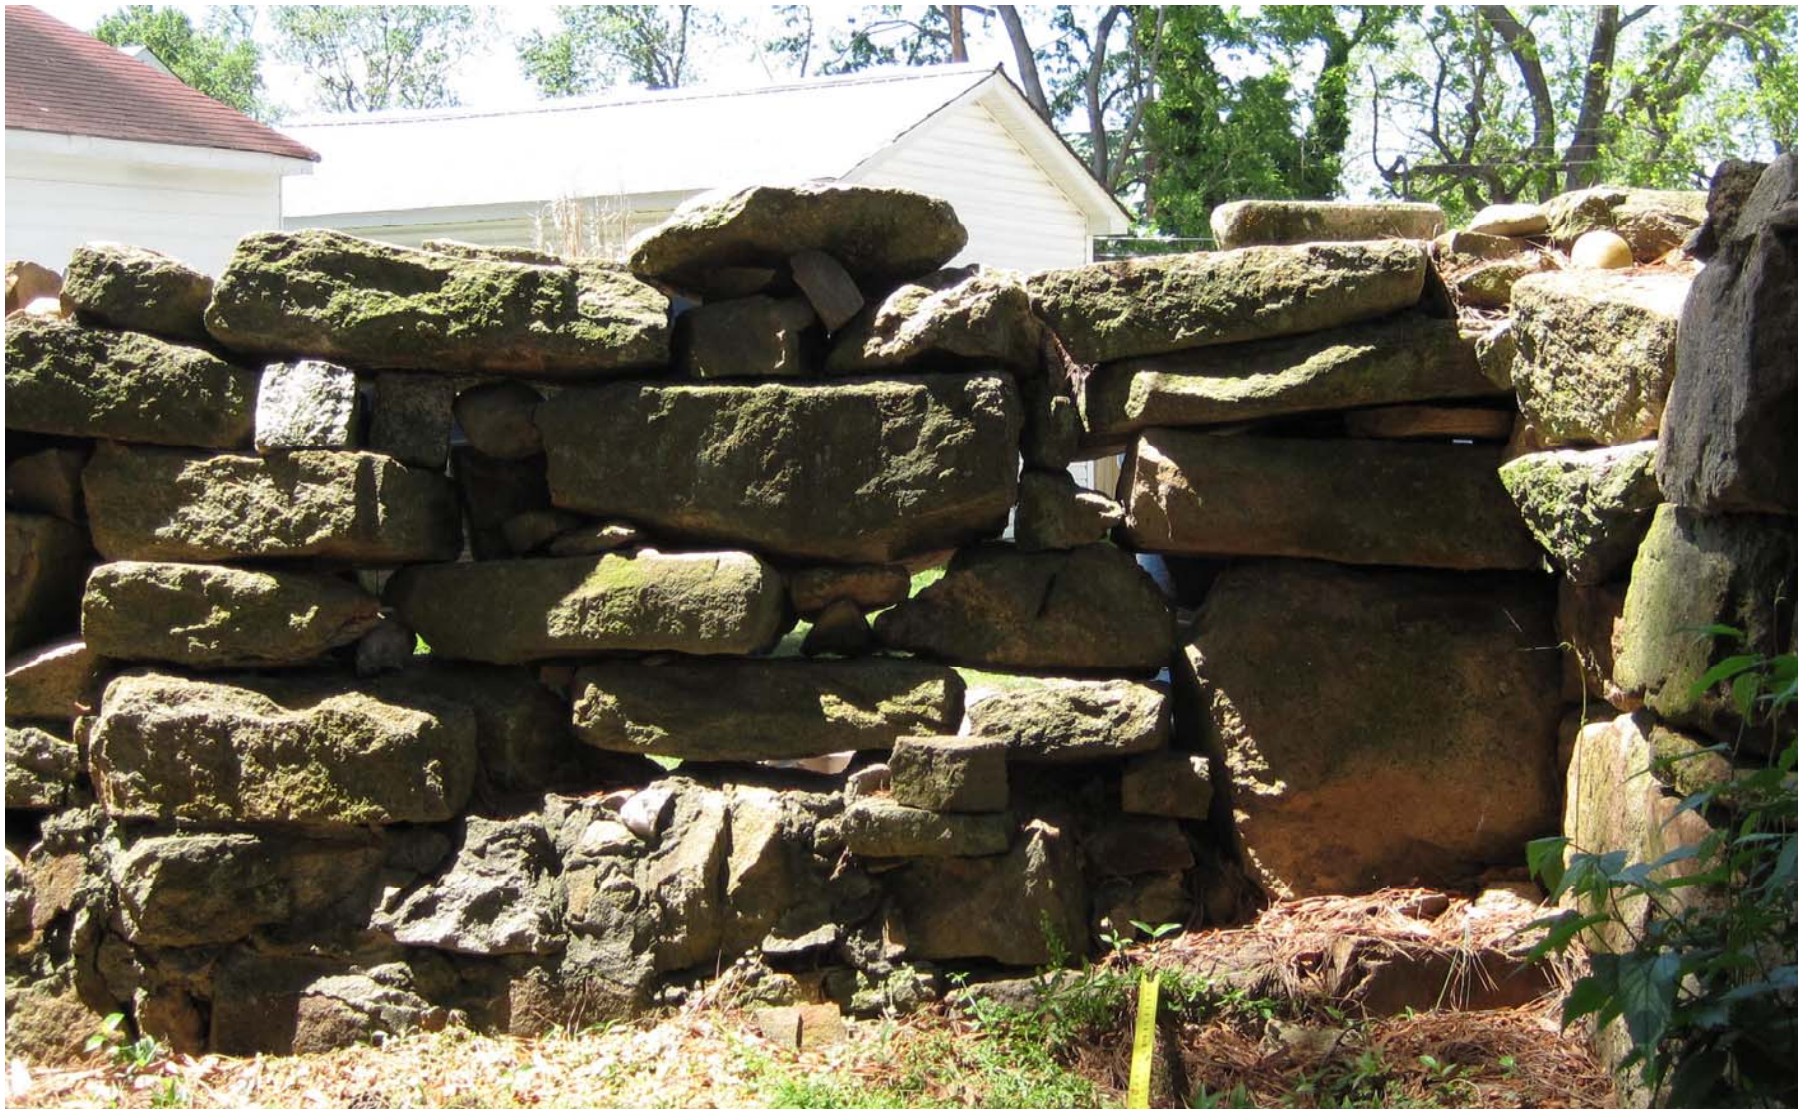
# THE OTHER PRIMARY AREA OF COLLAPSE UNSTABLY REBUILT

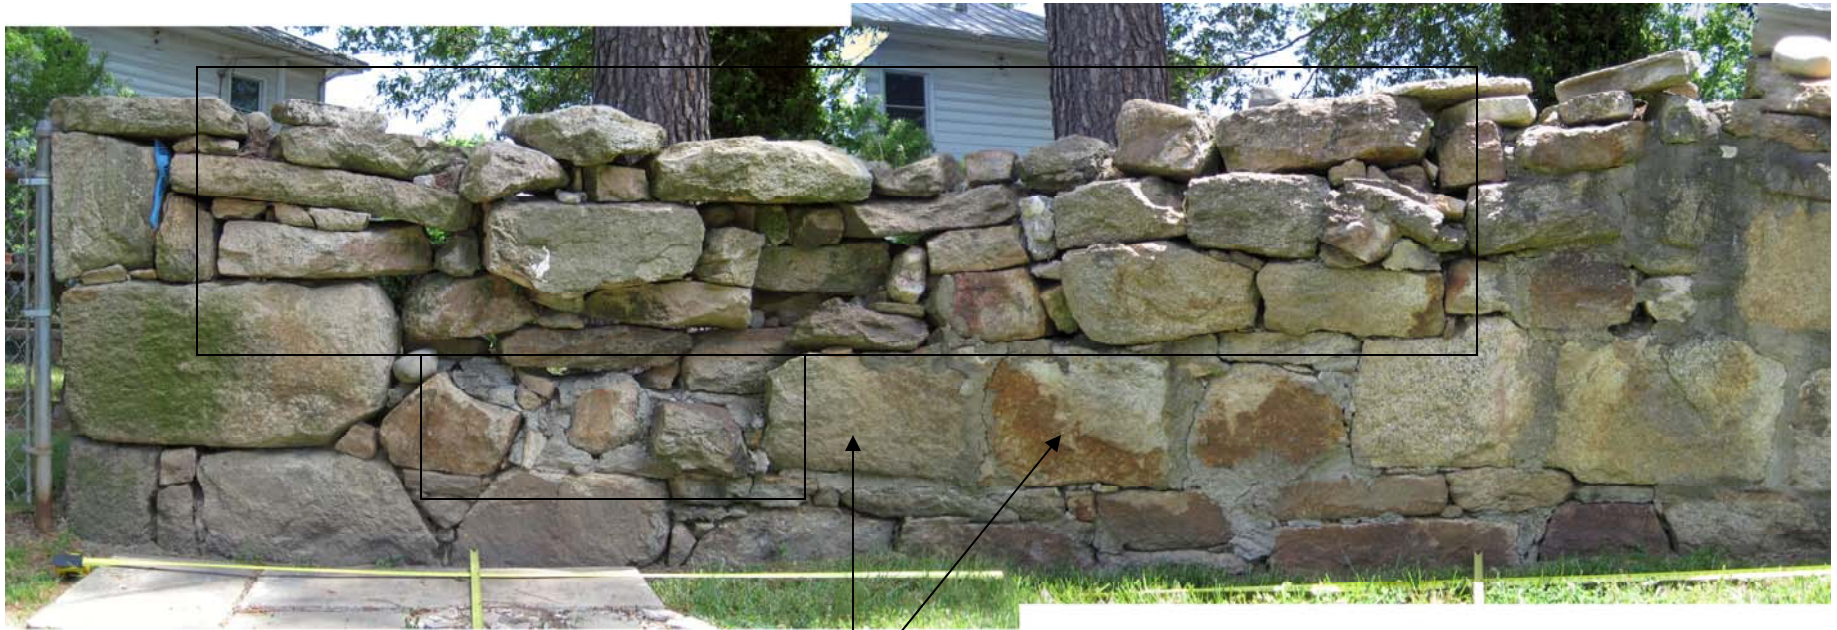
# UNSTABLE RUBBLE VIEWED FROM THE OUTSIDE

NOTE THESE TWO STONES ARE LEANING OUT ENOUGH TO REQUIRE RE-SETTING

THIS AREA BOUND UP WITH PORTLAND  
CEMENT  
LEANS BUT APPEARS TO BE PRESENTLY  
STABLE

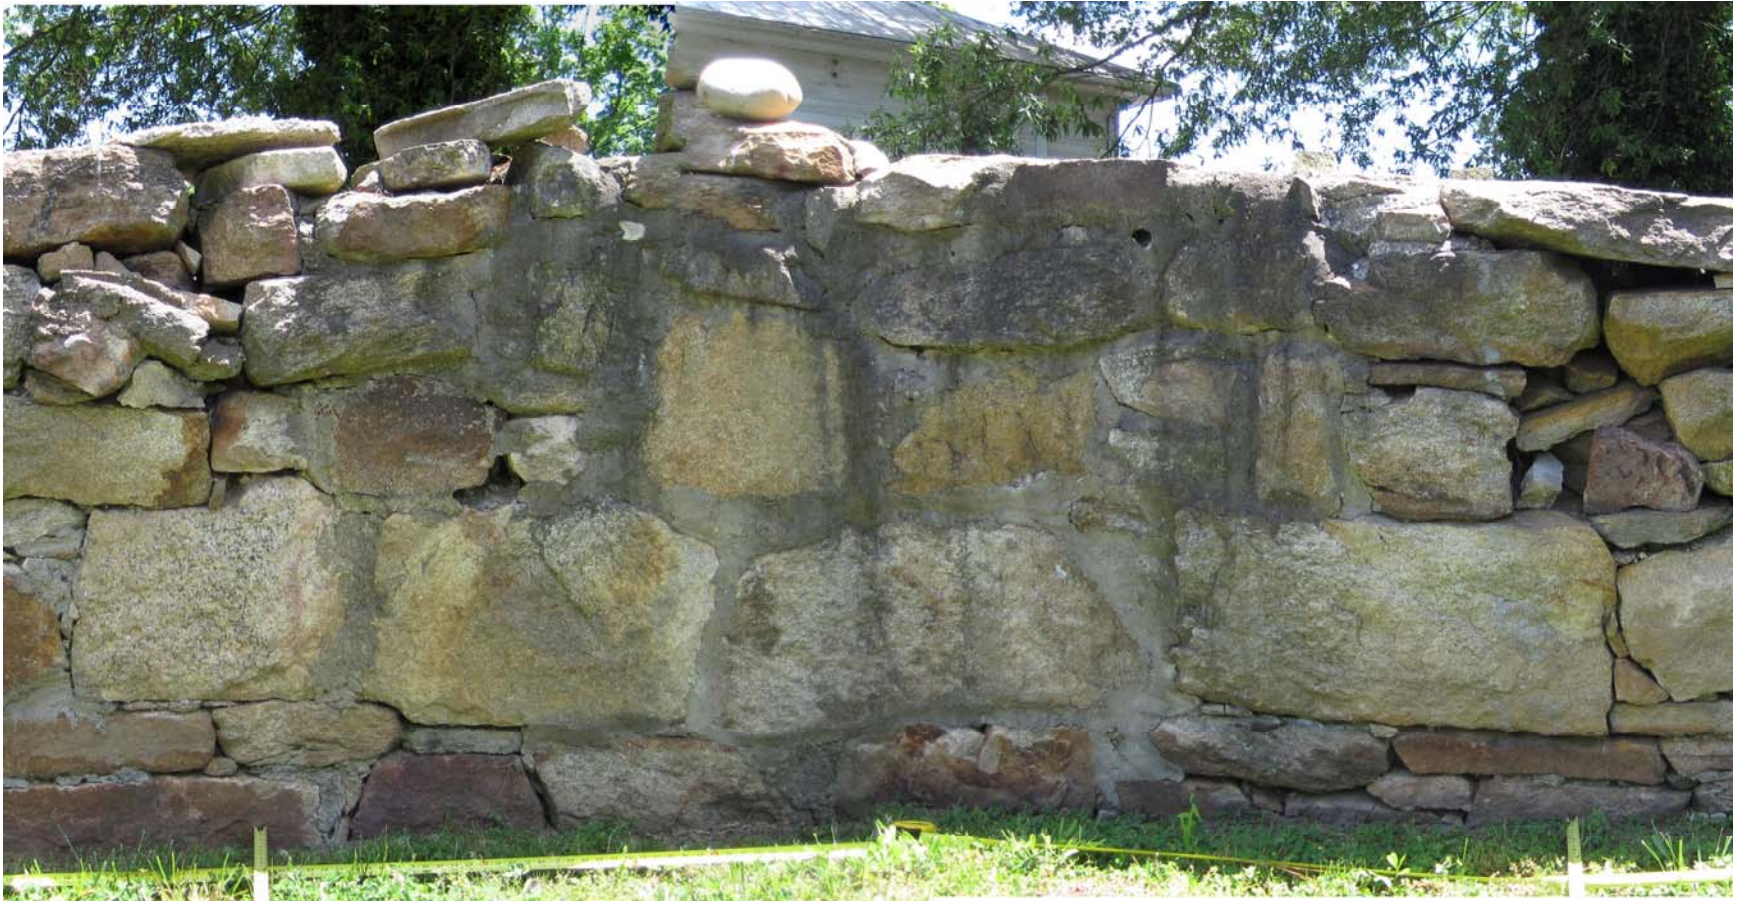
NOTE THE PORTLAND CEMENT SPANS BETWEEN THE TWO RUBBLE AREAS

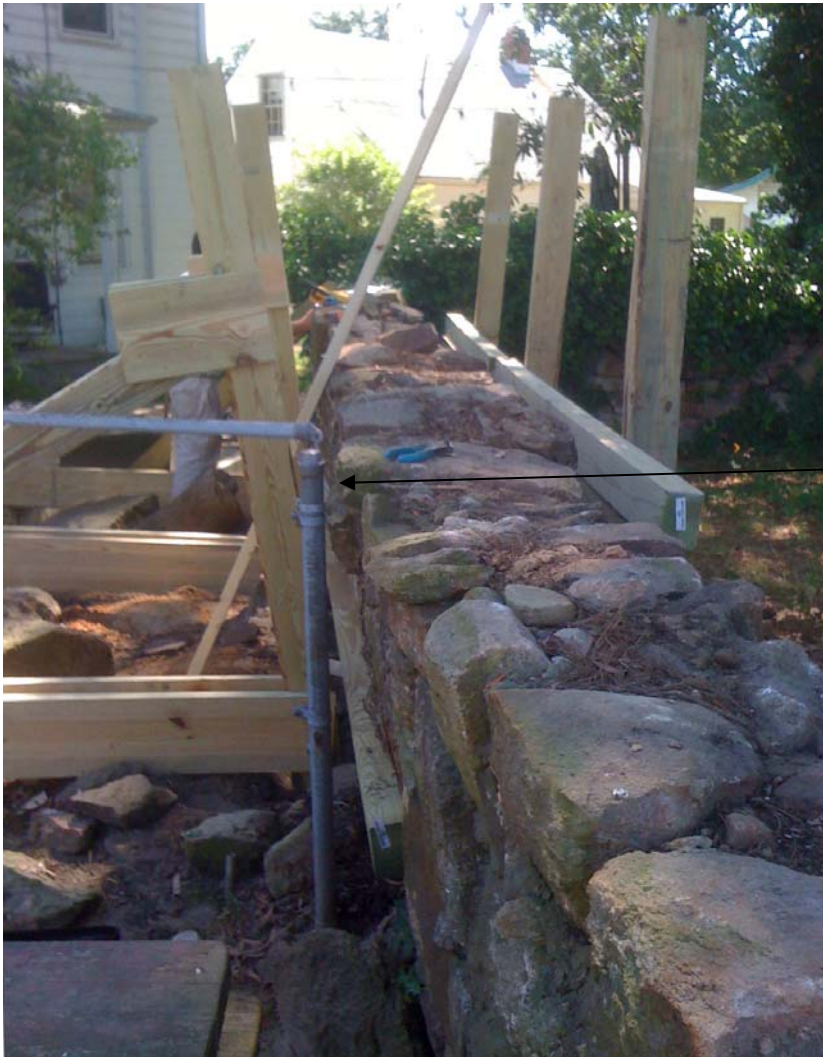
NOTE THE WALL IS LEANING OVER TO MEET THE CHAINLINK POST

# GETTING THE CRIBBING IN PLACE

WITH THE LEFT HAND BRACES IN PLACE, IT IS SAFER TO WORK ON THE OUTSIDE OF THE WALL

LEFT HAND CRIBBING IS JUST BEING PLACED

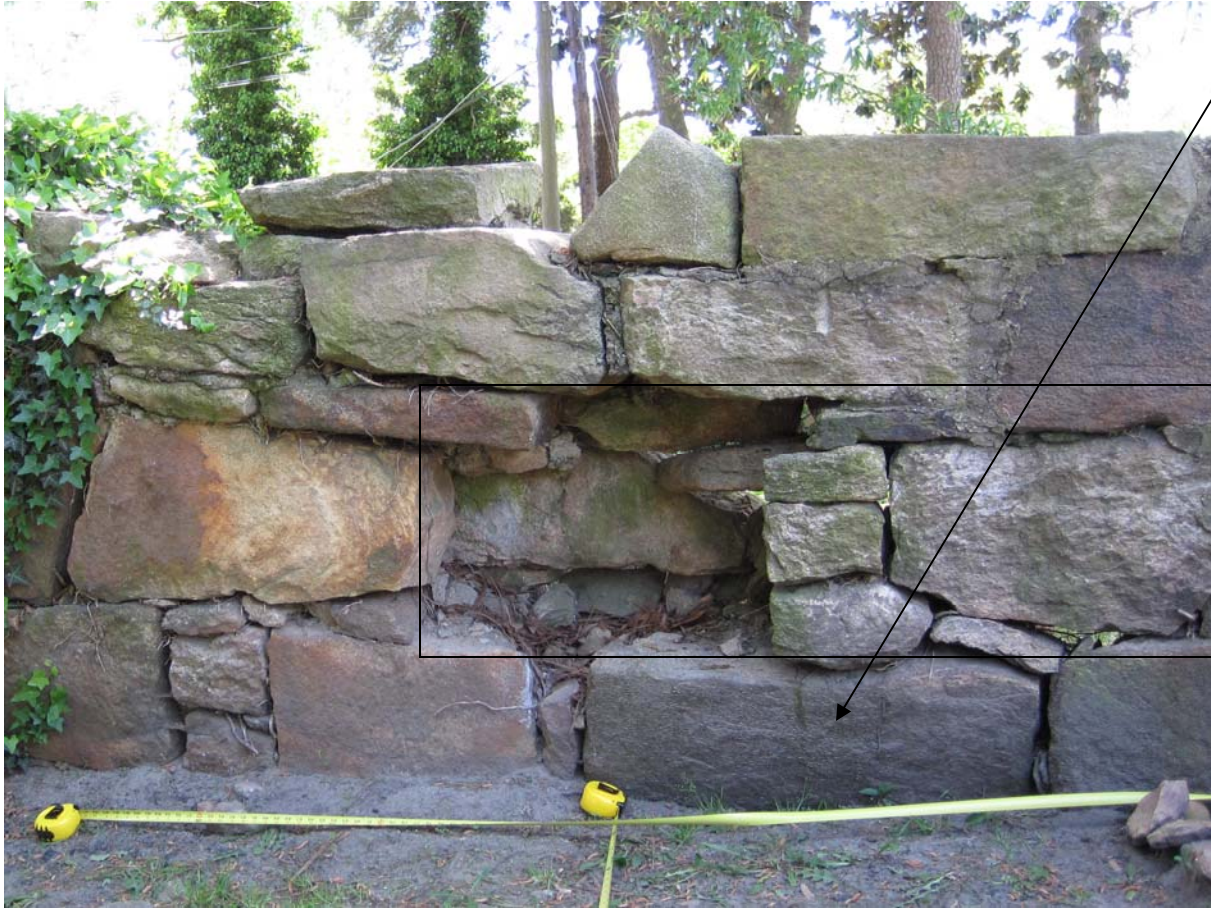
THIS STONE DEFIED REPOSITIONING AND FINISHED ROLLING OVER WHEN PRODDED, TAKING THE MAJOR STONES IN THE MIDDLE OF THE WALL WITH IT.

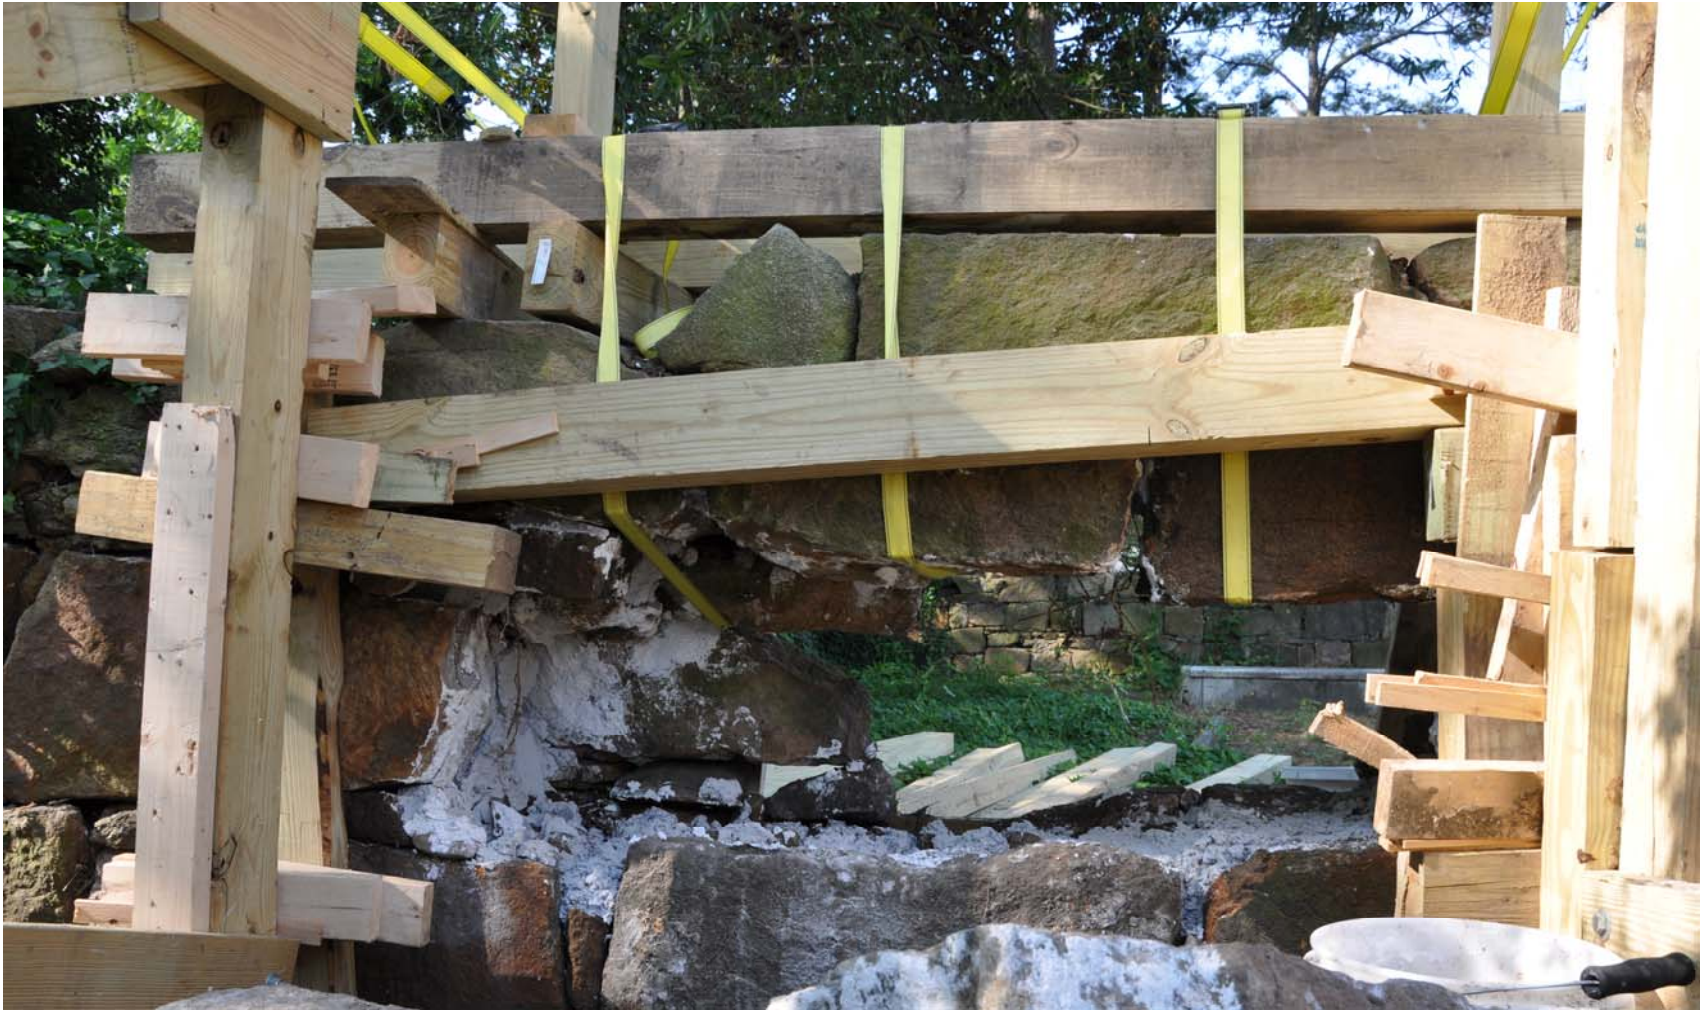
THIS PHOTO IS TAKEN AFTER THE LARGE CENTER STONE AND THE ONES ON EITHER SIDE WERE REPOSITIONED BACK OVER THE FOOTING [HAVING SLID OFF THE FOOTING IS WHY THE STONE WAS ROTATED] AND THE INTERNAL VOID FILLED WITH MORTAR GRAVEL AND FIST SIZED STONES

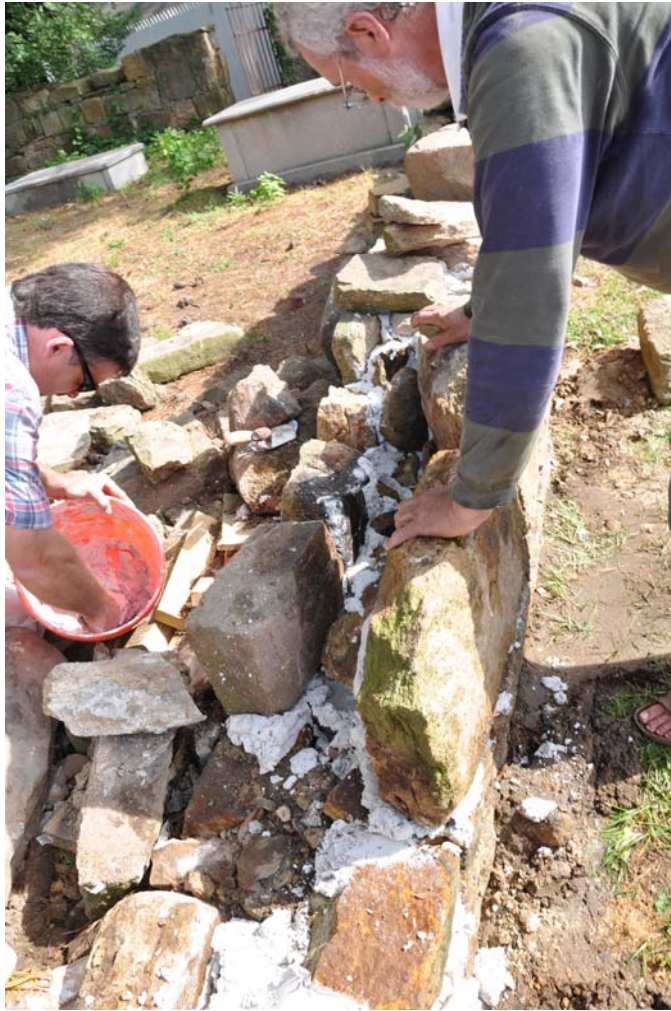
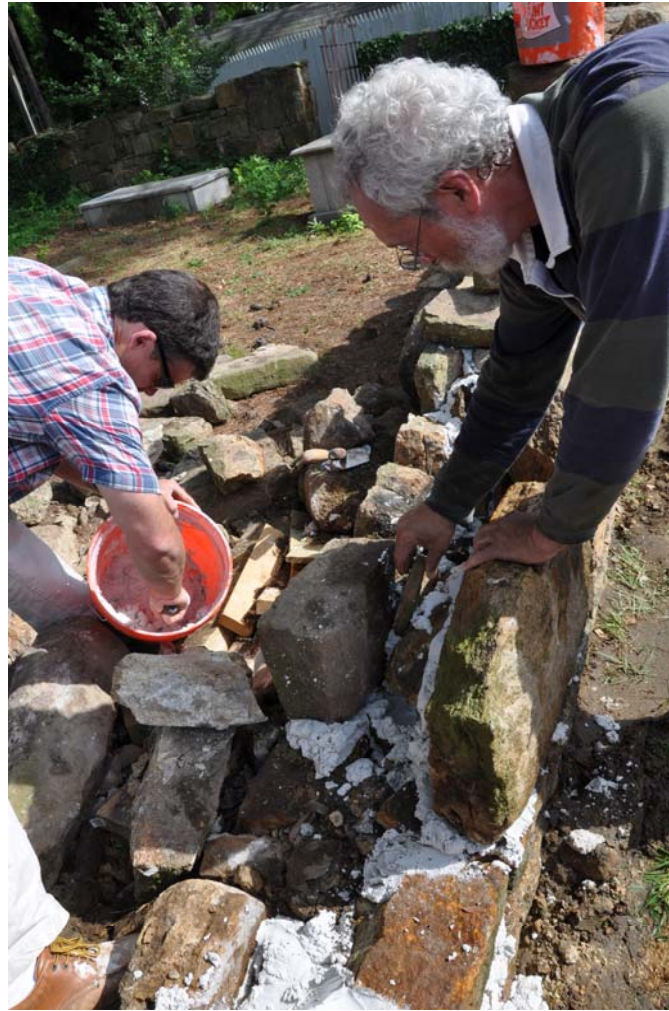
THESE VIEWS  
SHOW THE  
GENERAL  
CONSTRUCTION  
METHOD THAT  
USES PRIMARILY  
FACE STONES  
WITH SMALL  
RUBBLE INFILL.

ENOUGH  
THROUGH  
STONES ARE  
NECESSARY TO  
BIND THE FACES  
TOGETHER

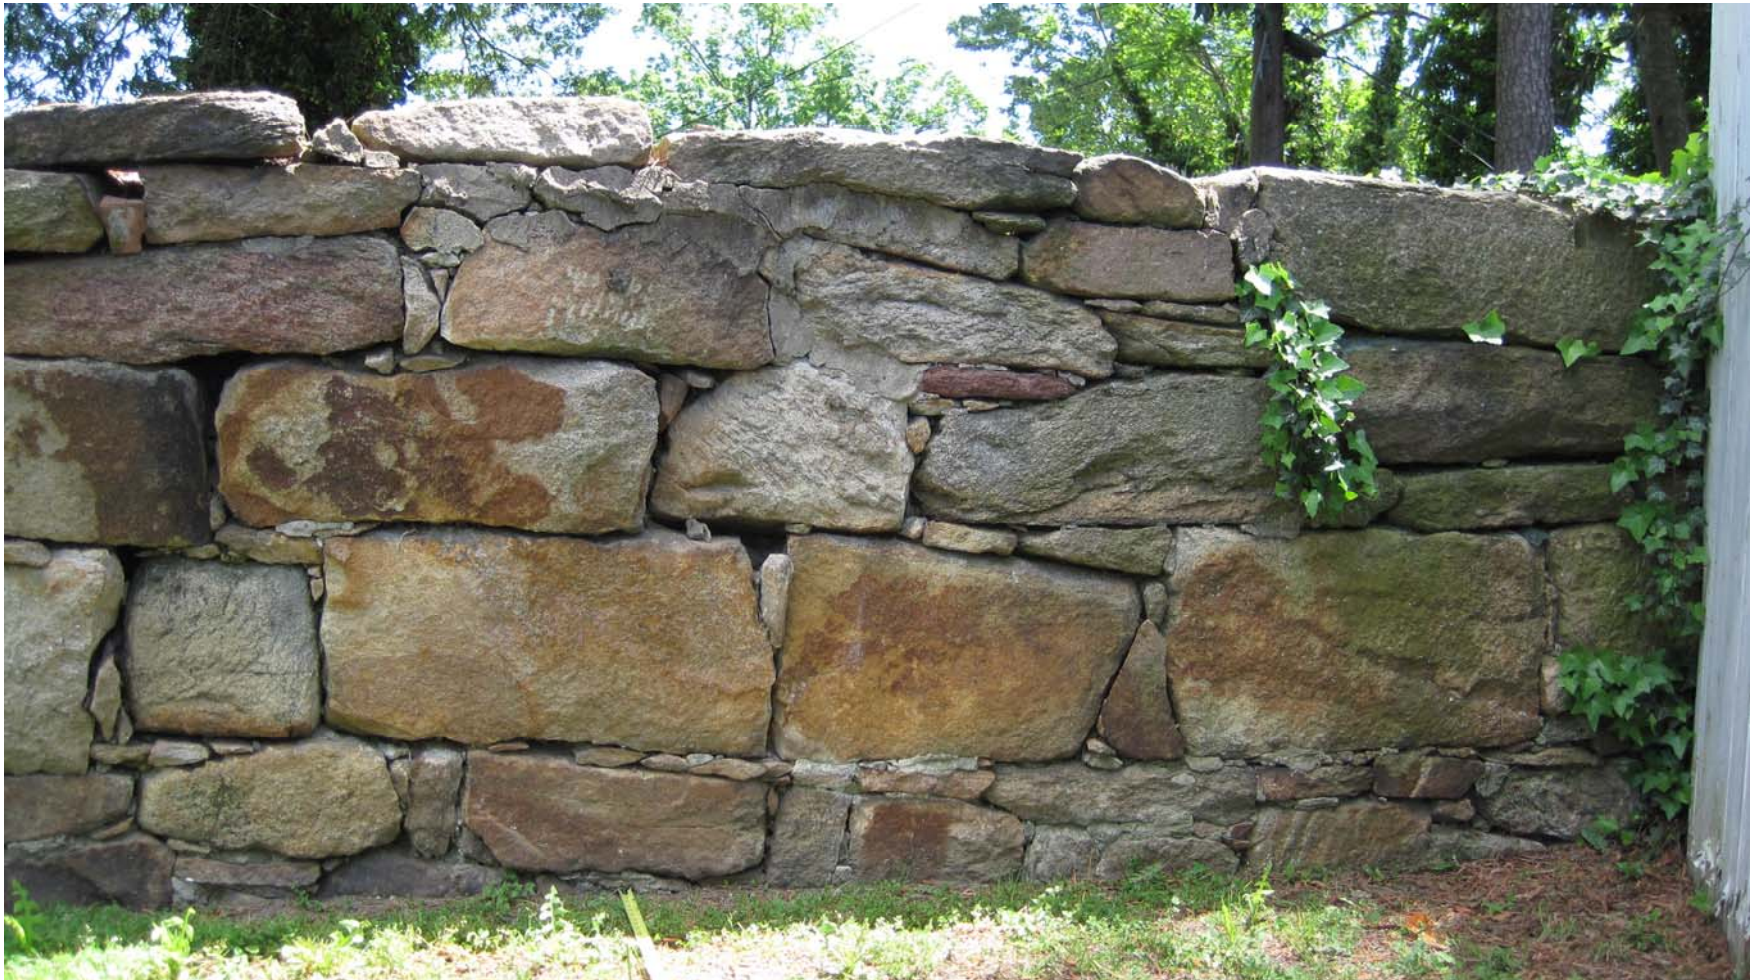
MAJOR FACE STONES RUN  
IN HORIZONTAL BANDS MAINTAINING  
THROUGH MORTAR JOINTS

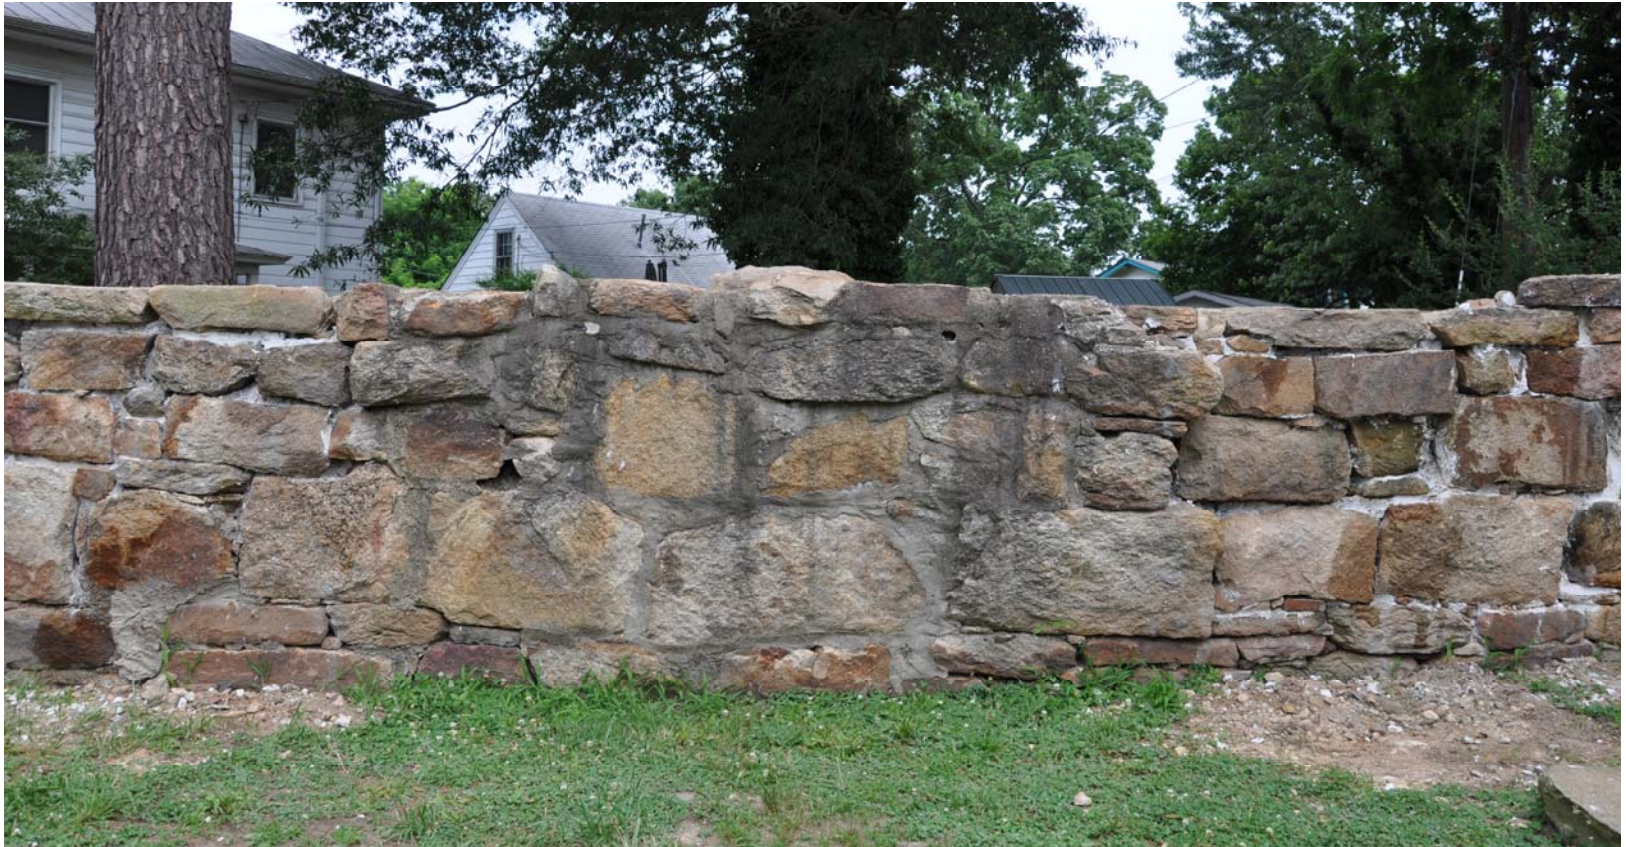
NOW THAT THE WALL ON EITHER  
SIDE IS STRAIGHT THE PORTLAND  
SECTION LOOKS WORSE

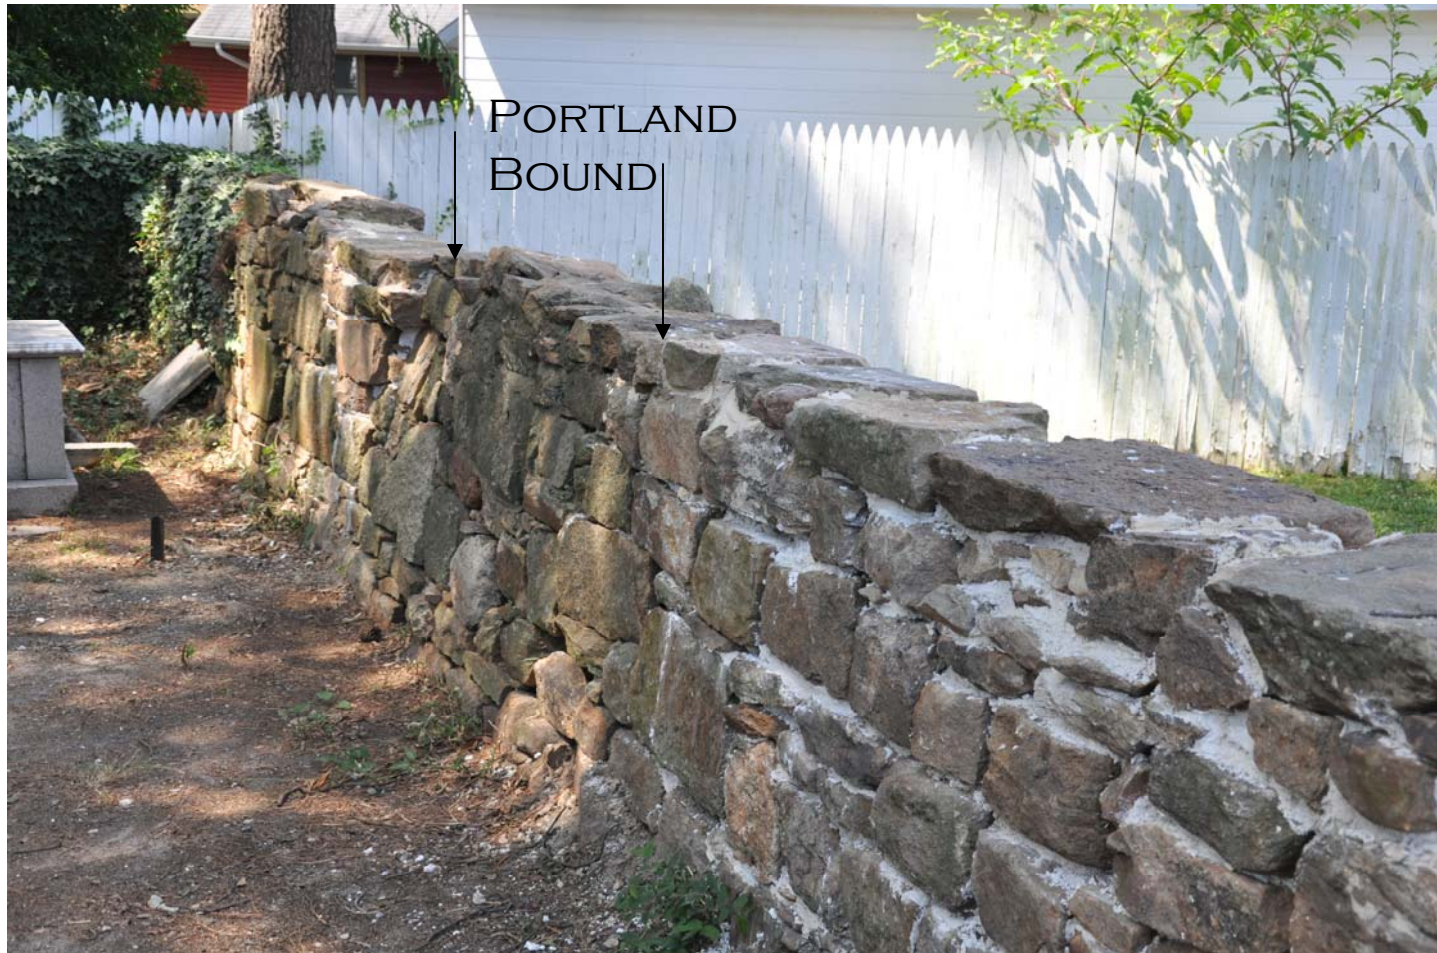
# THE PORTLAND CEMENT BOUND AREA LEFT LEANING AS IT WAS FOUND
