# VIOLET BANK CEMETERY

STONE WALL CONSERVATION

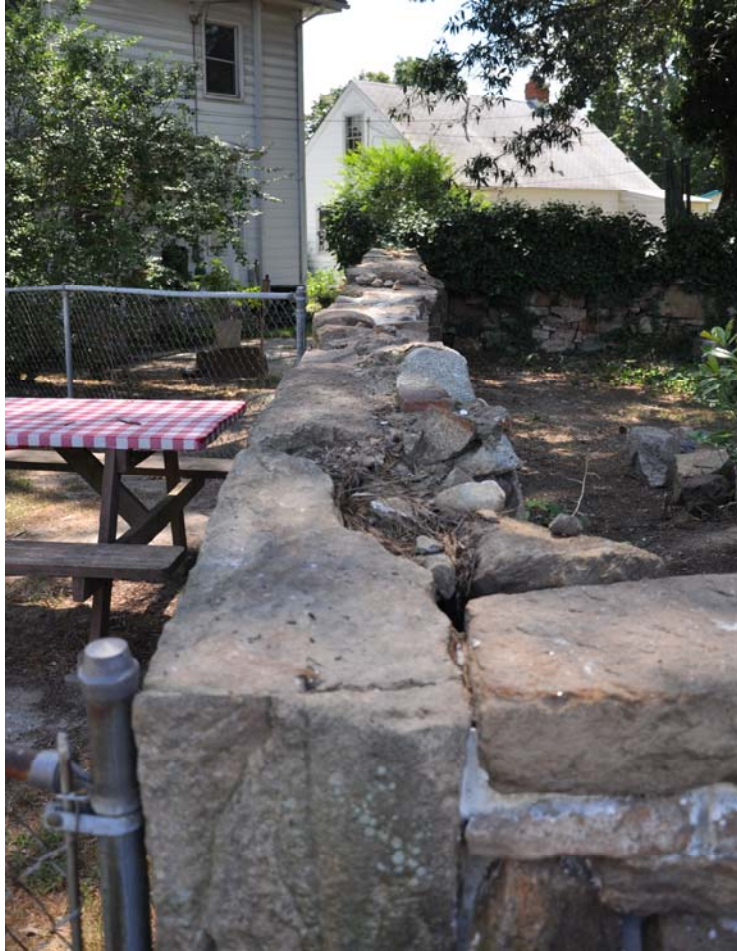
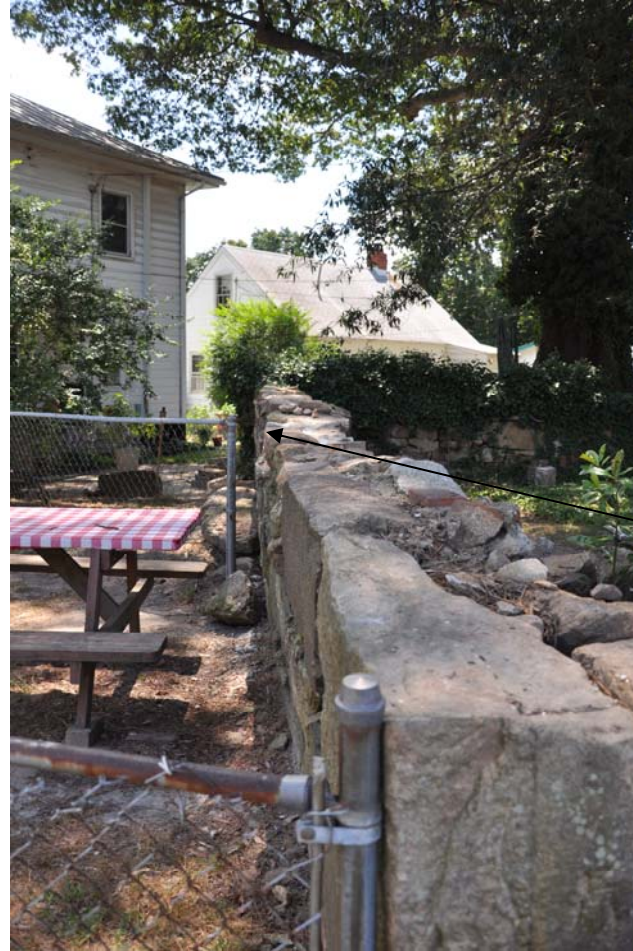
NOTE THE WALL  
NO LONGER  
LEANS OVER TO  
THE CHAINLINK  
POST BEYOND  
THE TABLE

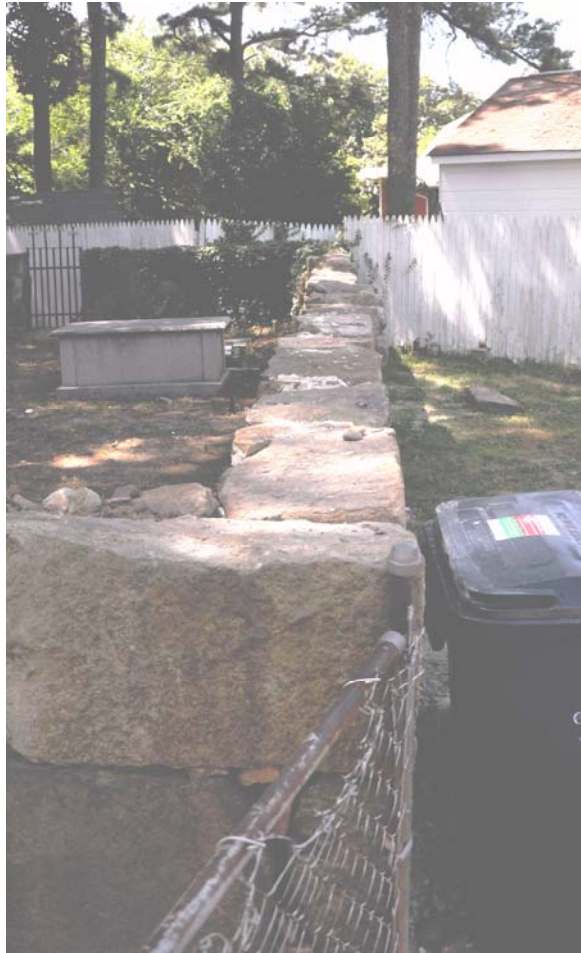
# BACK TO STRAIGHT\* WEST WALL

\*EXCEPT THE PORTLAND SECTION
