Old Senate Chamber

Gallery Evidence Investigation (Round One: November 2010)

John Greenwalt Lee Company Investigative Team:

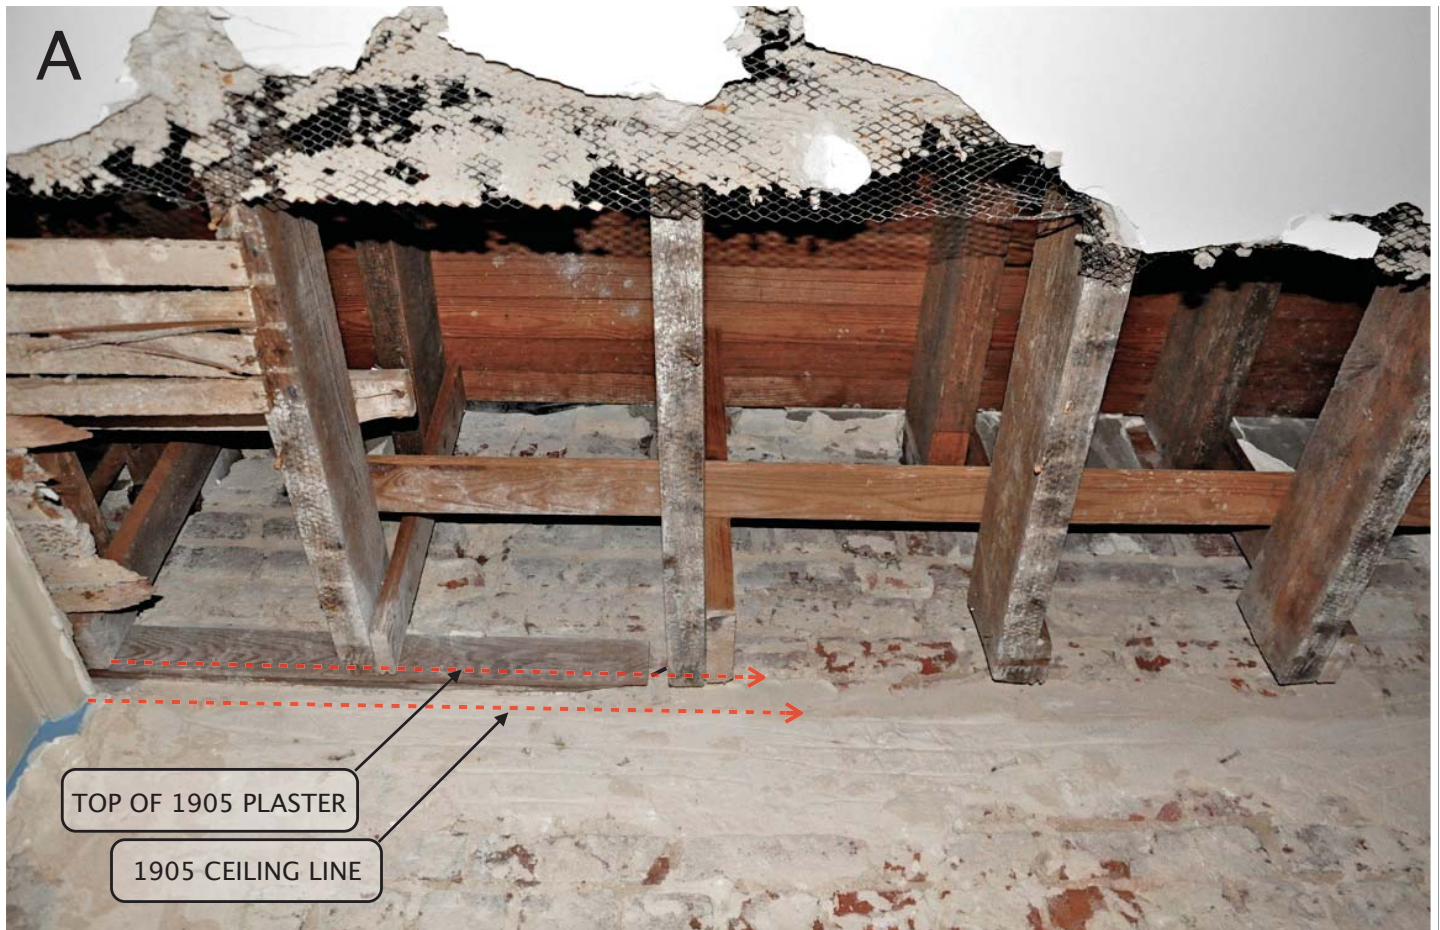
The ceiling line and top of 1905 plaster was established as the ceiling was being removed and while the joists were still in place to clearly define the location (A). With the 1905 ceiling joists out of the way and the remains of 1870s plaster removed, establishing the 18th c. ceiling and top of plaster was straightforward (B).

The original ceiling location does not raise the architrave, thus the beam of the architrave is exposed as an architectural element, visible and decorated on both sides and paneled below. This creates a coffered effect, a typical classical detail. In contrast, finishing the ceiling flush to the top of the column capitals, as was done in 1905, would have been unusual in the 18th c.

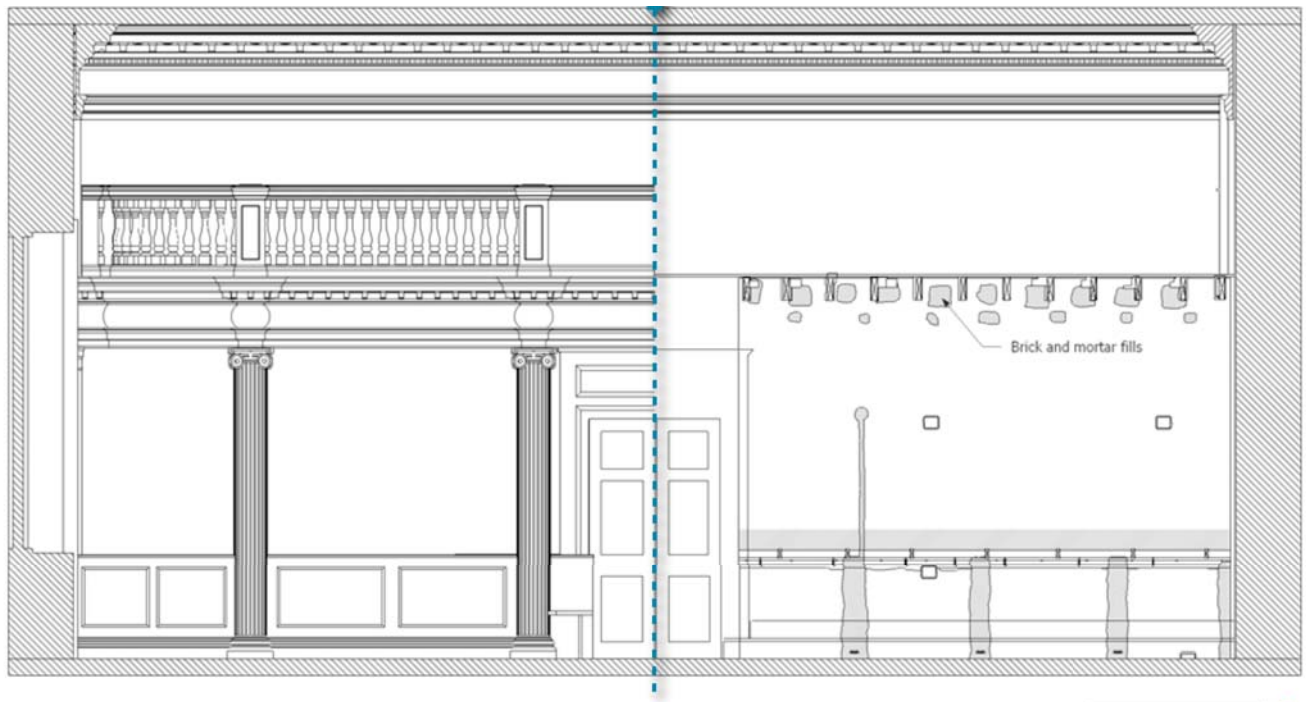
THIS DRAWING SHOWS THE 1905 FLOOR JOISTS AND THE ORIGINAL POCKETS AS FILLED CIRCA 1877

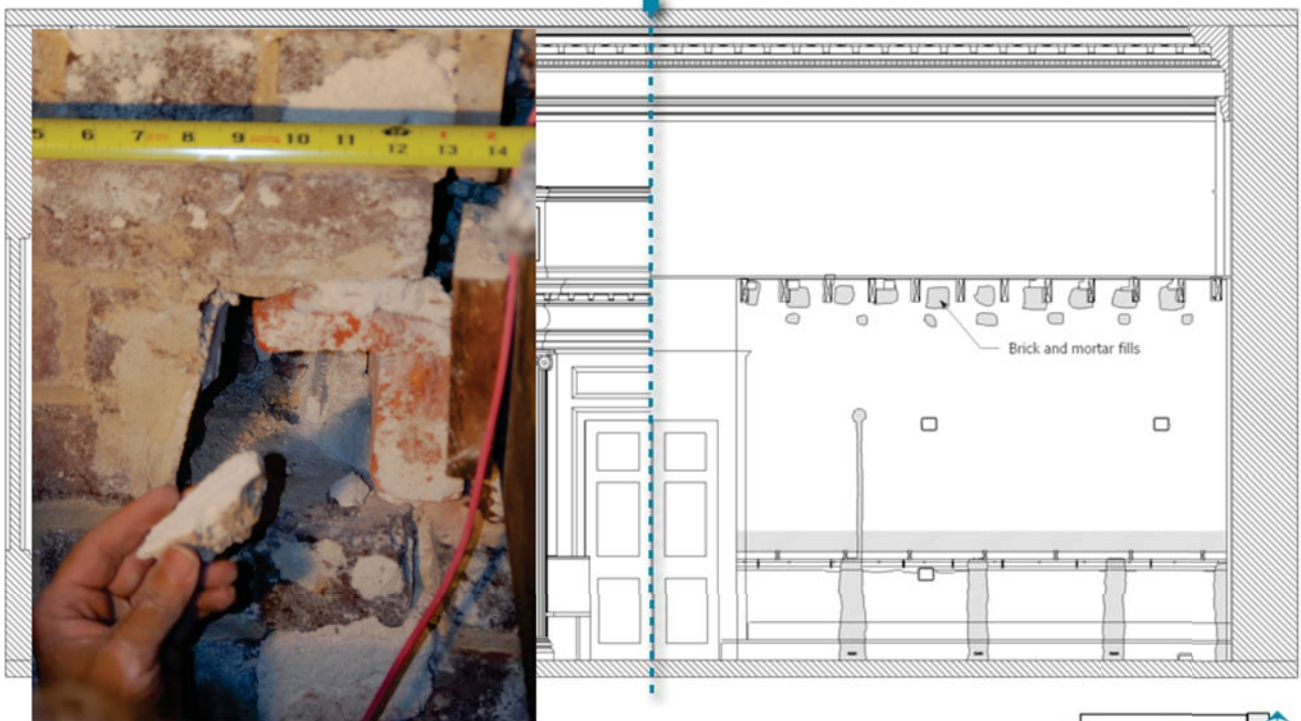
THE CIRCA 1877 INFILL WAS REMOVED FROM THE POCKETS, LOOKING FOR IMPRINTS OF THE ORIGINAL GALLERY TIMBERS AND CAPTURED FRAGMENTS OF ORIGINAL PLASTER

Examination of the 18th century joist pockets and associated ghosts shows the original floor line for the balcony was several inches lower than the 1905 and the original ceiling was significantly higher, creating a coffered ceiling. The distance between the original balcony floor and the ceiling beneath was about 14 inches, whereas the 1905 arrangement fills the entire 27" space behind the entablature.

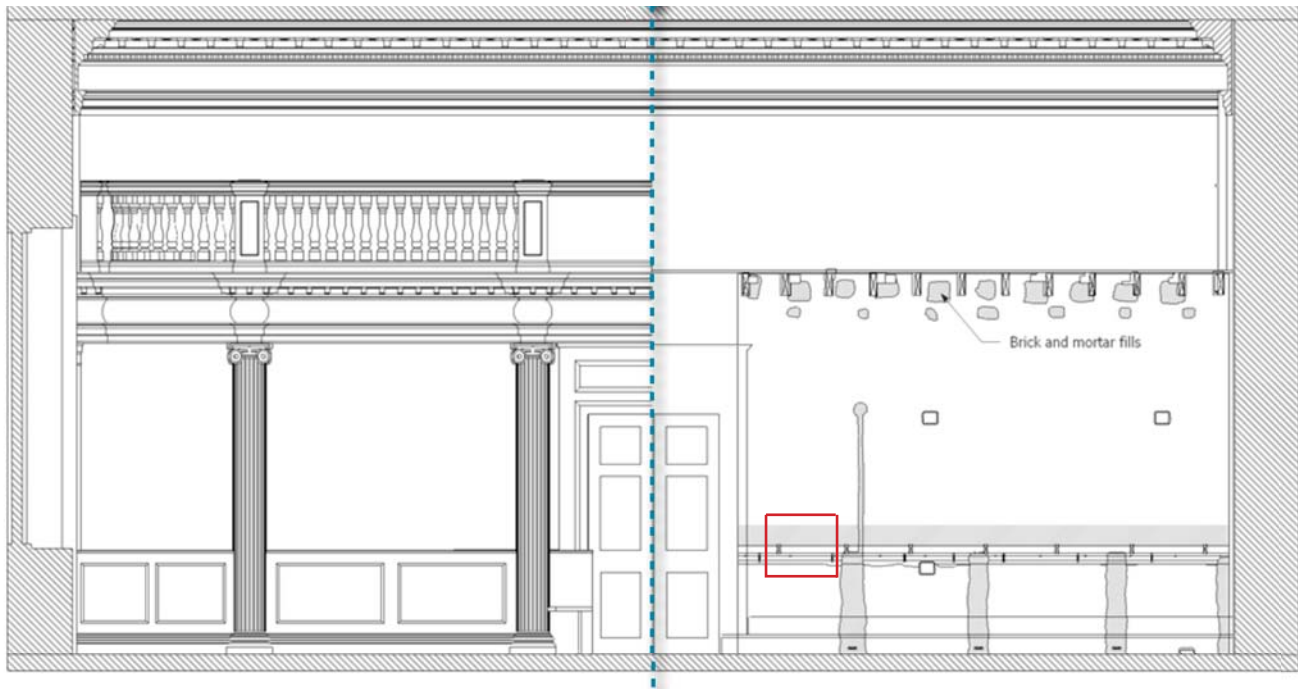
The wainscot was painted during construction, before the wall was plastered and before the mahogany/walnut cap was installed.

The original paint extent line therefore indicates the unfinished top of the wainscot.

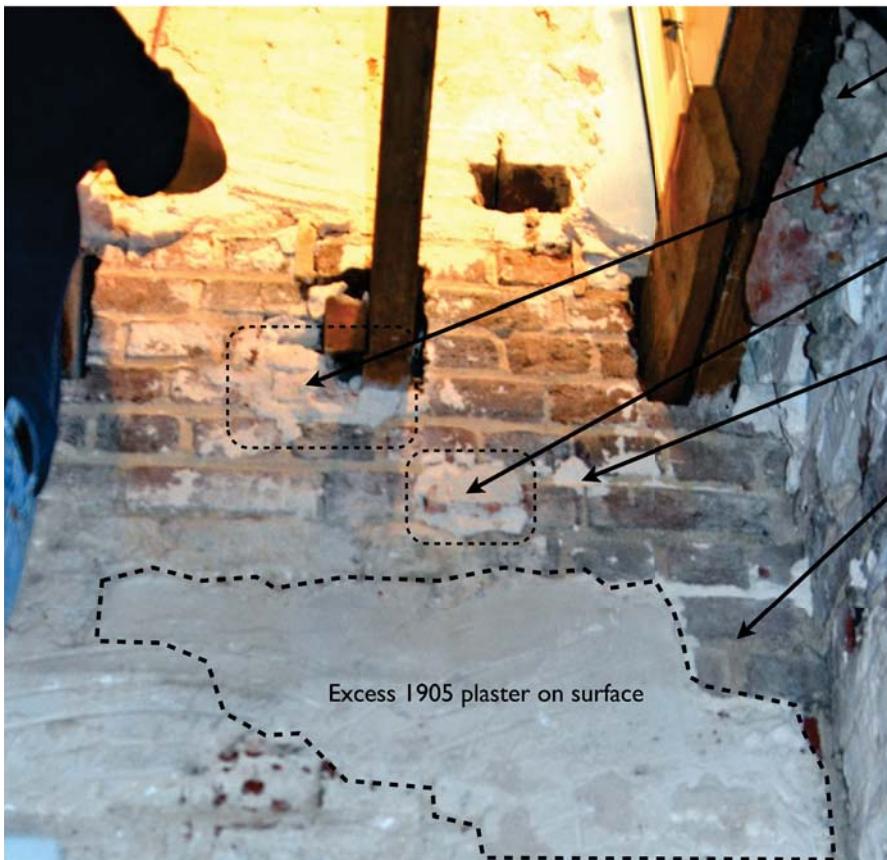
Note protrusion of 1905 brick and cement fill under gallery door

Position of filled original floor joist pocket closest to corner

Position of filled original ceiling joist pocket closest to corner

Additional hole with c1877 fill

Note this area has no evidence of original plaster

Note that the existing 1905 floor joist closest to the corner is not in an original pocket

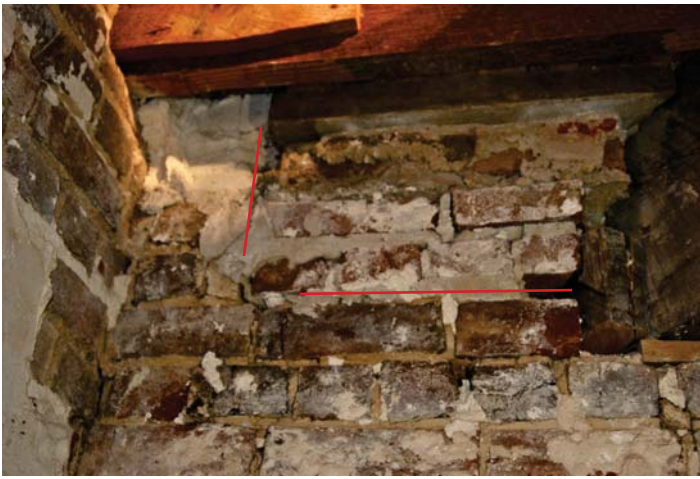
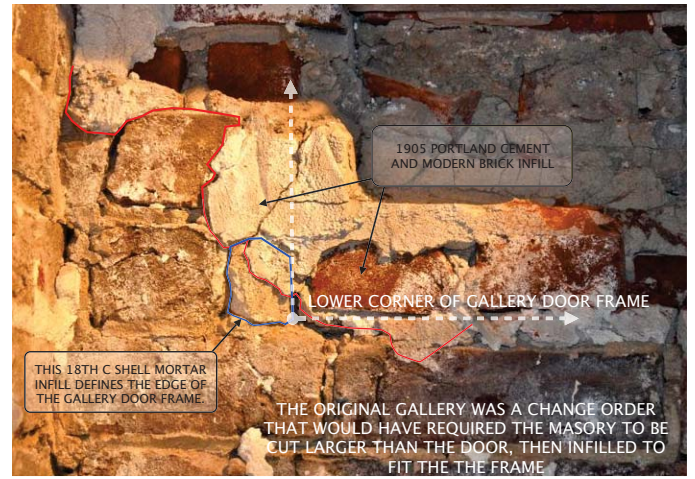
These 4 photographs show the evidence as revealed at the bottom of the masonry opening of the doorway to the balcony

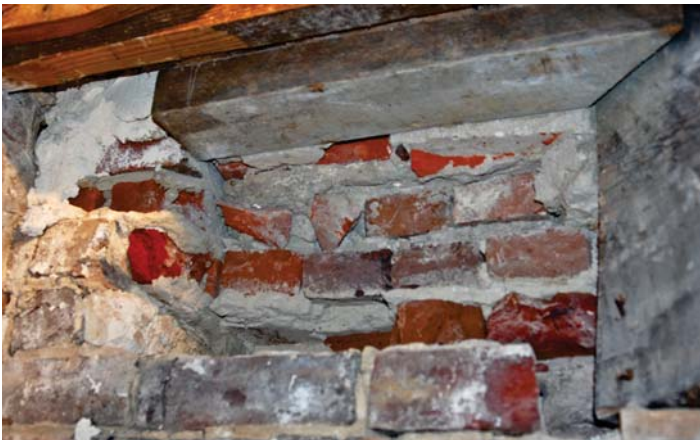
With the later fill removed the masonry opening becomes clearer

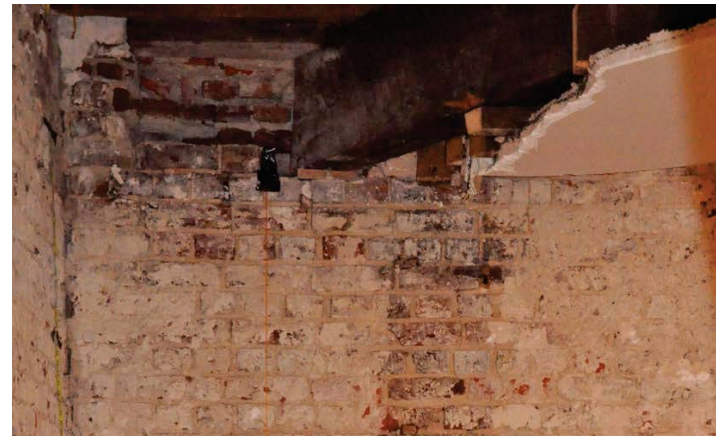
The opening in context with the pilaster ghost which has entasis

Probably the most unexpected finding was that the false entablature beam returning to the back wall masked two steps down from the balcony floor to the doorway in the masonry wall. As we slowly unpacked the 20th c. brick fill below the current door, it became clear that the historic masonry opening was noticeably lower than the current balcony floor and over a foot lower than the original floor. Then we noticed that there were no 18th c. floor joist pockets in the back wall within two feet of the door. This, coupled with the way the ghost of the floor section drops as it approaches the door, helped the evidence fall into place. The entablature beam ran to the back wall as a hollow plaster and wood armature, providing plenty of space into which to fit the descending stair. The panelled soffit is carried on the pilaster. Classical grammar requires that the edge of the soffit align with the neck of the pilaster making the pilaster almost square.

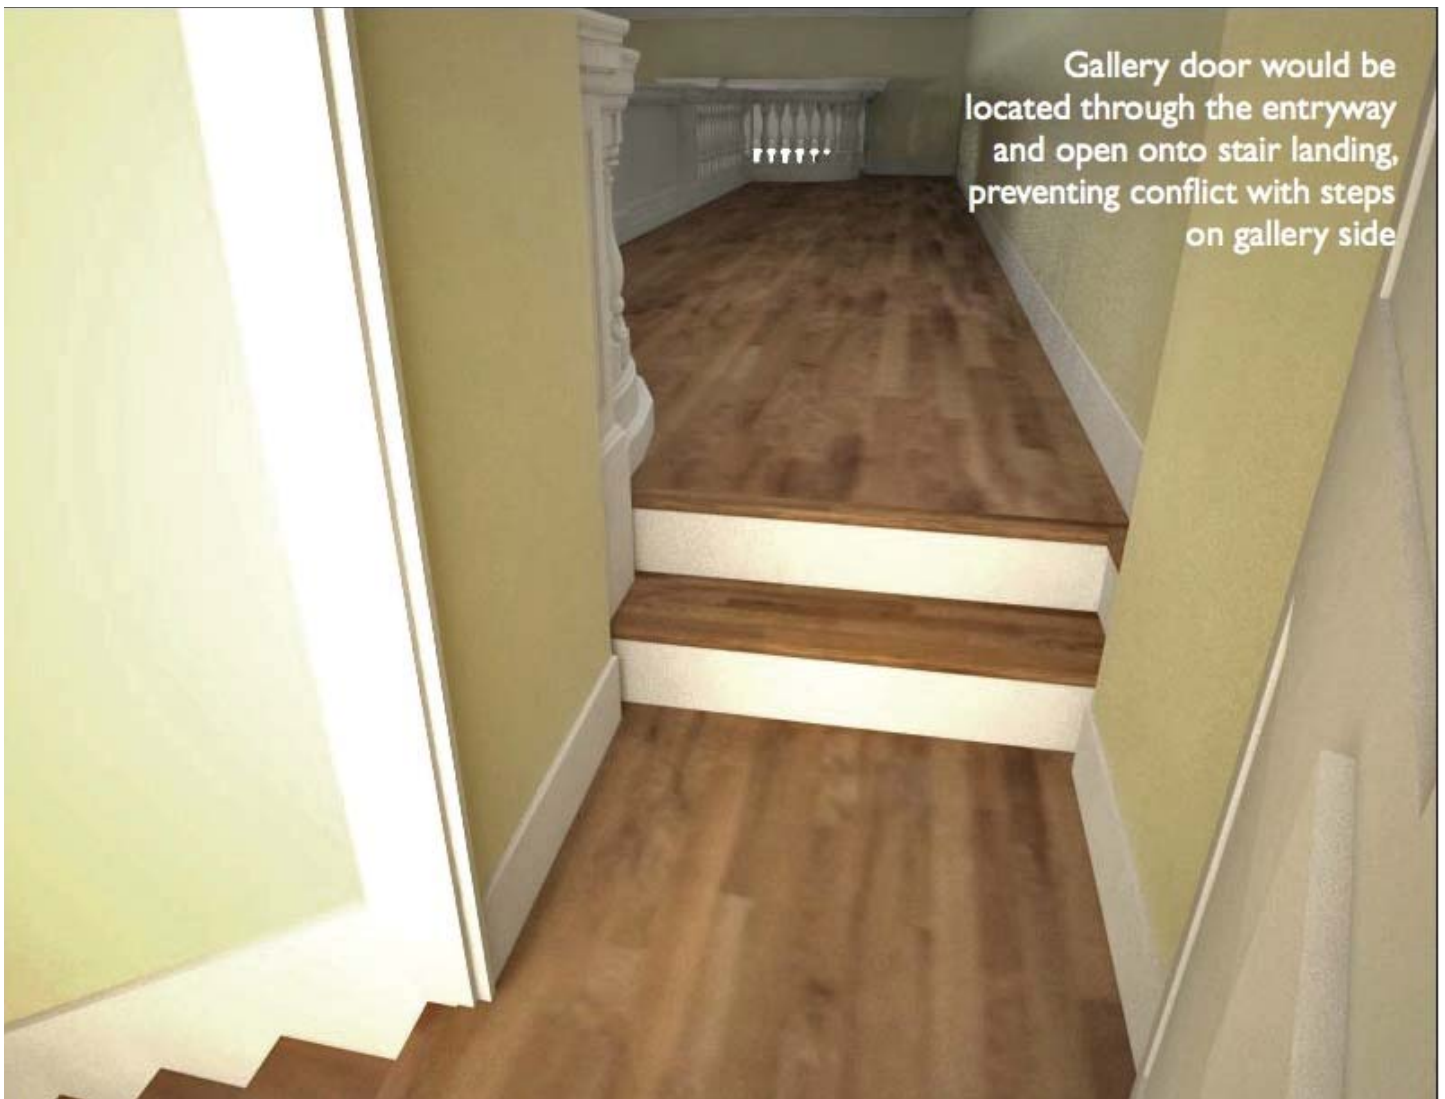
These three views visualize how the two steps integrate into the upper level of the gallery. The two steps within the Old Senate Chamber side of the wall fit nicely within the exposed decorative surfaces. Viewed from below they are completely invisible. The figure below right shows the timbers based on the pockets in

the backwall, extending out to support the feature. The other interesting point is that this arrangement makes it necessary to locate the door on the stair landing in the stair hall, as the swing of the door would be stopped by the steps if placed within the Senate Chamber.

Note: There is one minor glitch in these views. The landing of the stair that passes through the wall does not extend far enough into the Old Senate Chamber. The first riser within the Chamber would be approximately 6" back from the trim of the doorway. See the red line in the view to the right, labeled "Approximate line of treads and risers."

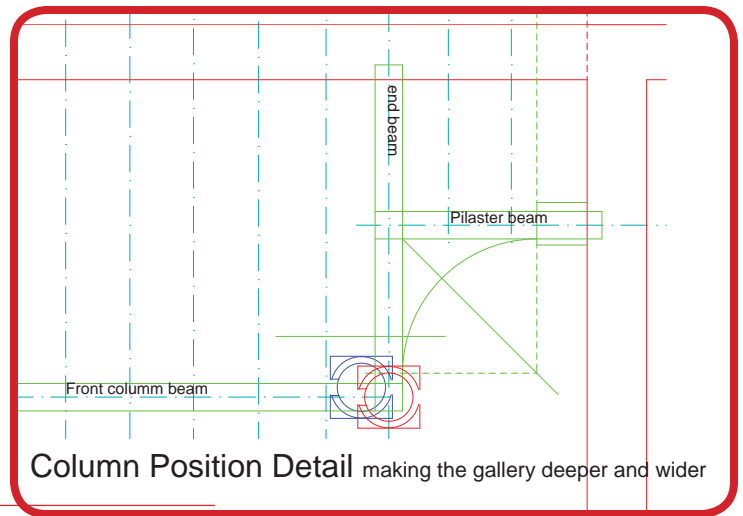
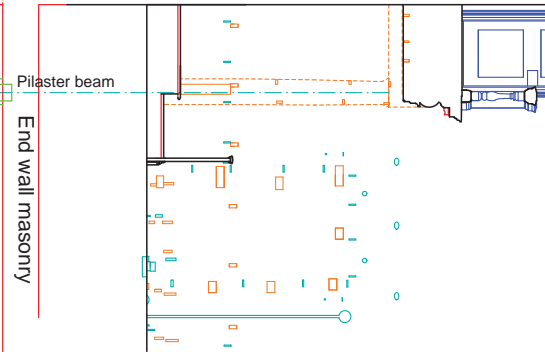
The elevation of the end wall showing the blocking and ghost of pilaster

Historic column location [red] based on the framing members that define the position versus the 1905 column position [blue]

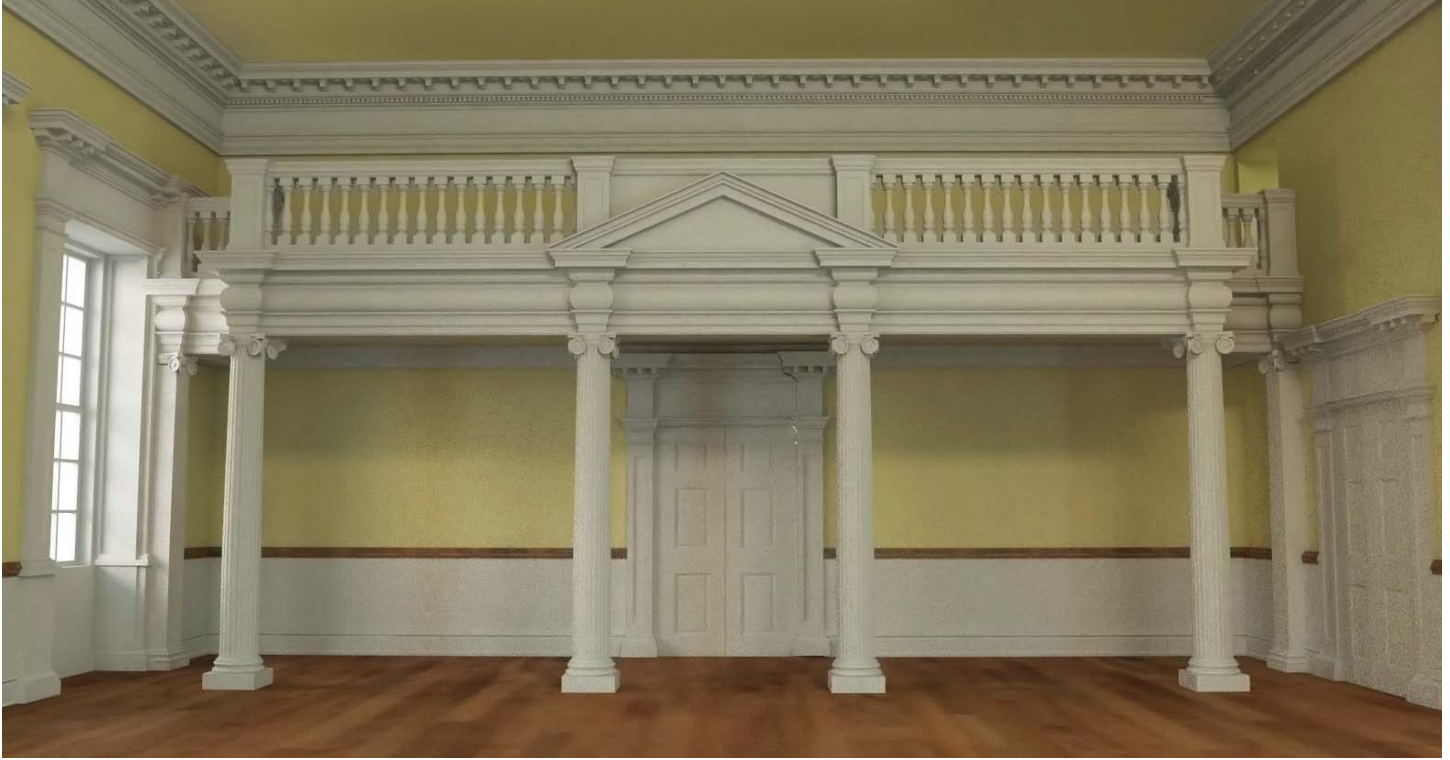
The pilasters are not quite wide enough, the intersection with the window needs refinement, and only the chair rail cap is mahogany.

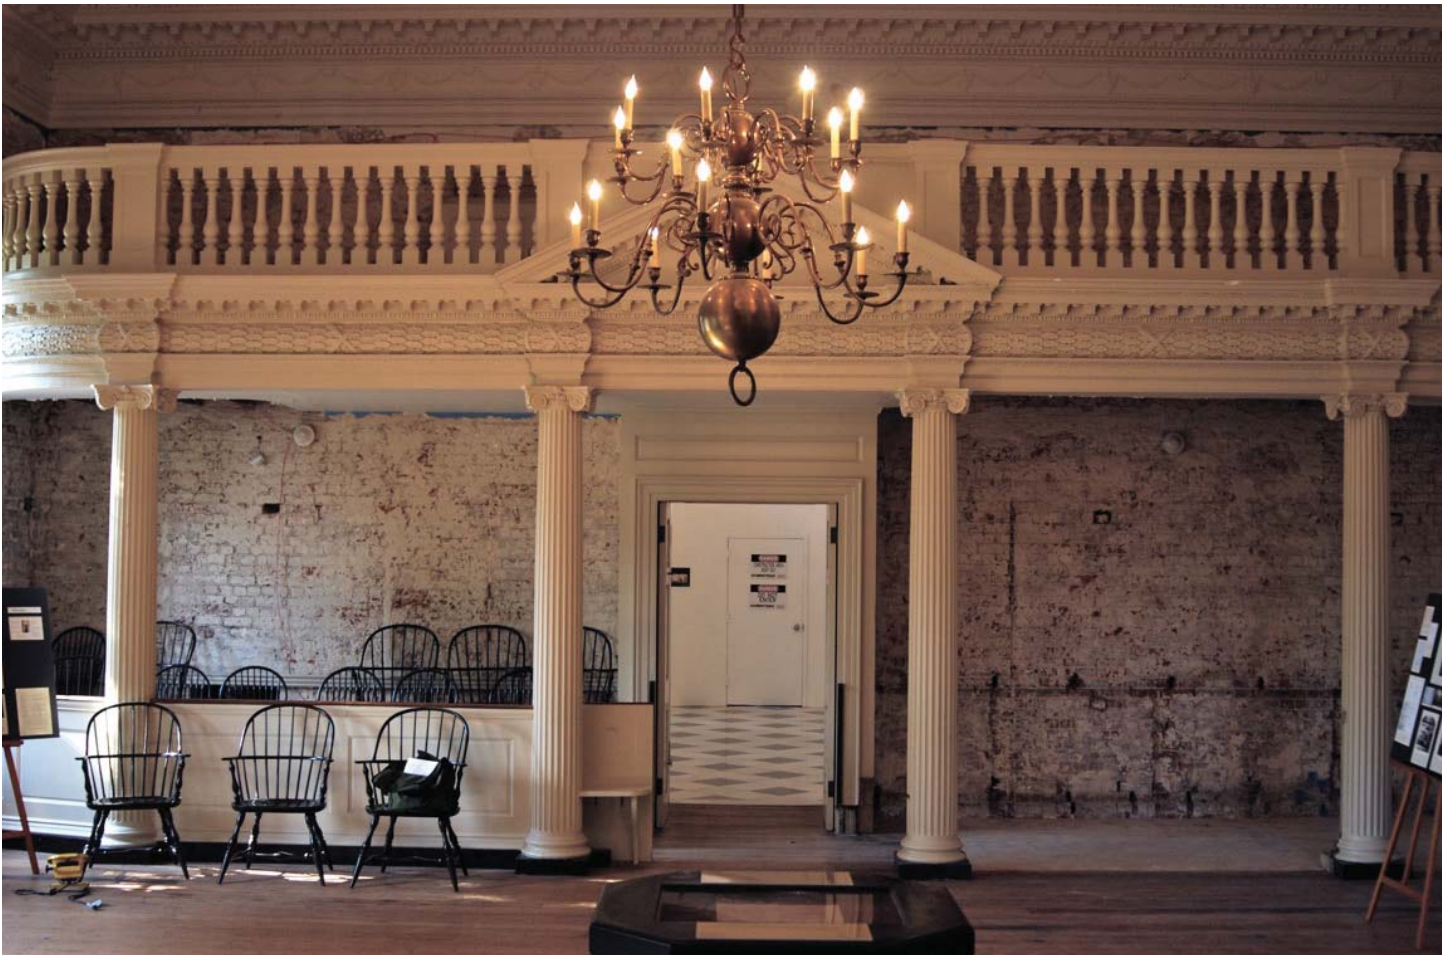
The work area at the end of this round of investigations with the 1905 gallery wainscot and risers deleted moves it in the direction of the 1783 appearance. Getting the

proportions and column locations correct will further improve the appearance while significantly adding to the historical accuracy.
