Since the dawn of time, man has attempted to conserve culture and display artifacts as restored objects without confusing the new and the old and taking in inside to a protected environment. Menokin has allowed us to consider this desire and find it within our grasp.

The home of Francis Lightfoot Lee, signer of the Declaration of Independence, Menokin was possibly designed by William Buckland. As such it was a good candidate for being a revered artifact.

Wood Conservation Challenges at Menokin

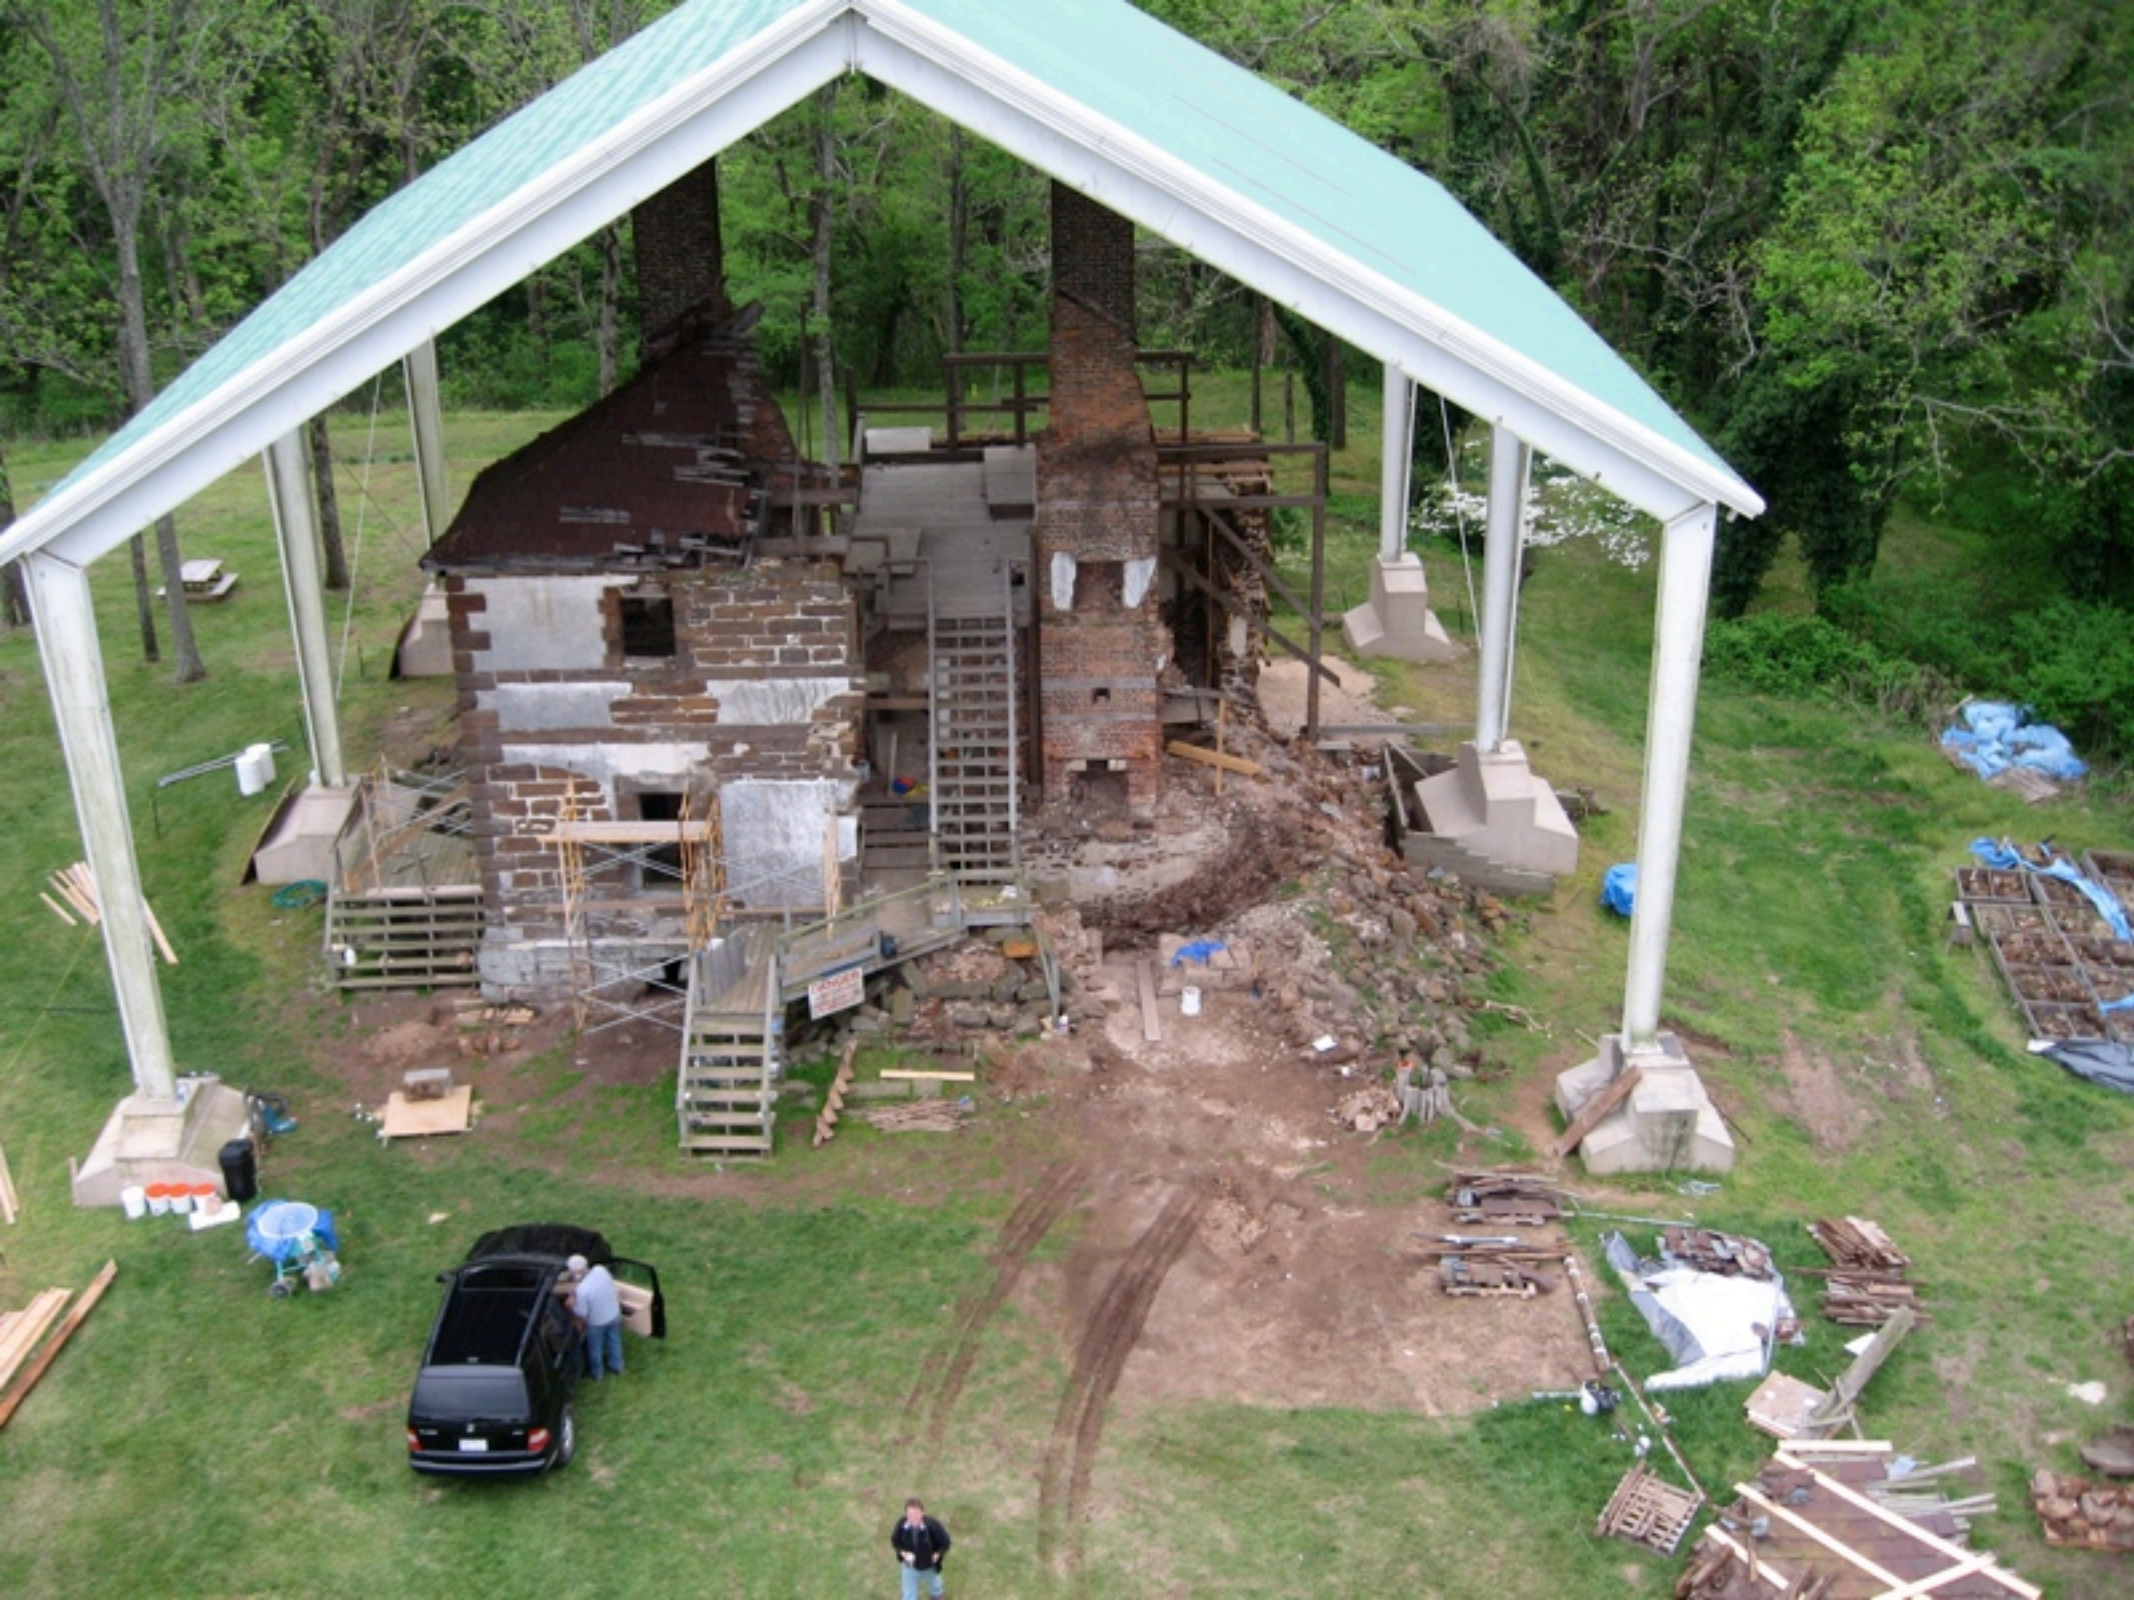
Many teams had attempted to arrest the march of mother nature and the general story lead to recommending demolition and reconstruction.

John Lee and I had dealt with worse [well, worse elements, but not necessarily everything at this level]. We jumped in to stabilize and document the ruin.

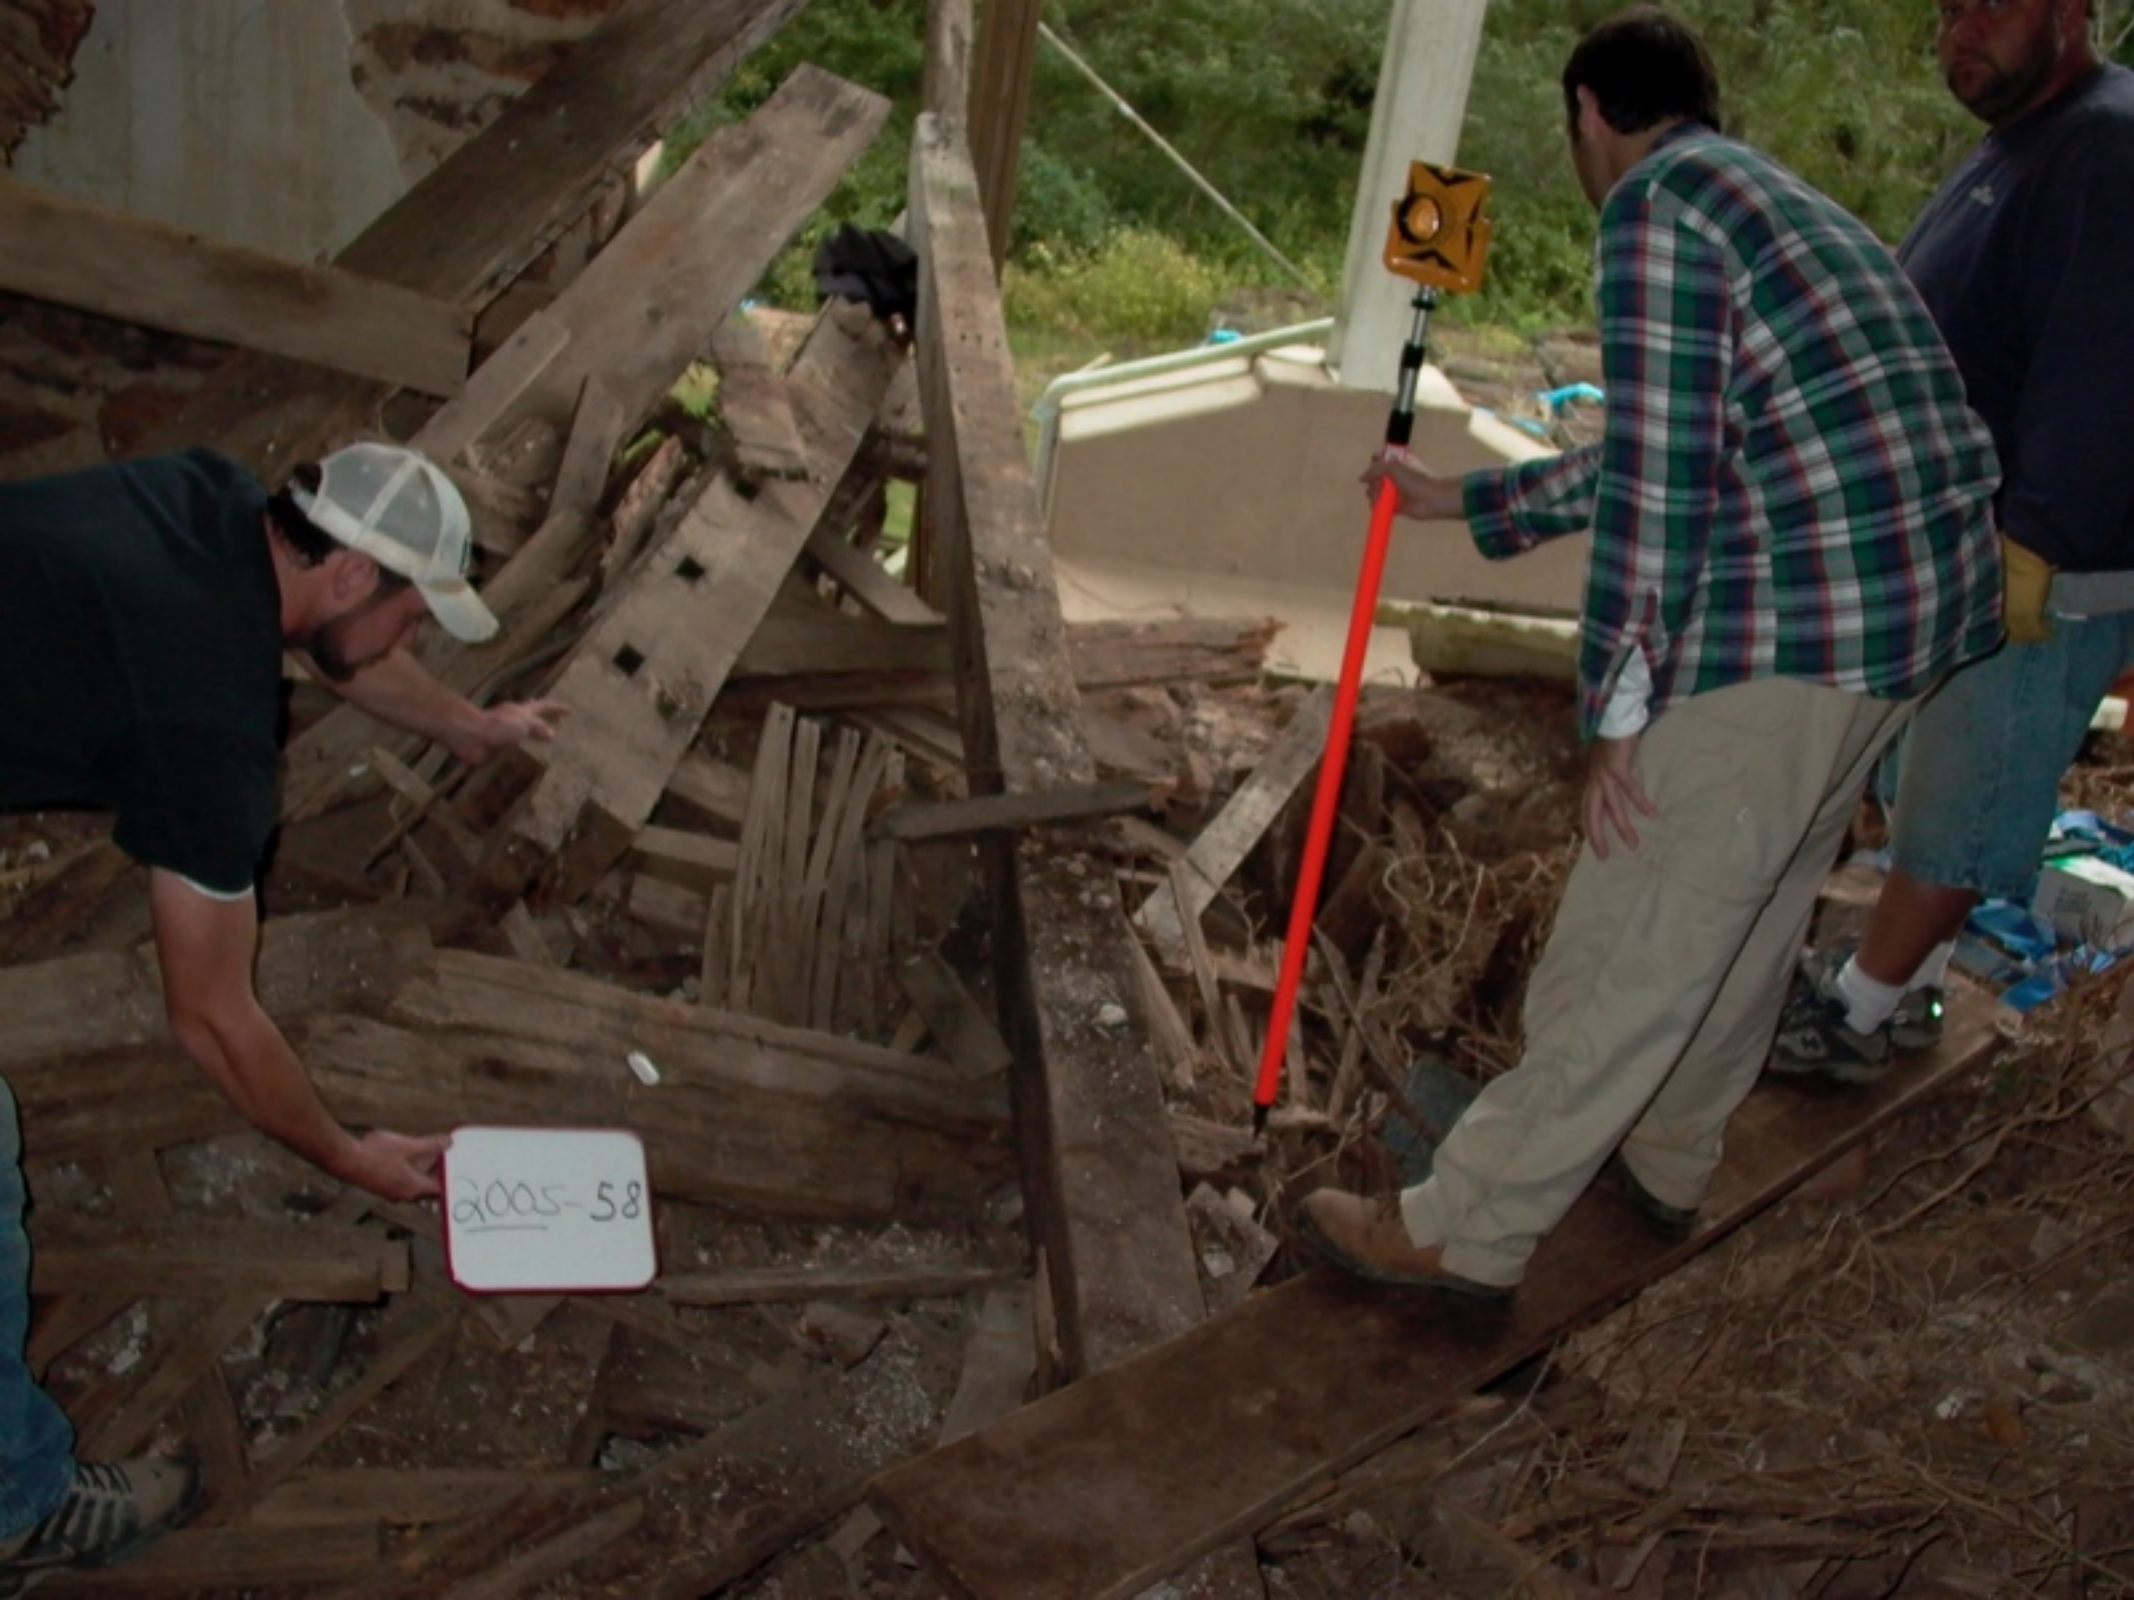
Field notes for measured drawings to establish the framing plan so that sense could be made of the collapsed members that must be removed to allow the displaced walls to be straightened and the building understood as it was conserved. Involving a crew of careful archaeologists the ruin was methodically unpacked and catalogued.

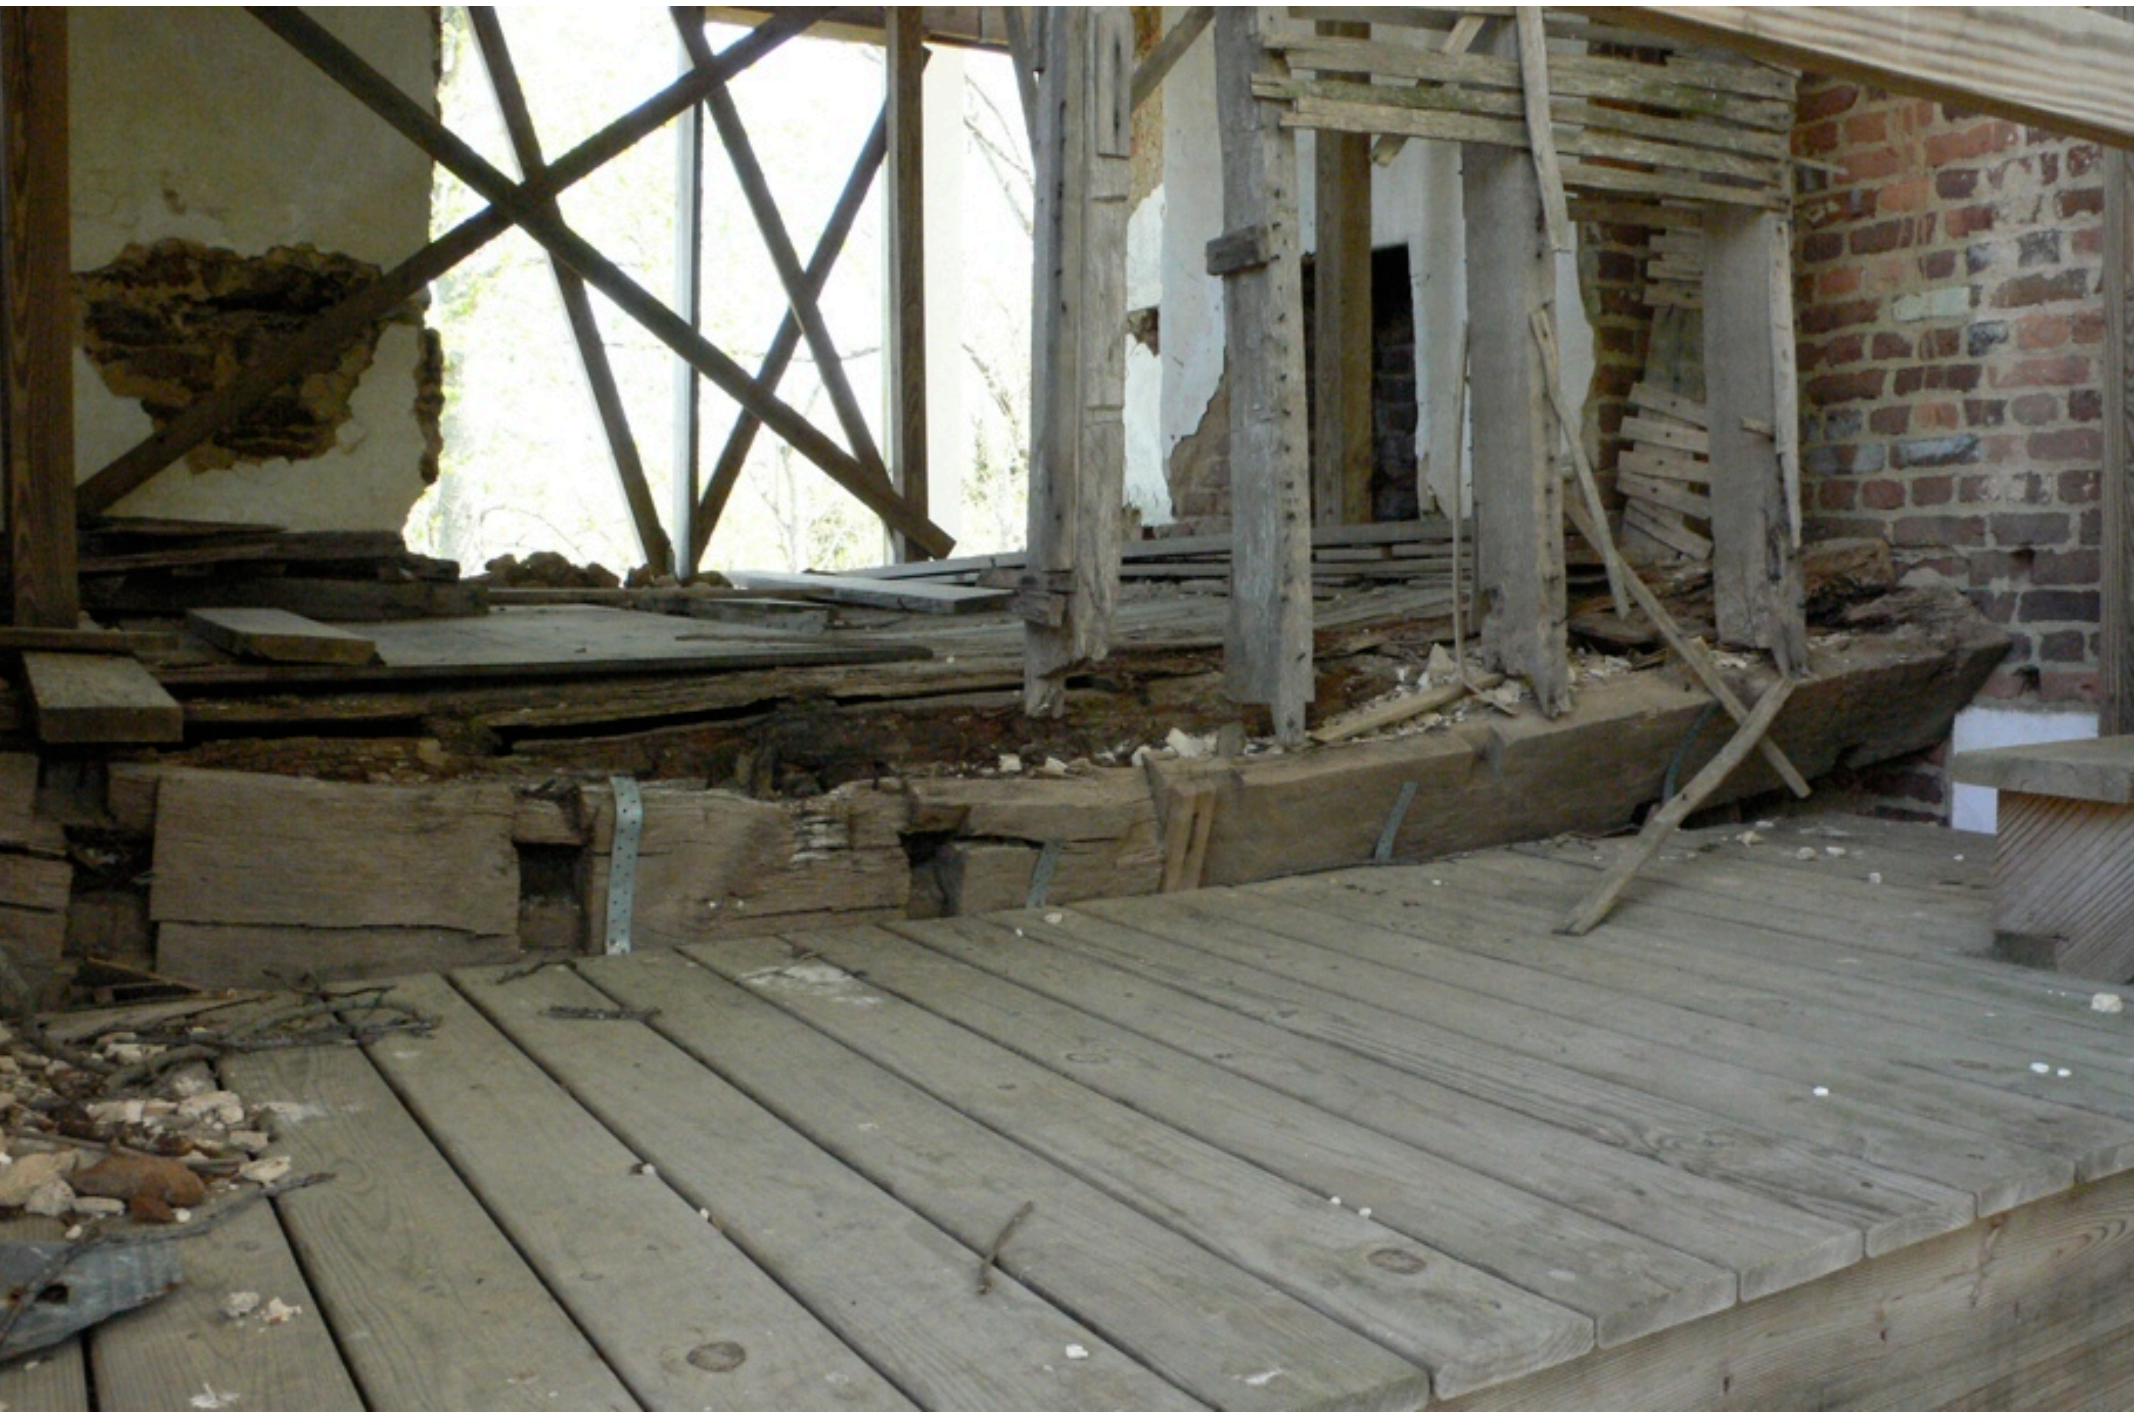
Dealing with the fallen elements was bad enough. Some of the portions still in place presented even more problems. Some like this girder could not be conserved in place and must be removed, conserved and eventually reinstalled.

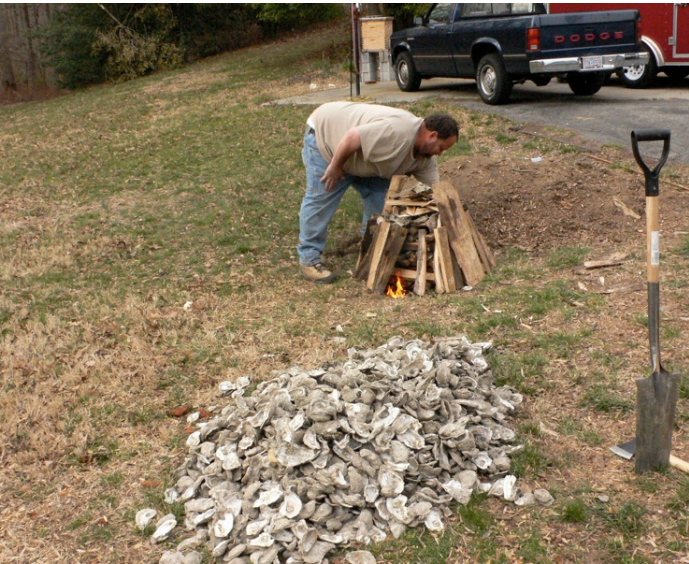
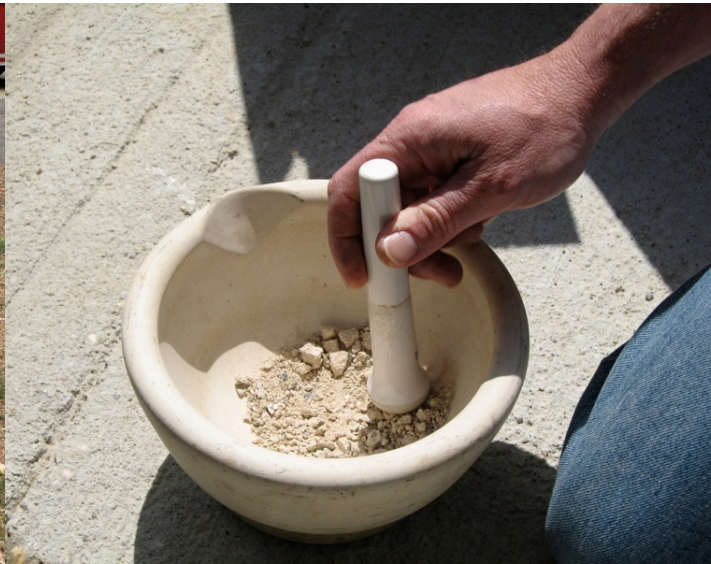
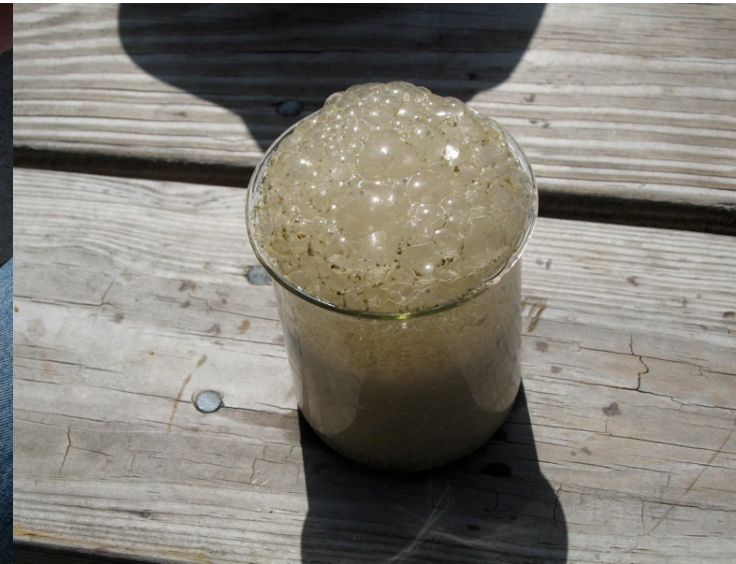
Mortar making

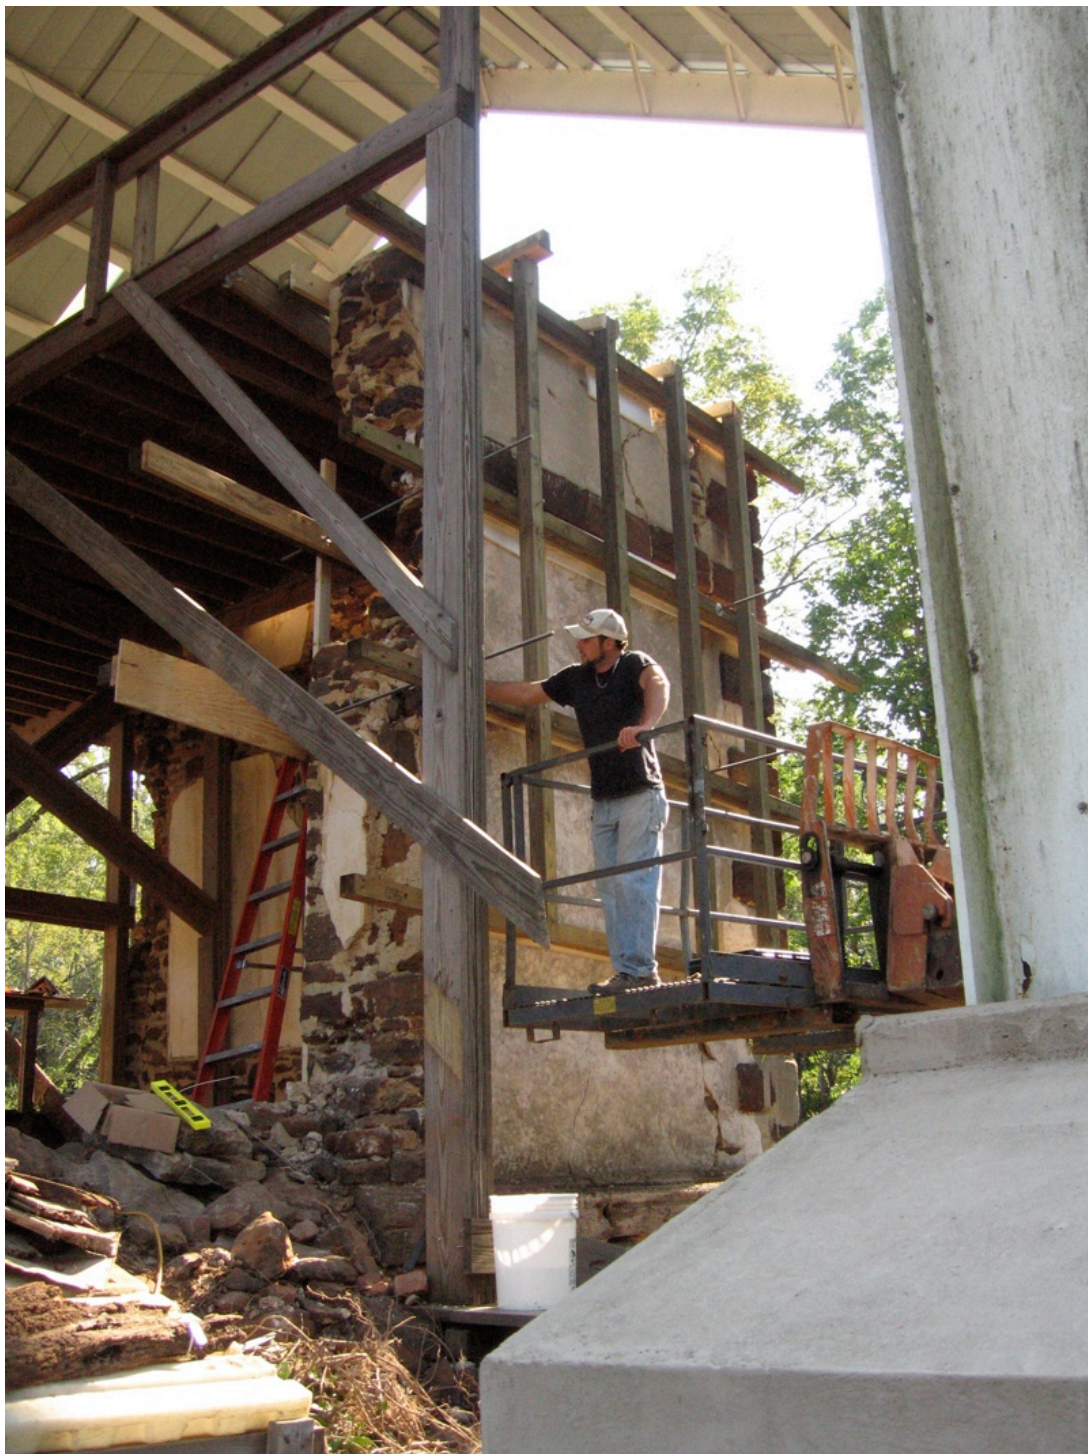
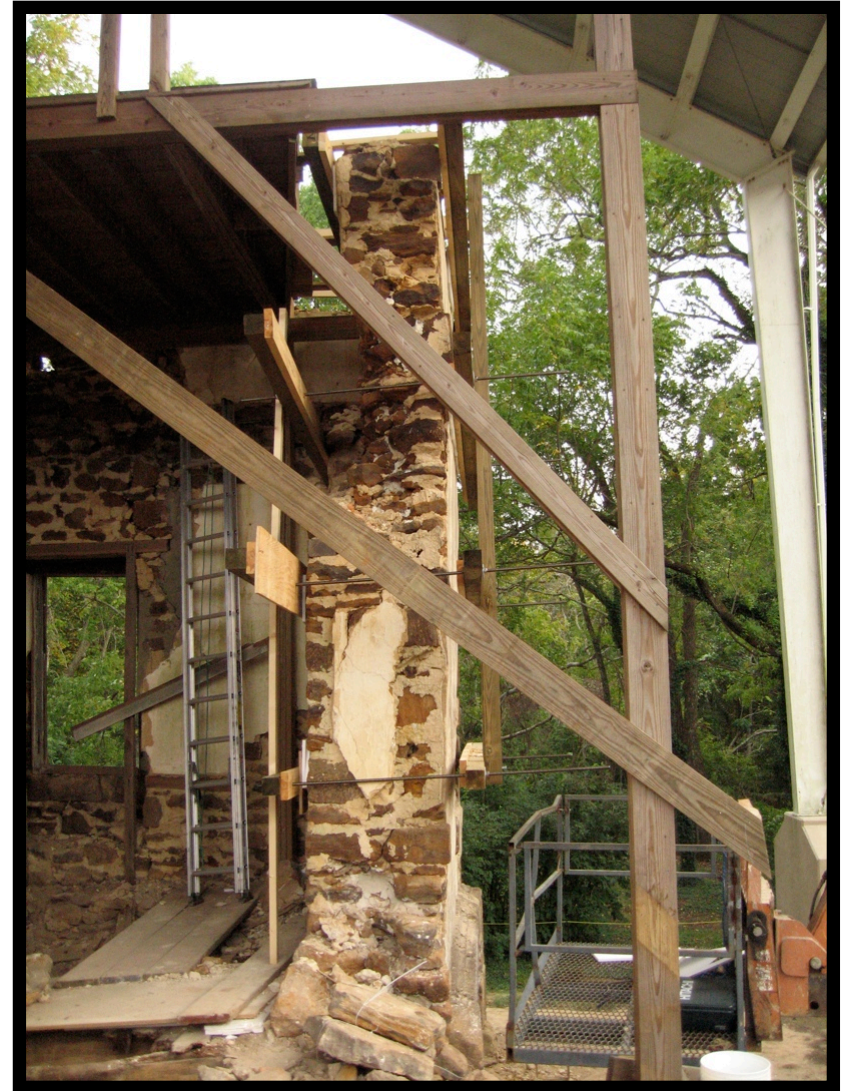
Strongbacks, tightened bolts, and a come-along

Strongbacks and wrenches

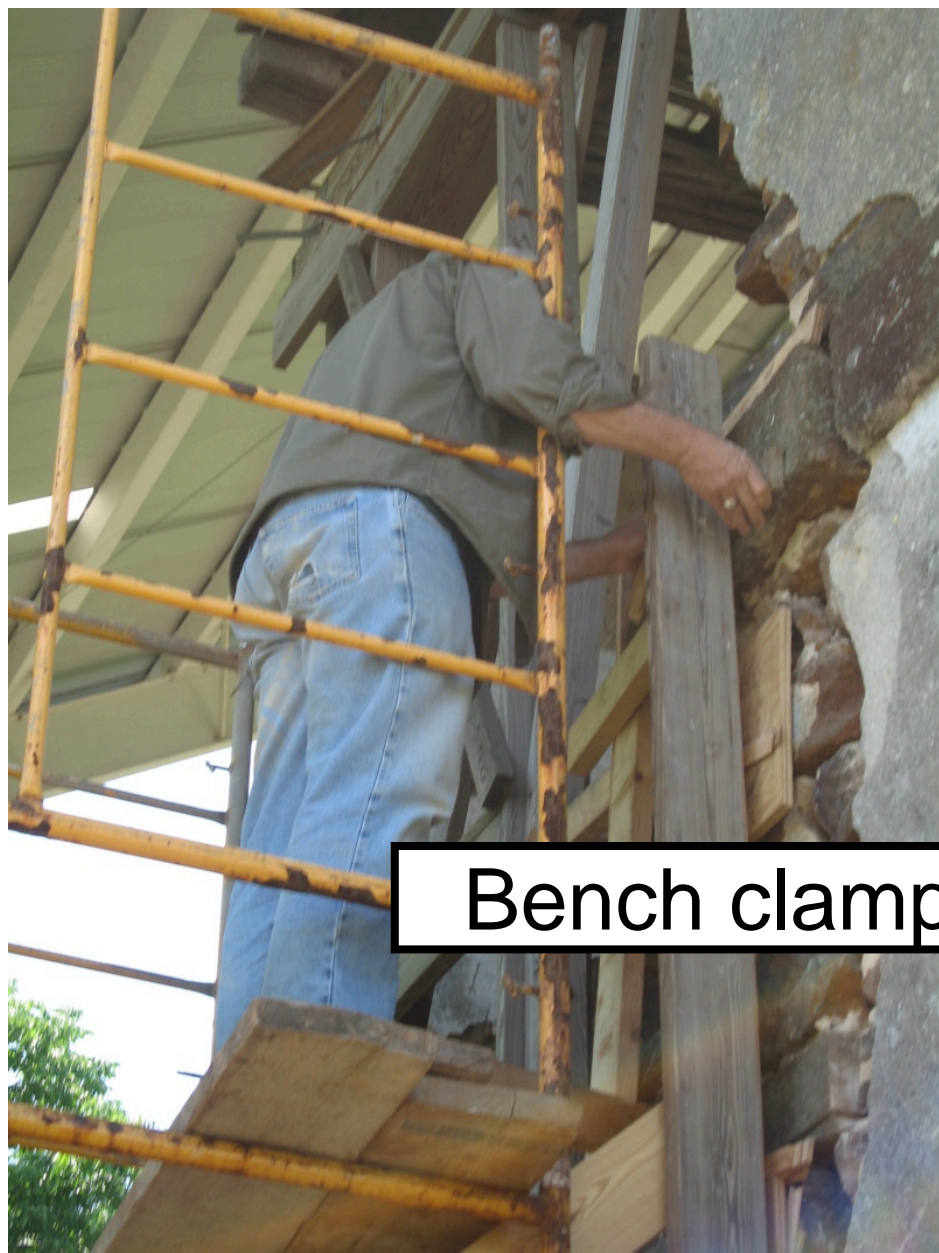
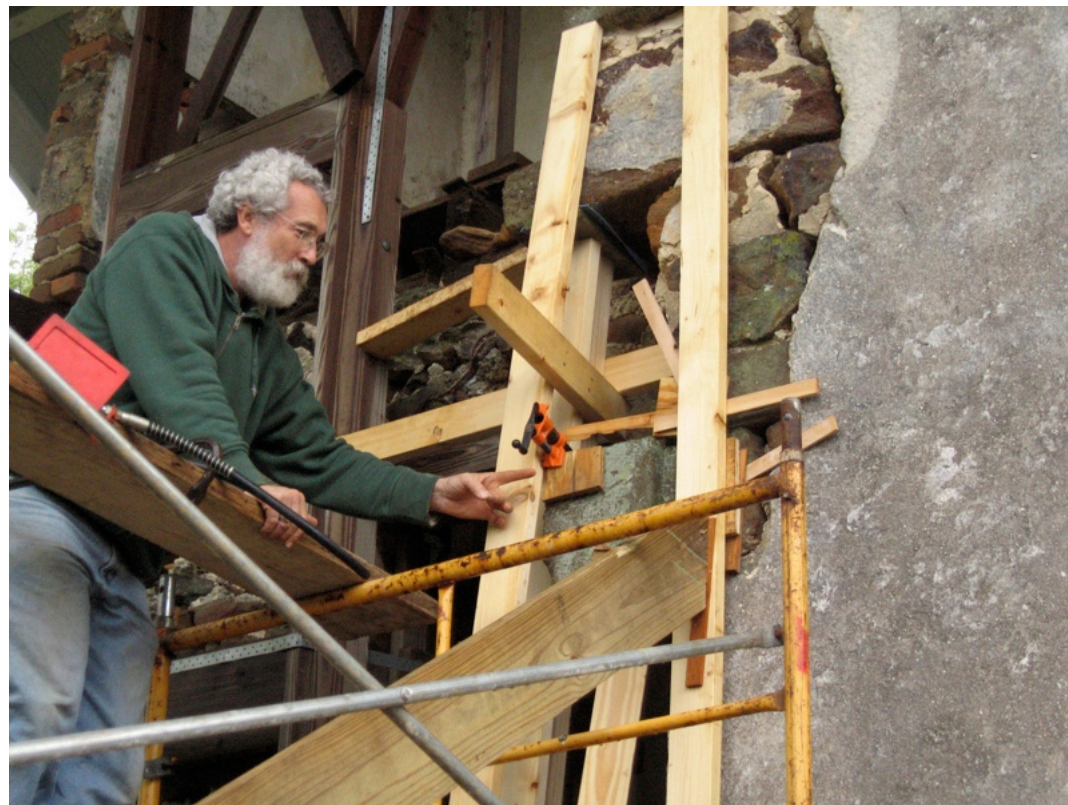
Bench clamps and Wooden Wedges

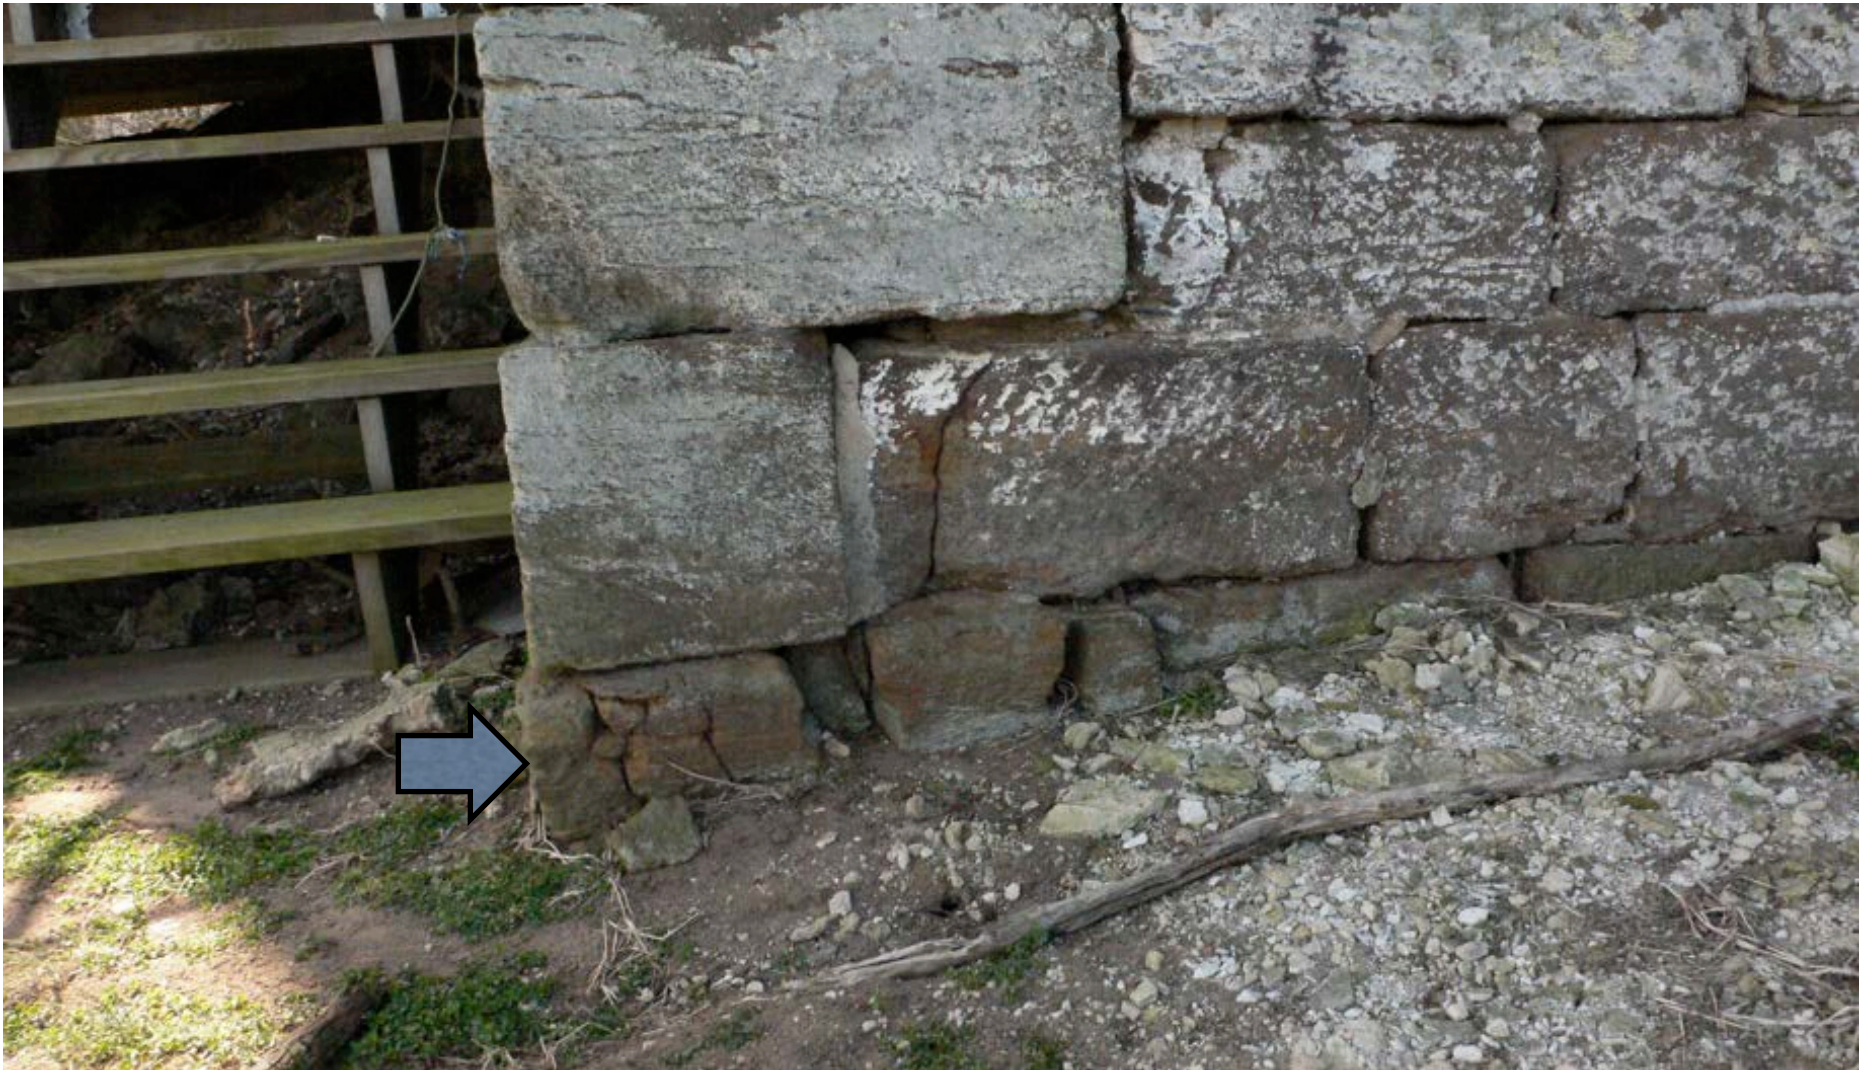
Cornerstone in Trouble

One week when we arrived to work we found the corner stone had gone from t pieces to a dozen.

Remnants of the stone removed
After lifting the corner on steel bars

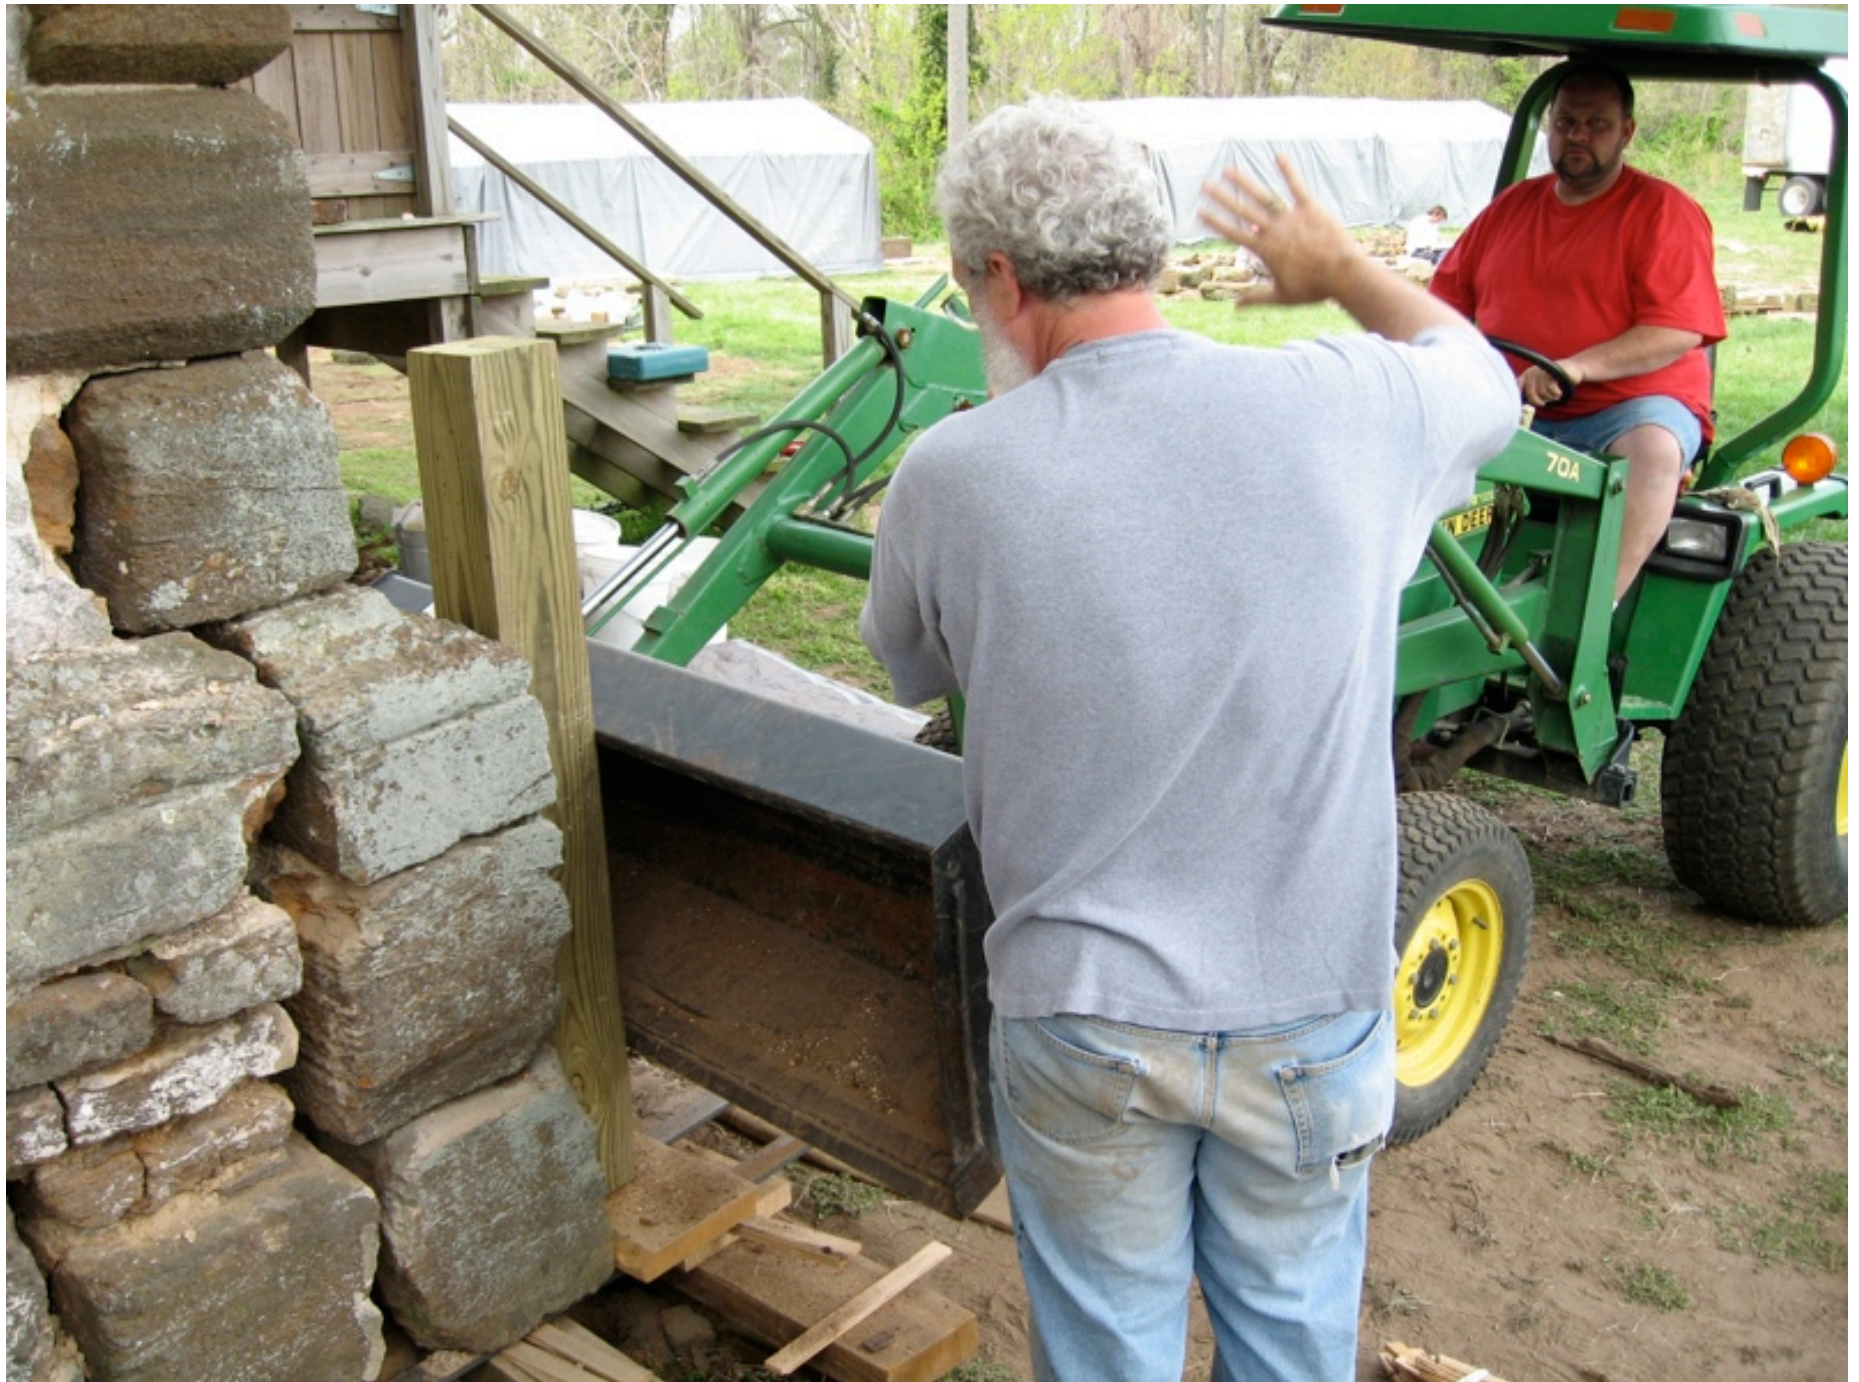
With a little horsepower assistance

Before and After Corner Realignment
