Since the dawn of time, man has attempted to conserve culture and display artifacts as restored objects without confusing the new and the old and taking in inside to a protected environment. Menokin has allowed us to consider this desire and find it within our grasp.

The home of Francis Lightfoot Lee, signer of the Declaration of Independence, Menokin was possibly designed by William Buckland. As such it was a good candidate for being a revered artifact.

Wood Conservation Challenges at Menokin

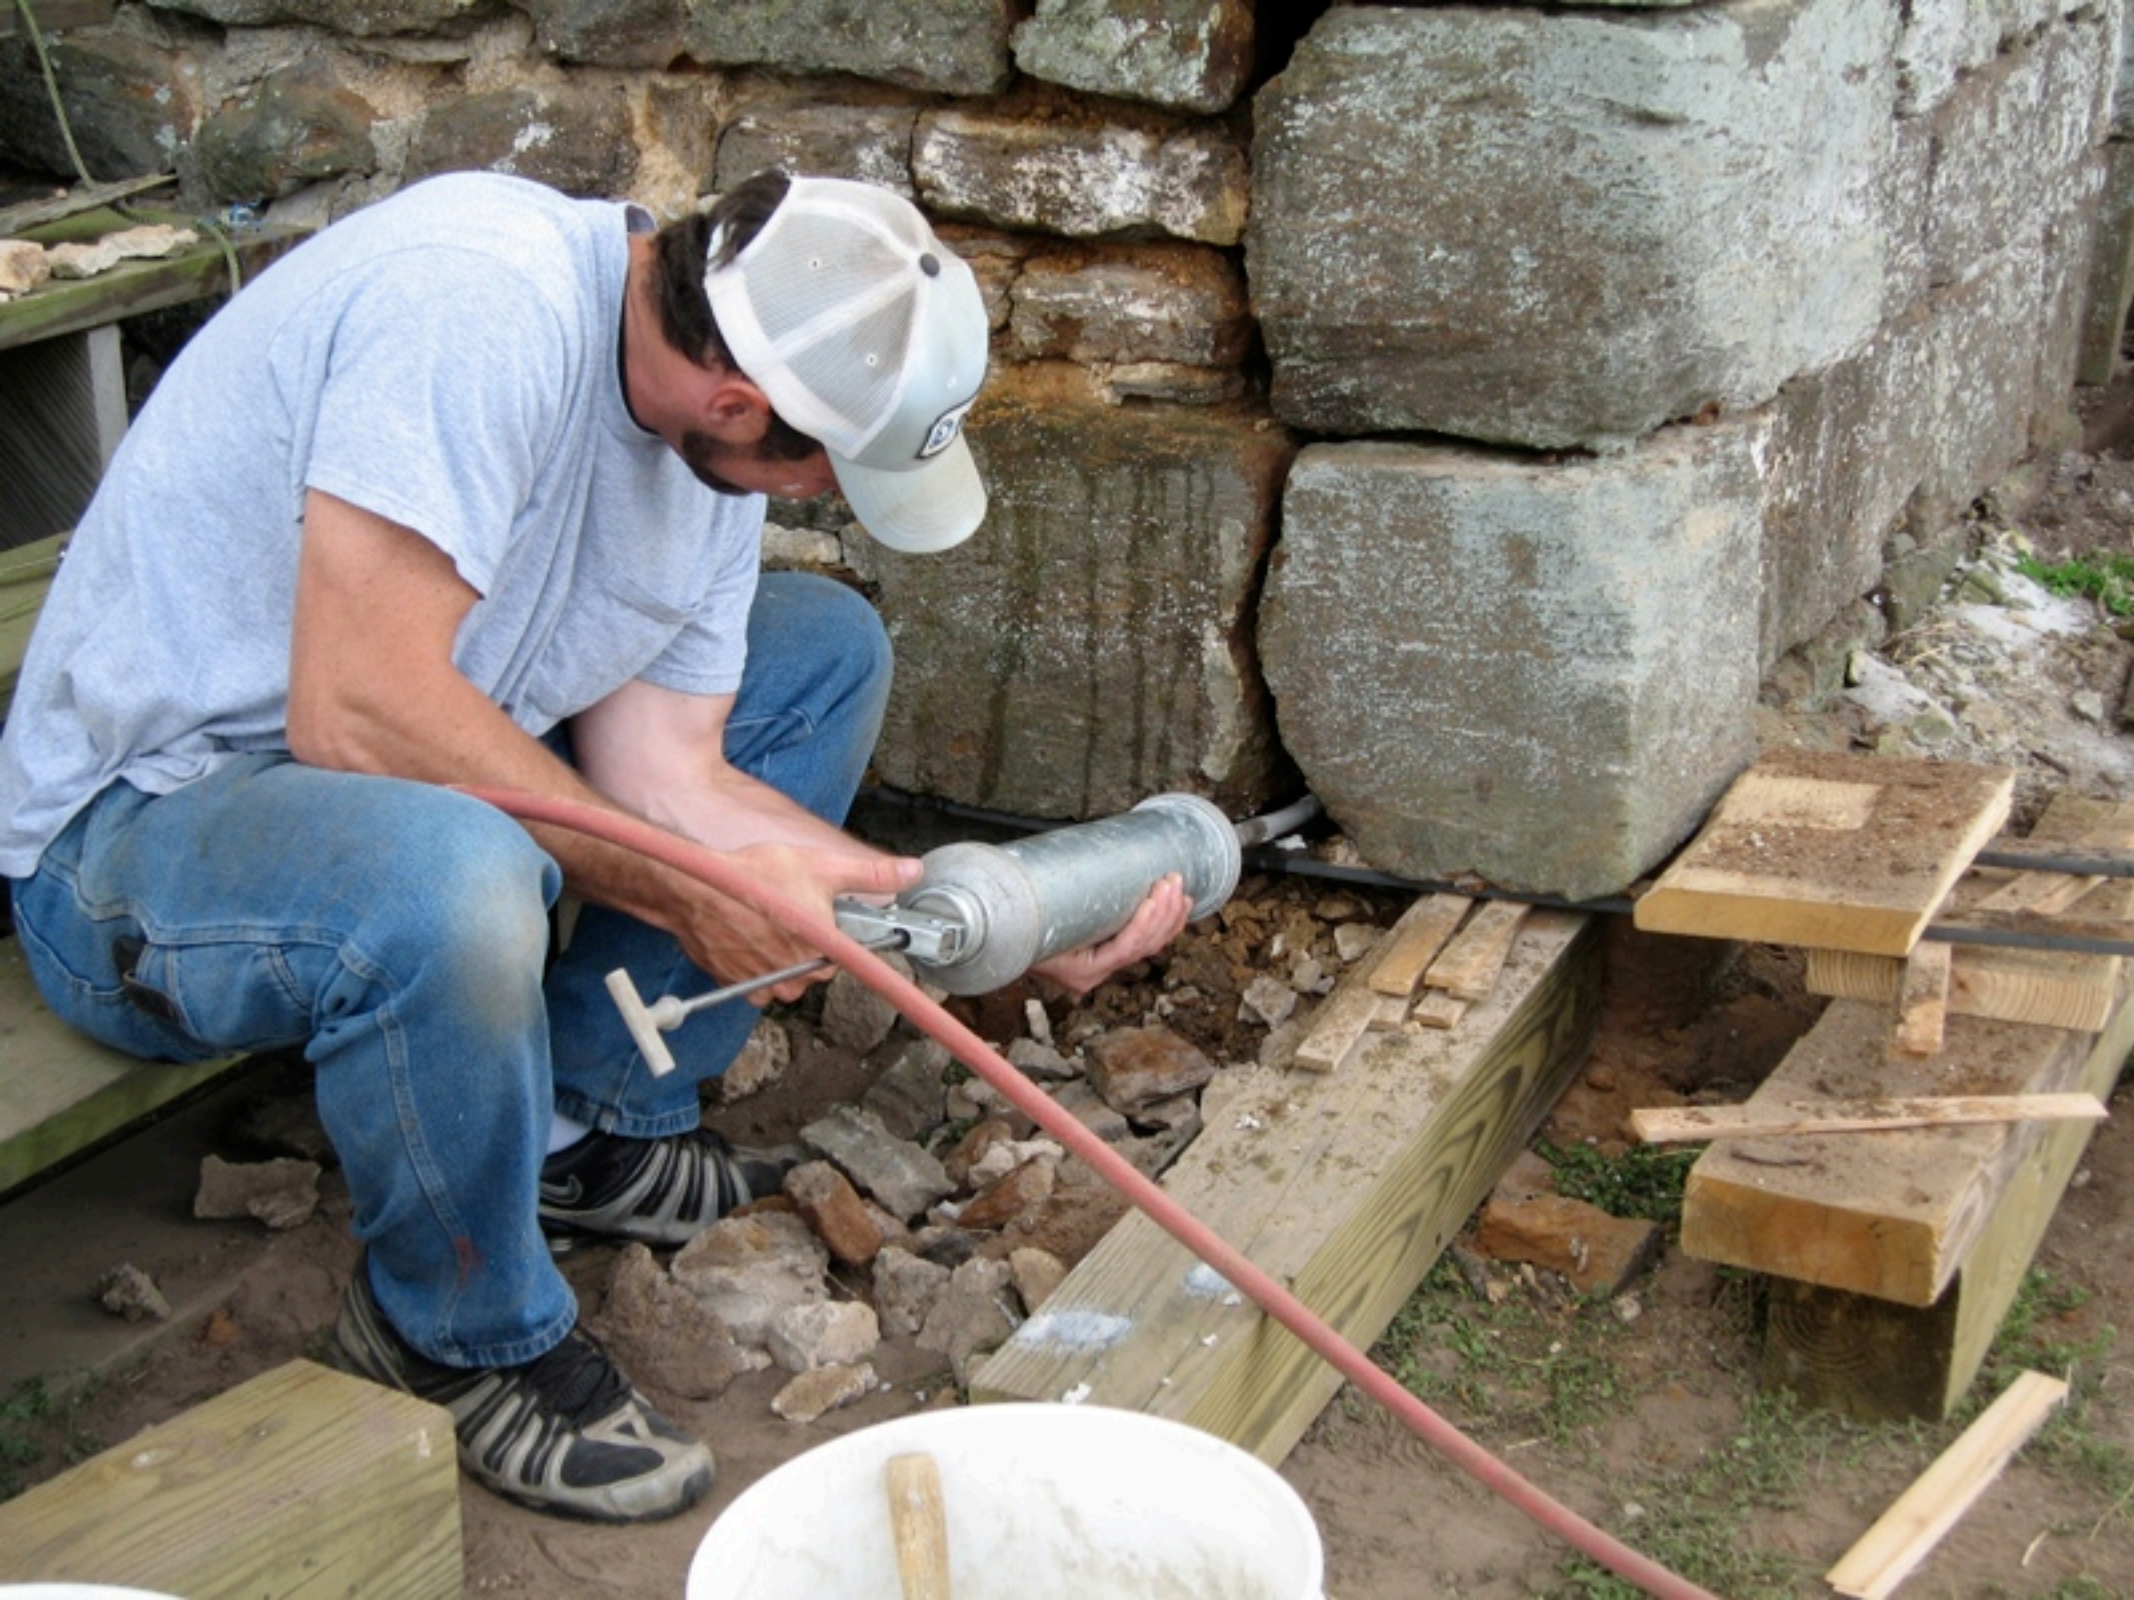
Making a Composite Cornerstone

Grouting voids with lime mortar and reinserting the recast cornerstone. Note the rebar in the trench. This is to allow the stone to easily roll into position.

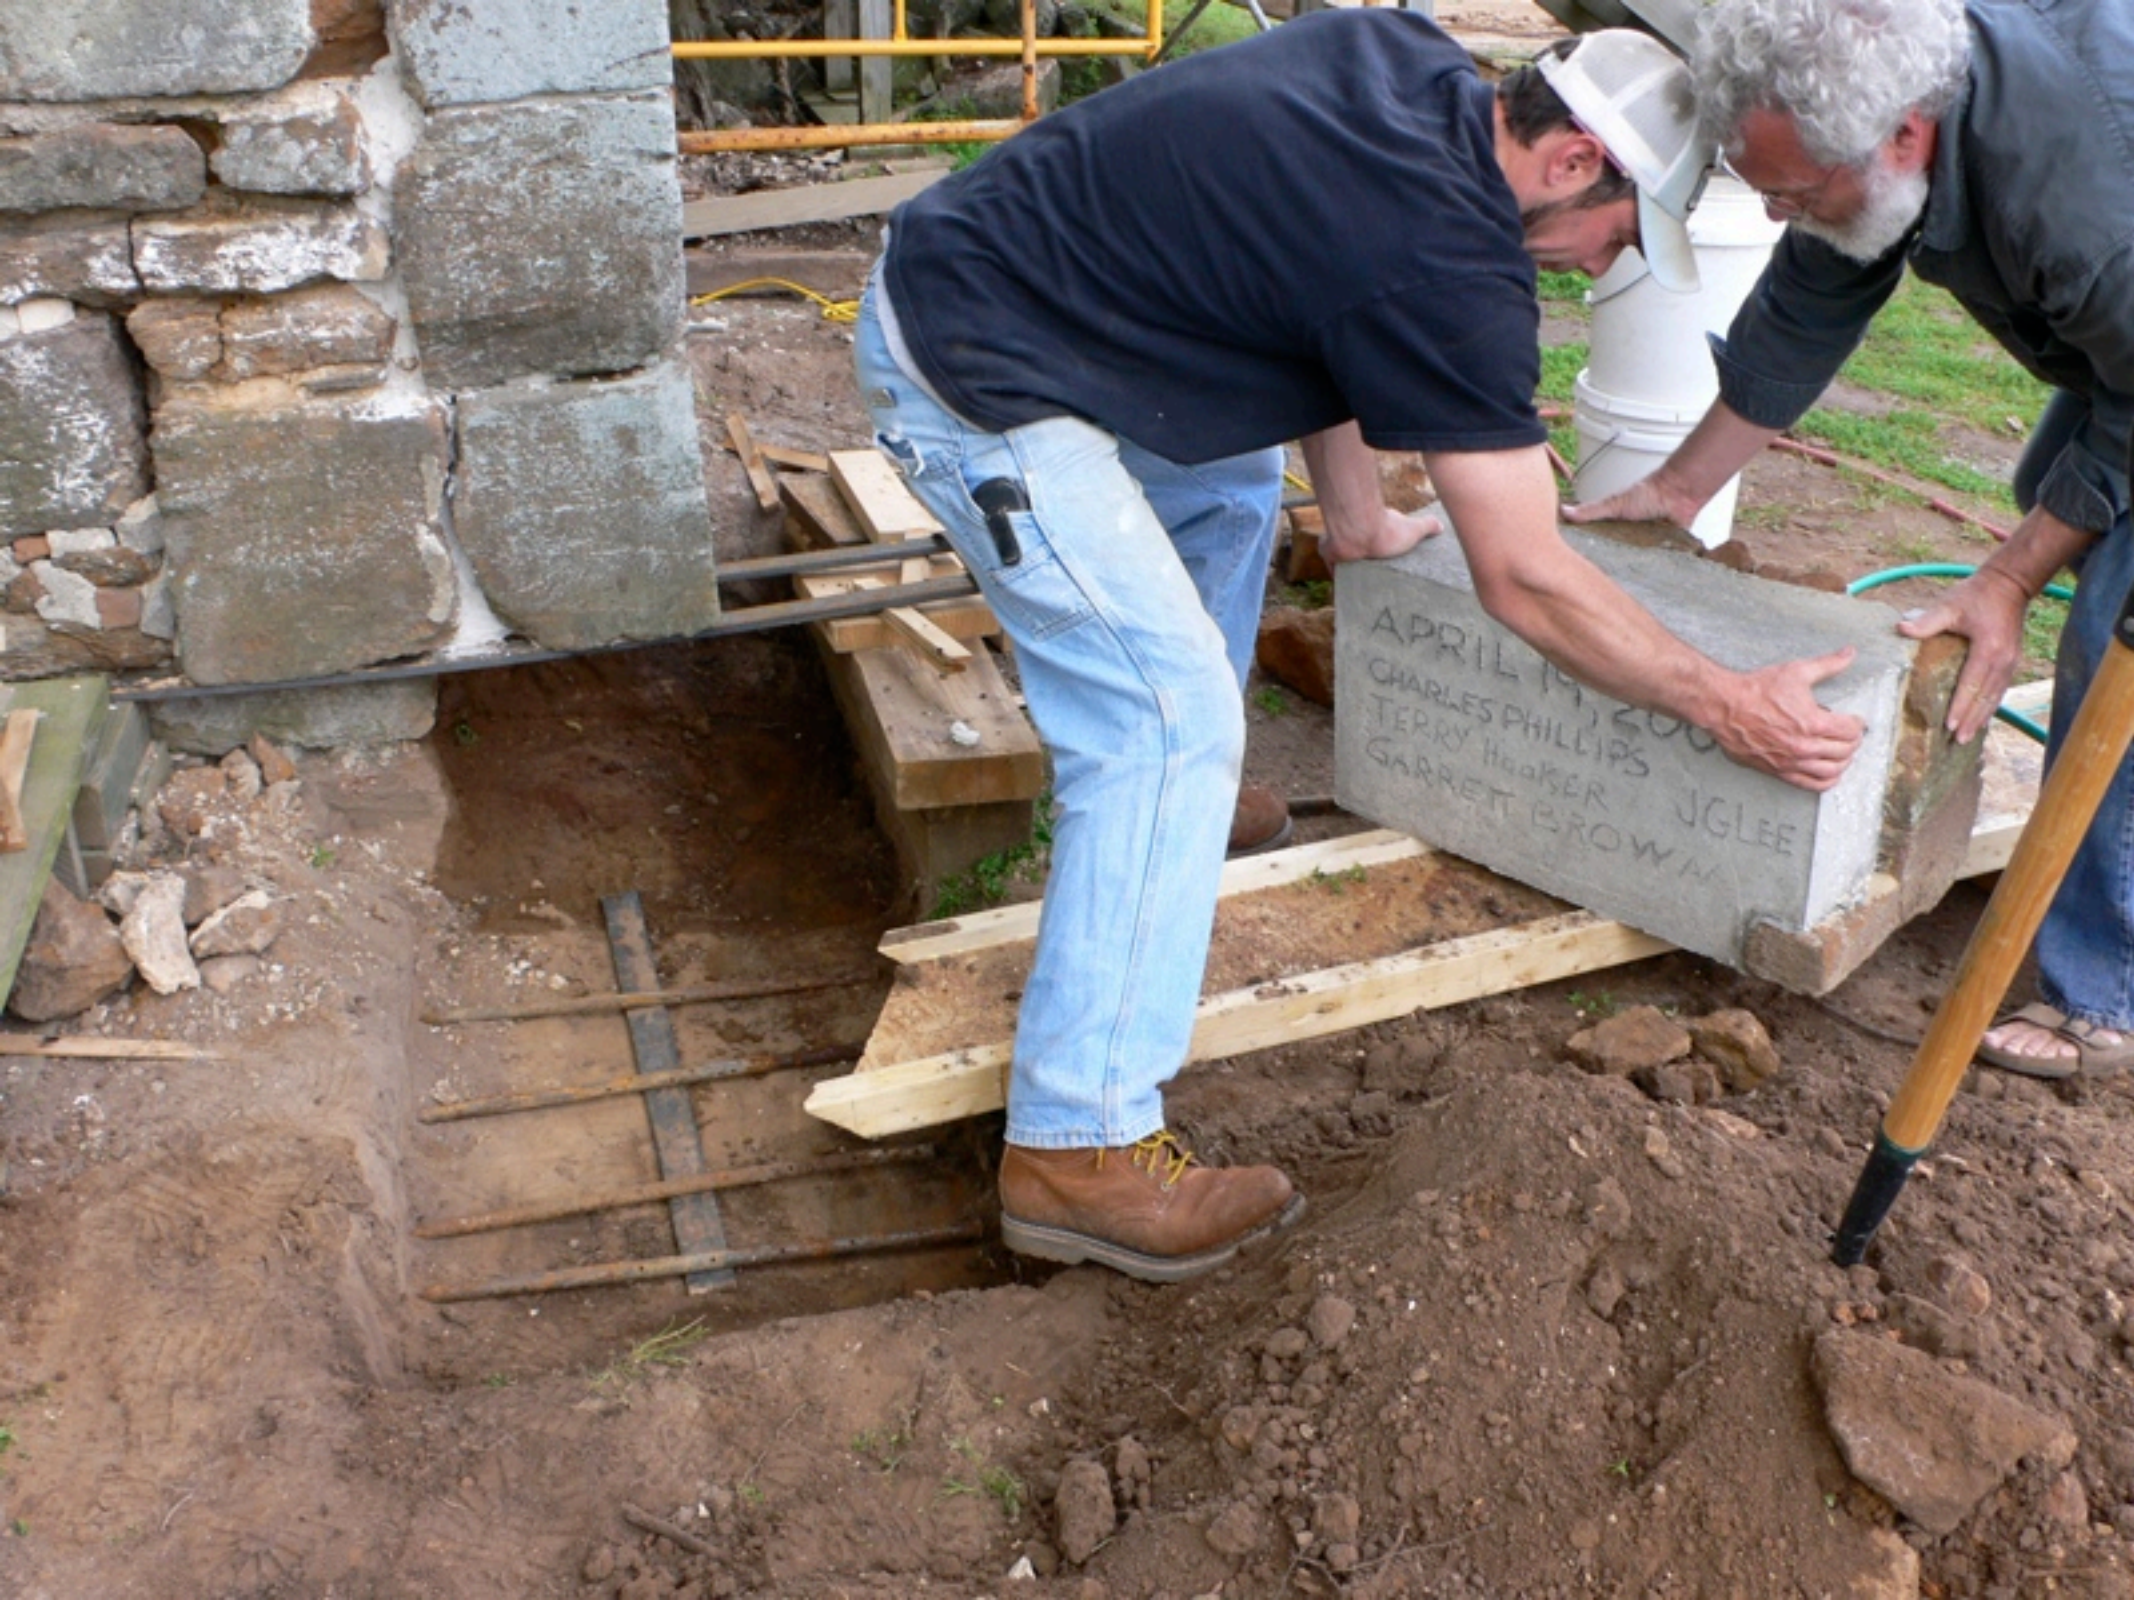
The exposed concrete of the cast stone is awaiting a matching Jahn repair fill to match the adjacent fragments.

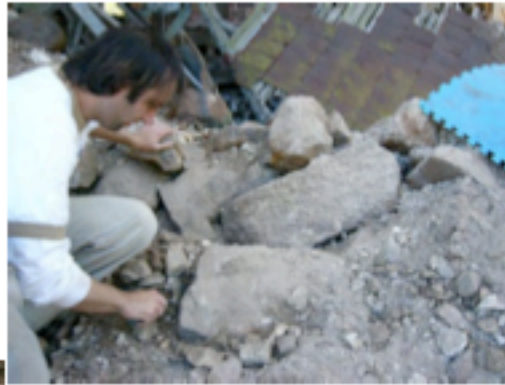
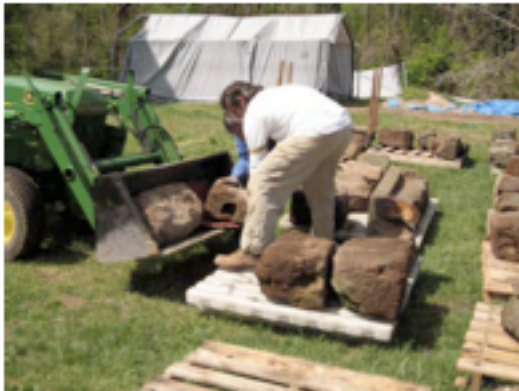
After tagging the artifacts with numbered stainless tags and stainless aircraft wire, the dimensions were measured and an electronic transit mapped three points on each object to record the artifact's three-dimensional location within the rubble pile. This data is being used to continue the spatial recreation of the collapse in AutoCad that might assist researchers in understanding the original relationship of the artifacts to one another.

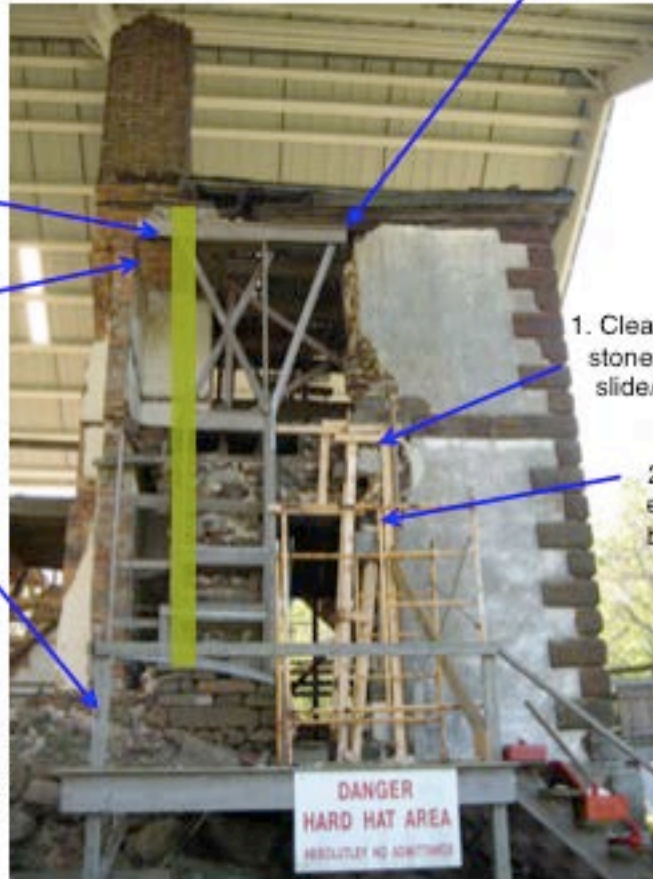
Tasks in Order: Repairs to the East Wall

4. Install wall plate to supply lateral support to 5. support the end of truss with new column supported on ledger below second floor

6. Remove temporary supports and platform.

8. Identify window wood (in storage) to refine dimensions and allow reinstallation of stone.

9. Lay rubble wall between windows (or something else?)

3. Re-establish contact between wallplate + masonry

1. Clean debris from behind stones, allowing them to slide/rotate back into place

2. Stabilize the entire edge of wall, top to bottom

7. Move and catalogue wall fall and identify window and beltcourse stones.

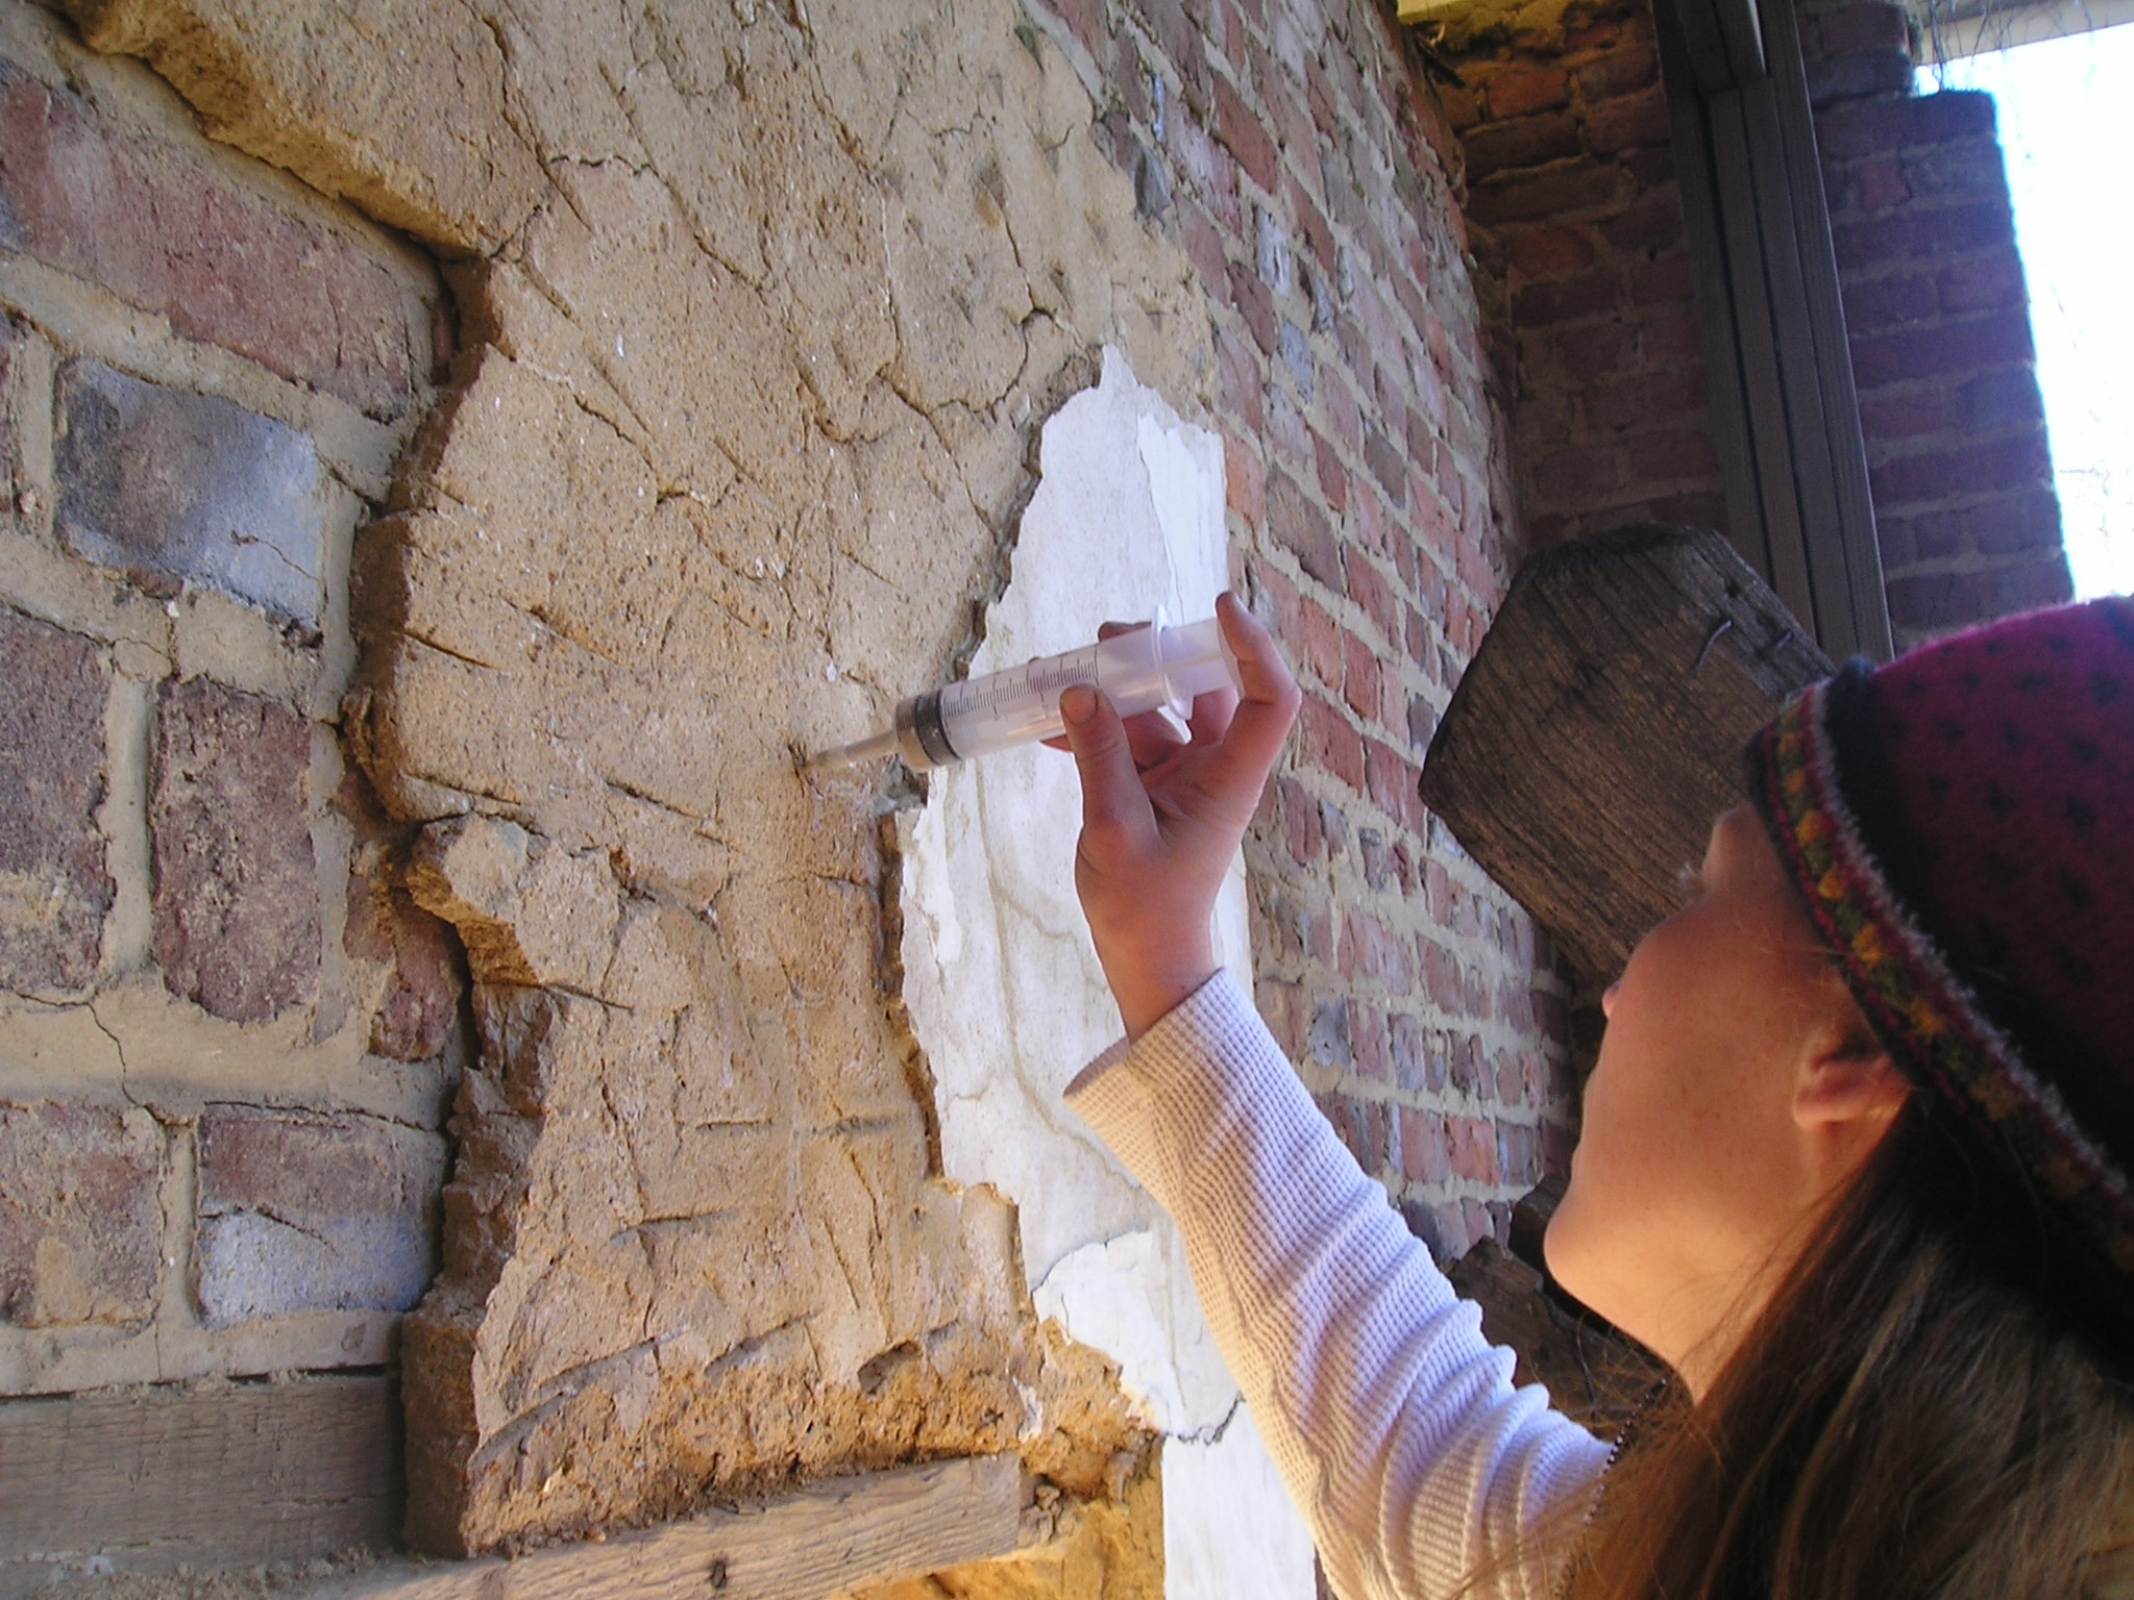
Plaster stabilization injecting calcium bicarbonate followed with a high surface area calcium hydroxide to fill voids and cracks.

Other areas were temporarily stabilized with a matrix of wood strips and styrofoam padding.

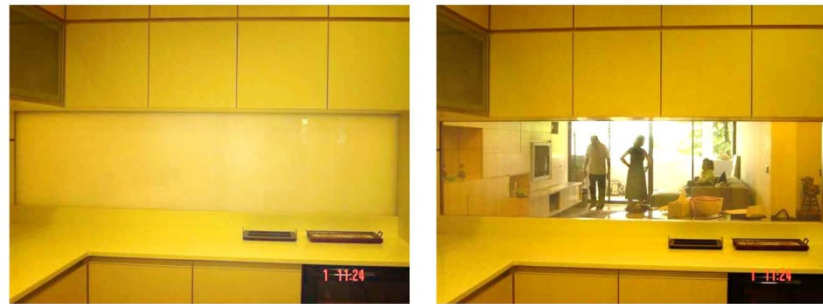
SWITCHABLE PRIVACY GLASS

PARAGON: SWITCHABEL PRIVACY GLASS is a high-tech privacy glass. At the flip of a switch, the electrified glass will go from a transparent to a frosted/translucent state.

SIZE. Our standard maximum size is 38 5/8 x 96"; however, we regularly produce larger laminates, sometimes with multiple units of privacy films within the laminate. In these cases the electrified switchable interlayer is separated by a 1/16" gap between the two pieces of film. This area can either be left clear at all times or can be covered by an etched finish; creating a small stripe.

- Provides privacy at the flip of a switch.
- On mode - Transparent; Off mode - Translucent
- Operating Voltage: 110 - 220VAC
- Response Time: Less than 1 second
- Transmittance: On - approx. 75%; Off - 4%
- Haze: On - approx. 2%; Off - 80%
- UV Blocking: 98%
- Know for highest optical clarity available and highest level of service.

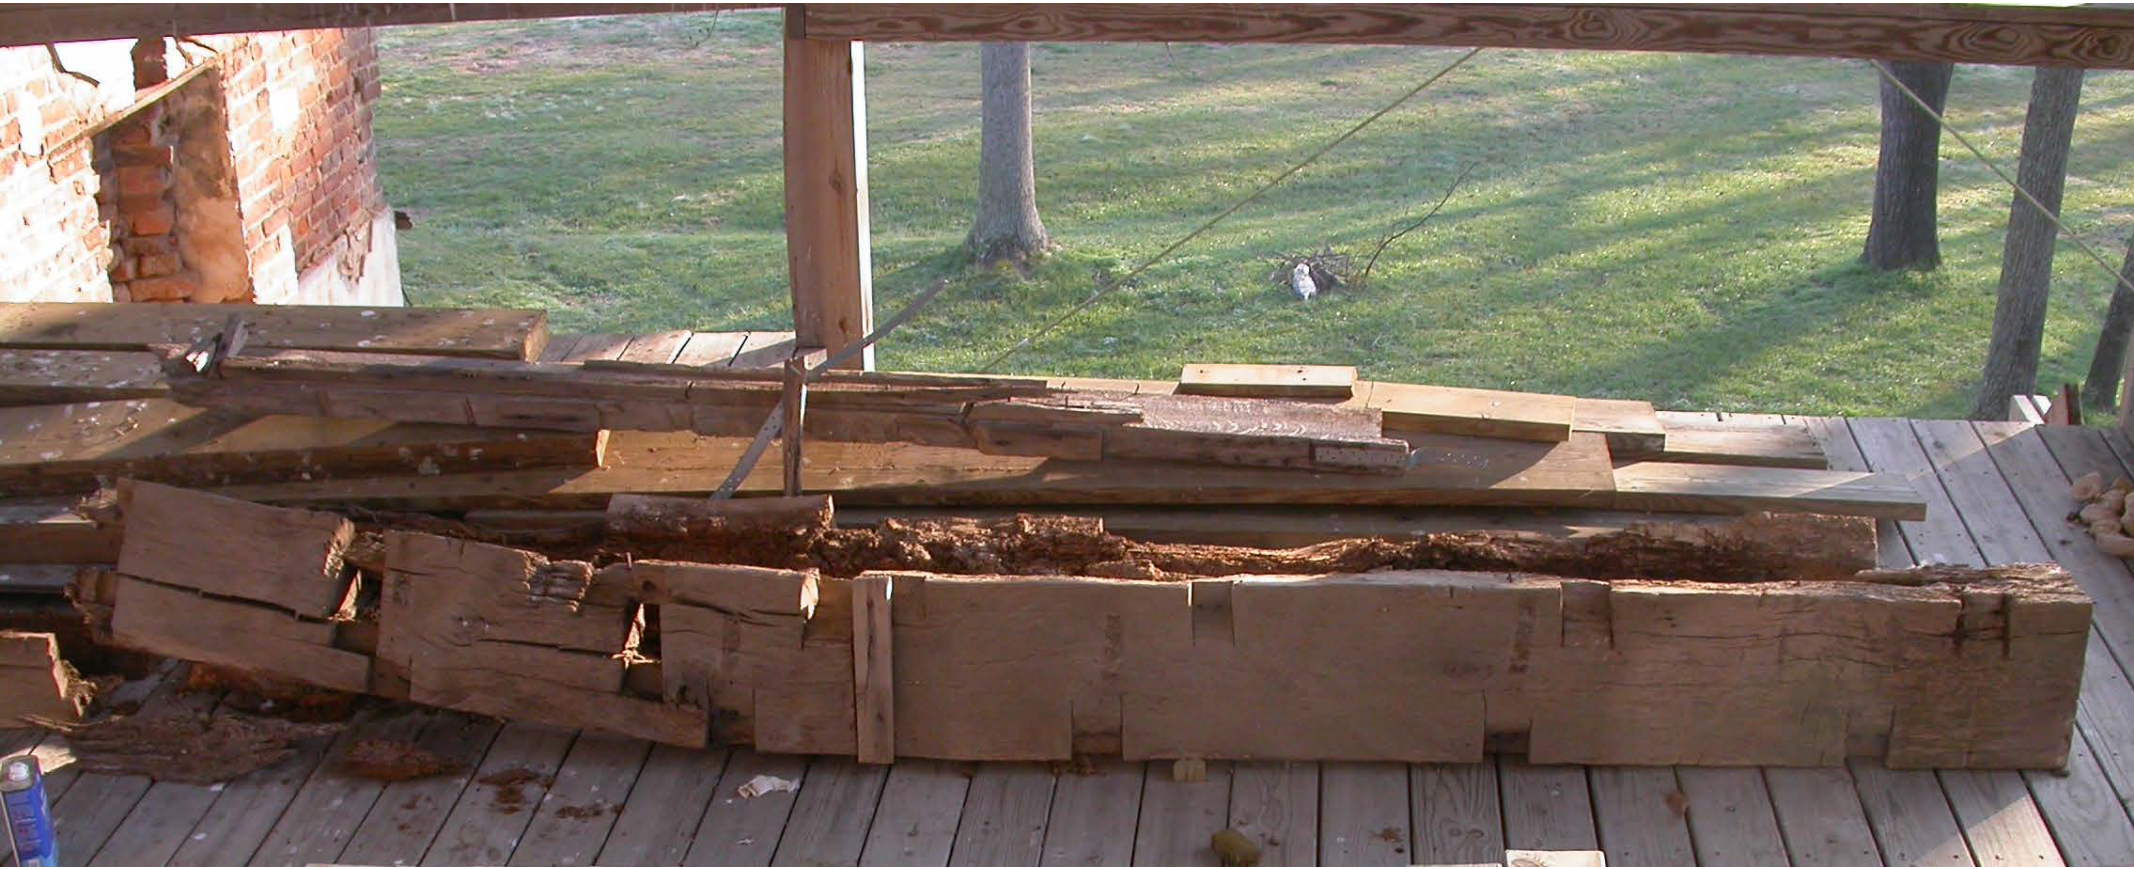
Needless to say it had to come out in several pieces.

Happily virtually all the skin was intact, but the largest pieces were badly warped.

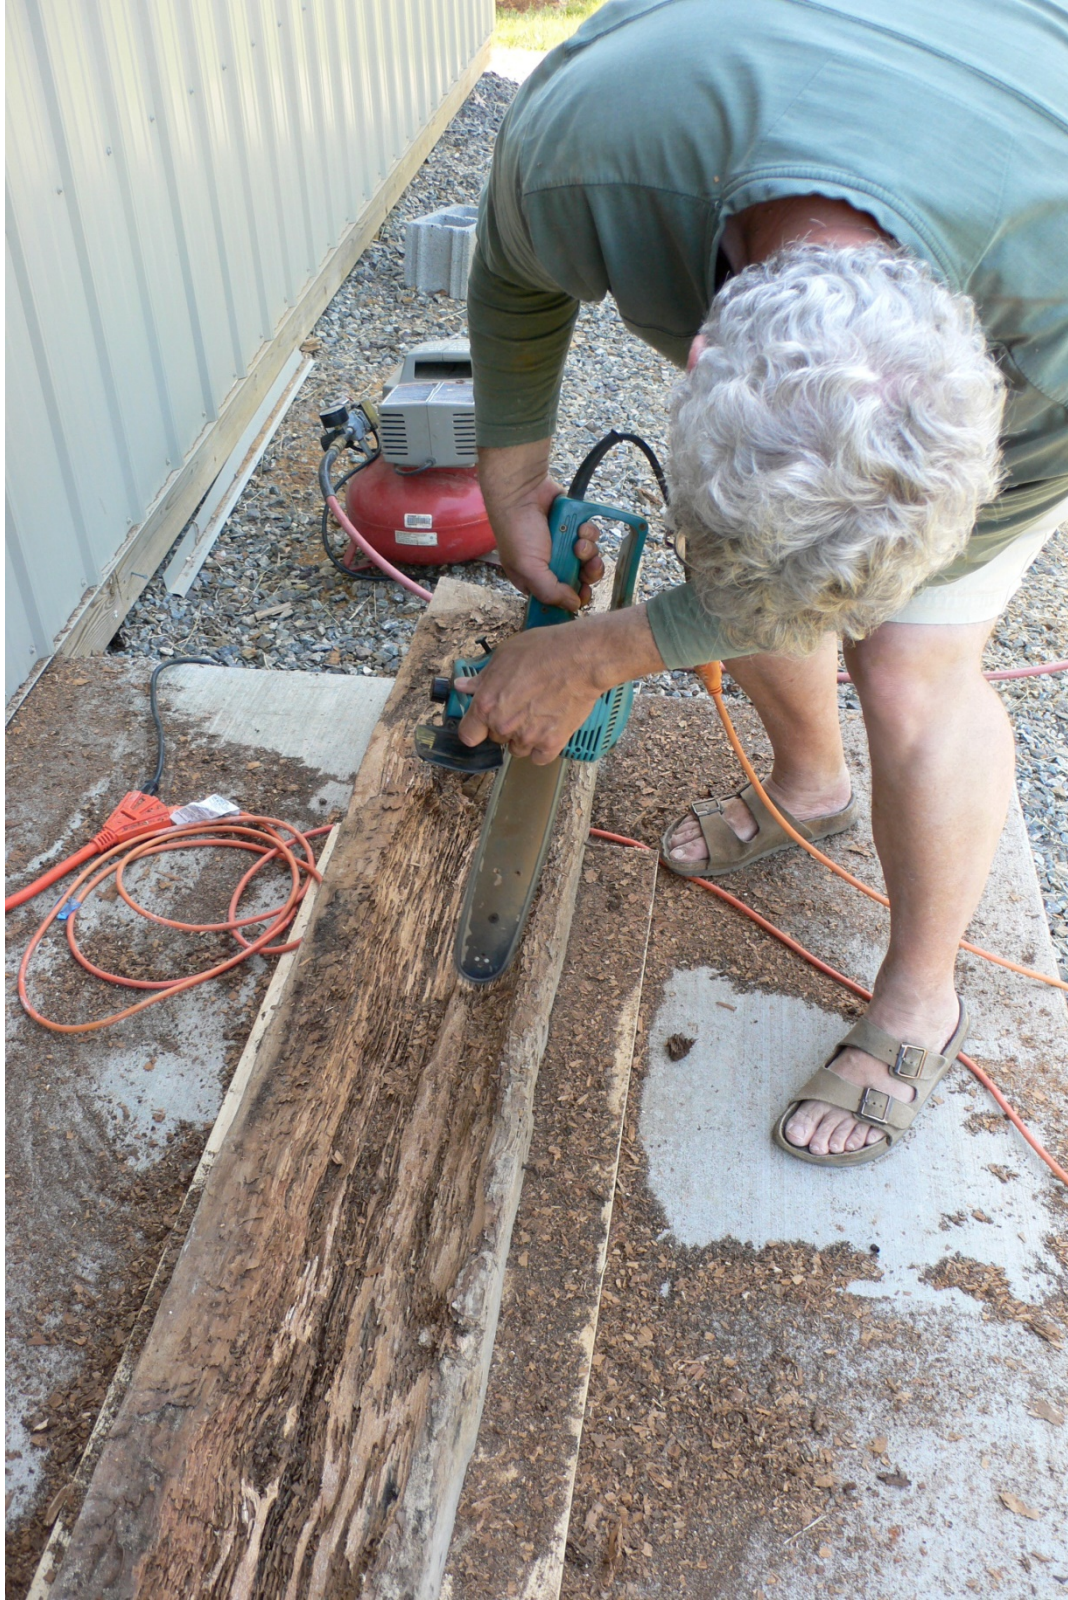
John and I decided that getting this girder back into location at full weight plus was a serious problem. If we removed rather than consolidate the internal frass and made a hollow carbon fiber core filled with foam it would be much lighter and probably stronger.

I began the process of removing the unwanted interior frass and over three days of wet work removed the three axis warpage.

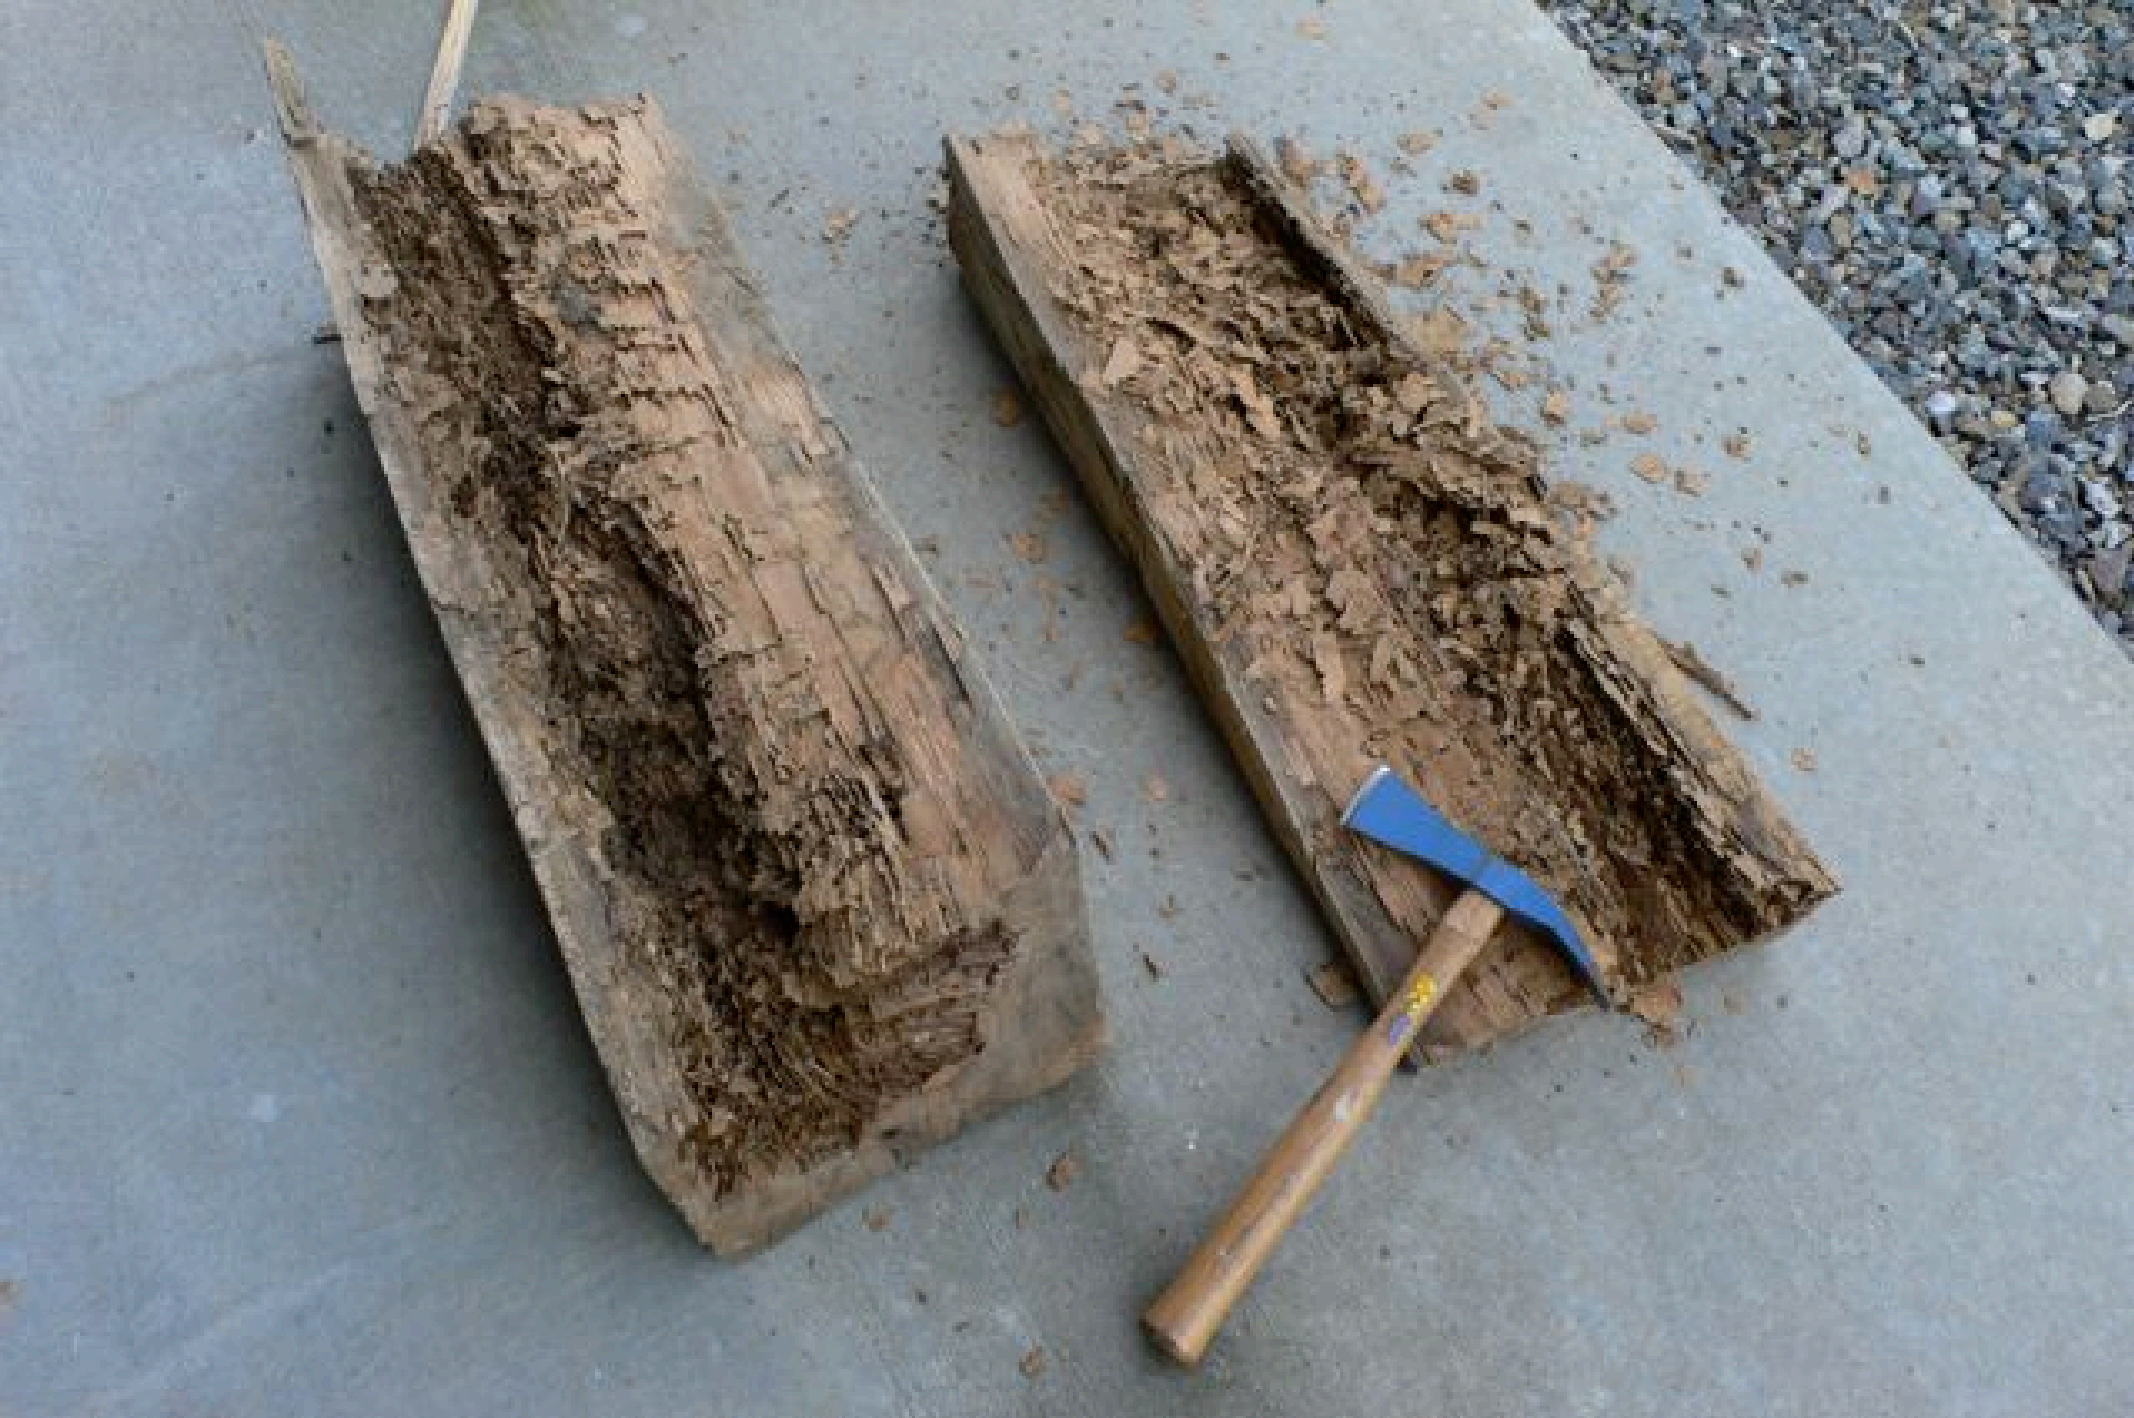
Non-Menokin test sample

John in the meantime was experimenting with carbon fiber. Taking a similar timber fragment salvaged from a dumpster in Annapolis, he hollowed it out and set up a vacuum forming shop to test the concept.

SUPPORT ARMATURE FROM EPOXY/CARBON FIBRE CLOTH VACUUM FORMED TO BEAM INTERIOR

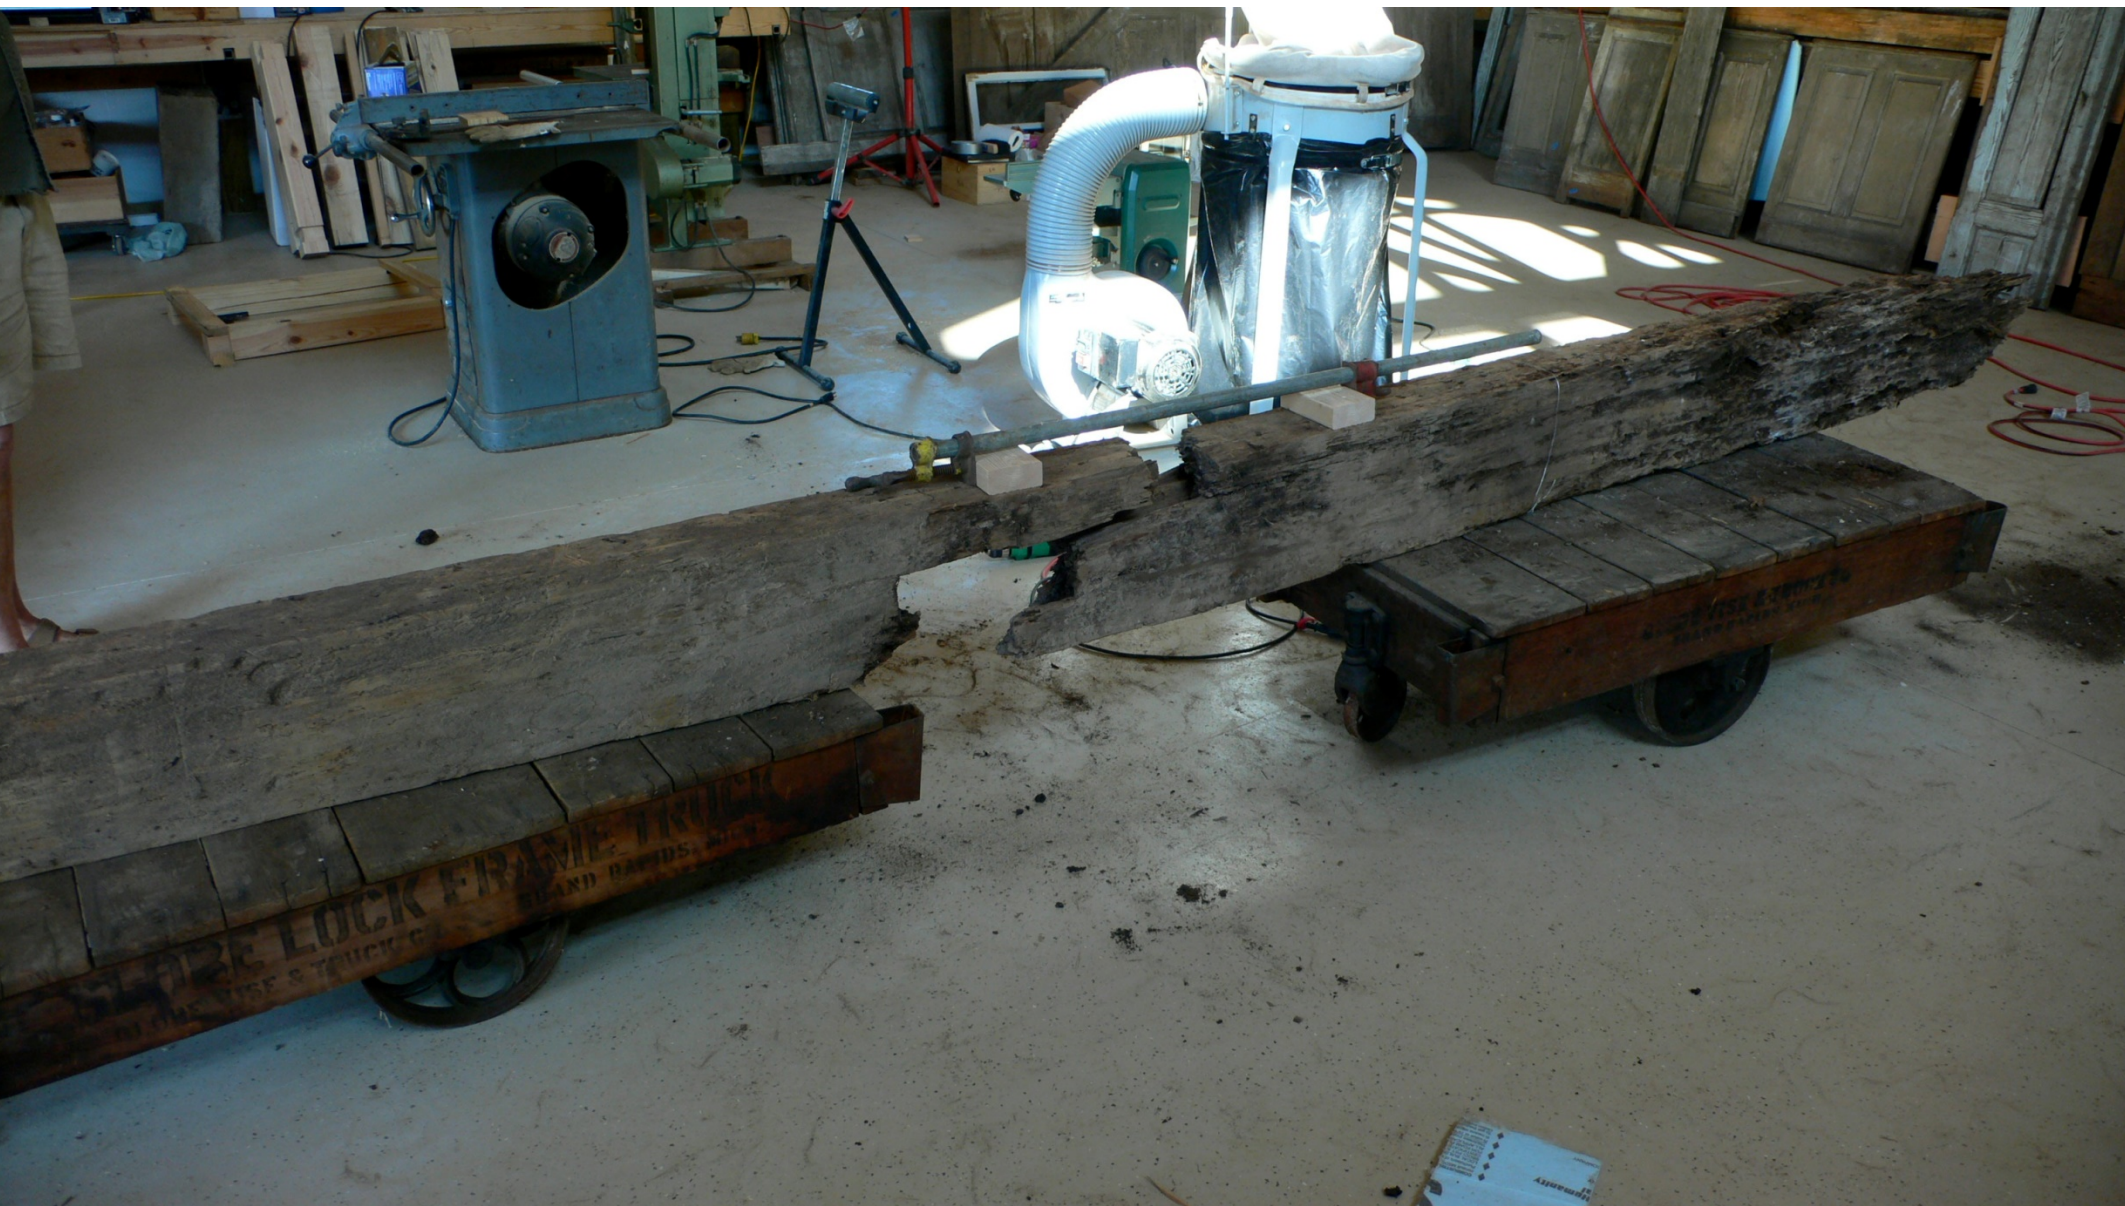
In looking at this principle rafter we decided to go back to basics.
