Since the dawn of time, man has attempted to conserve culture and display artifacts as restored objects without confusing the new and the old and taking in inside to a protected environment. Menokin has allowed us to consider this desire and find it within our grasp.

The home of Francis Lightfoot Lee, signer of the Declaration of Independence, Menokin was possibly designed by William Buckland. As such it was a good candidate for being a revered artifact.

Wood Conservation Challenges at Menokin

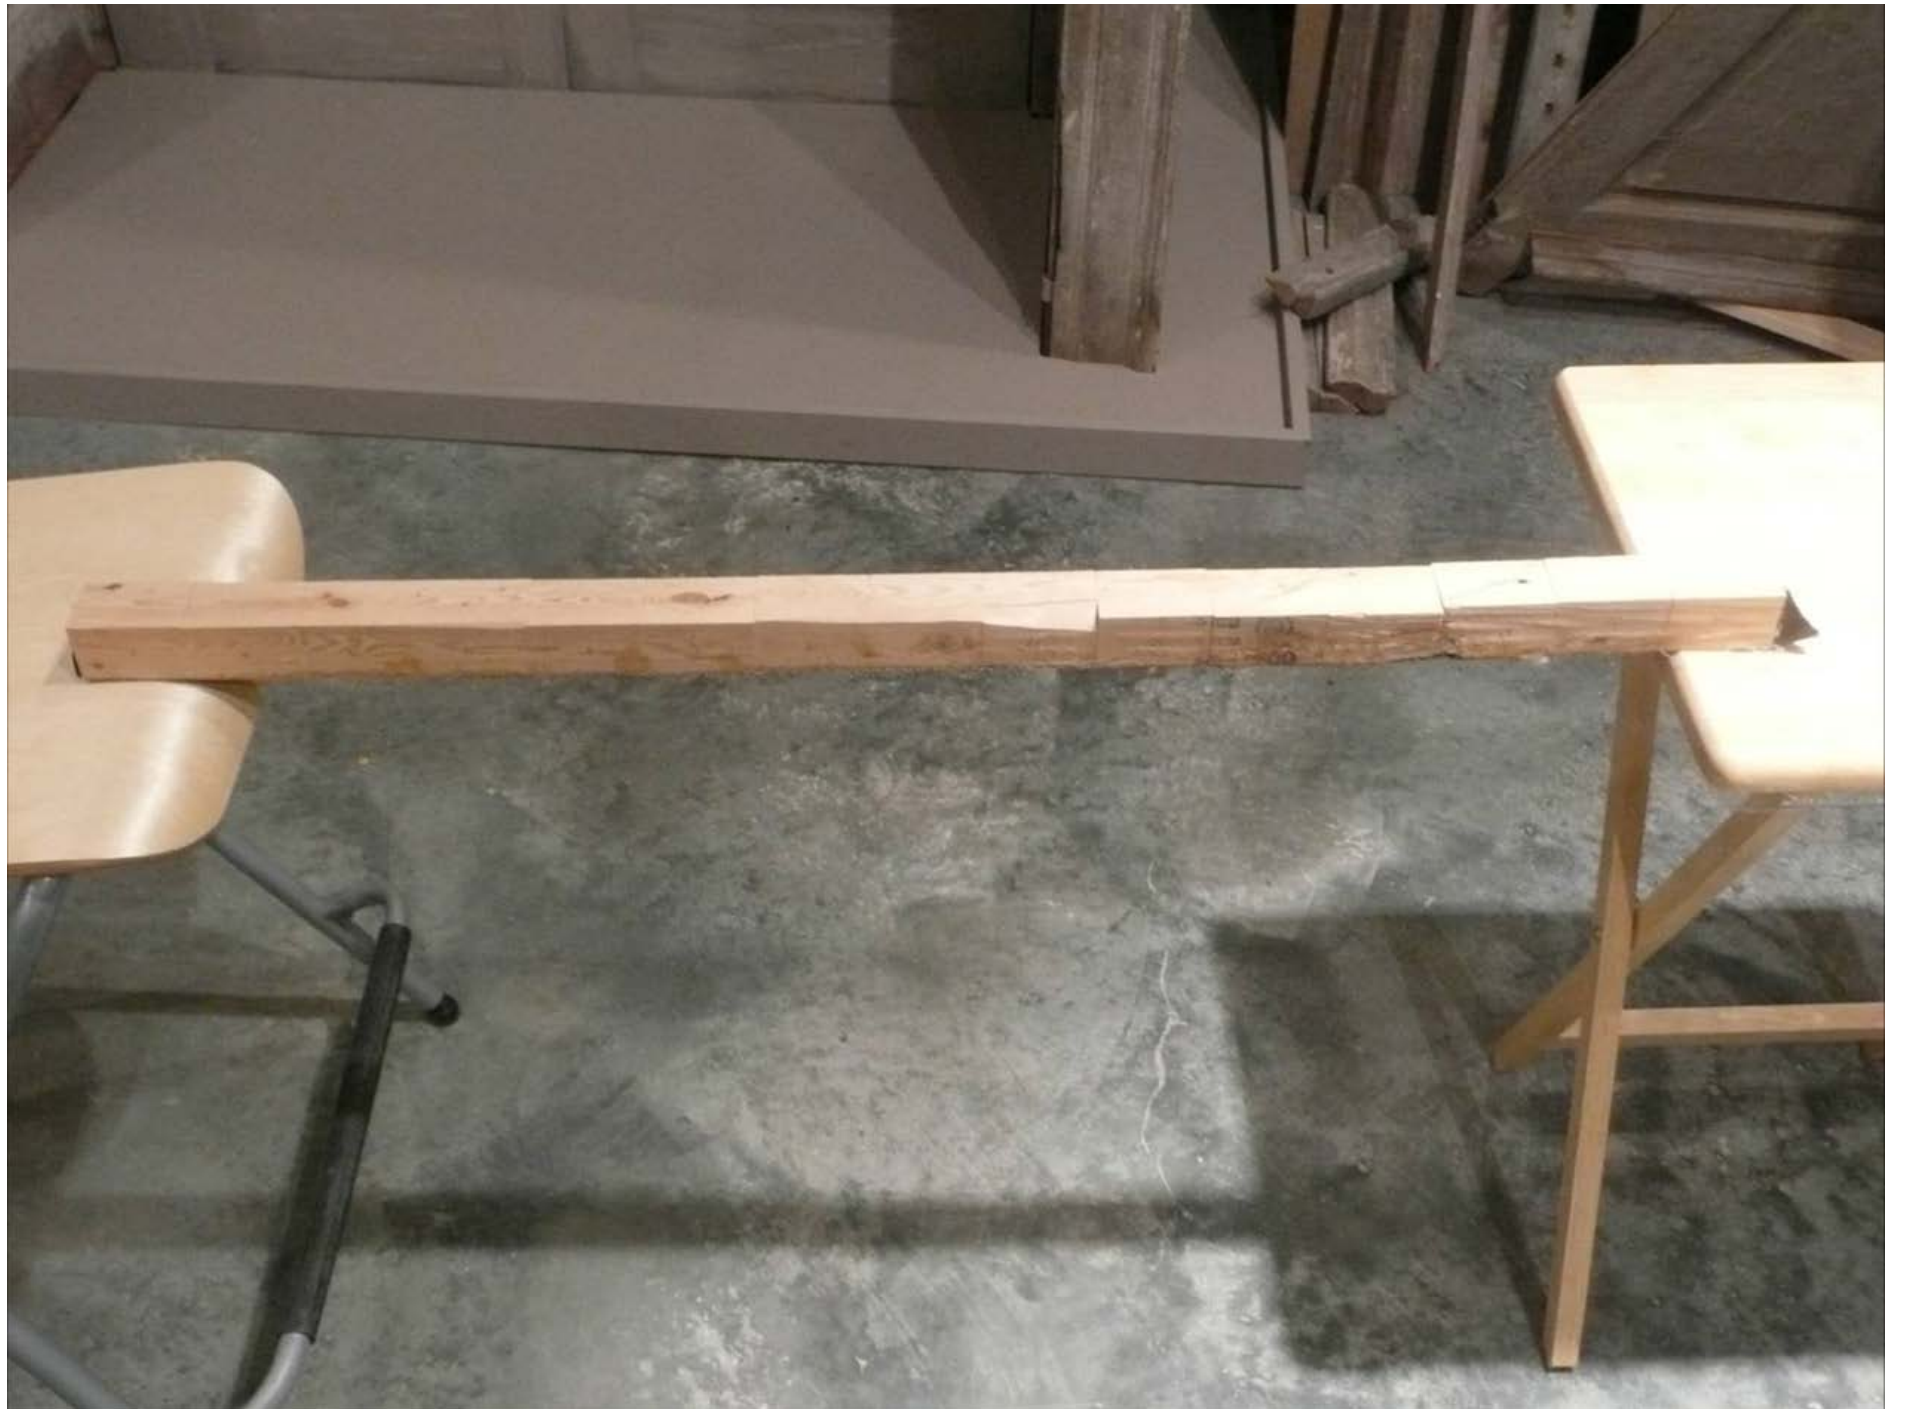
We started a testing program for wood carbon fiber and resin composites.

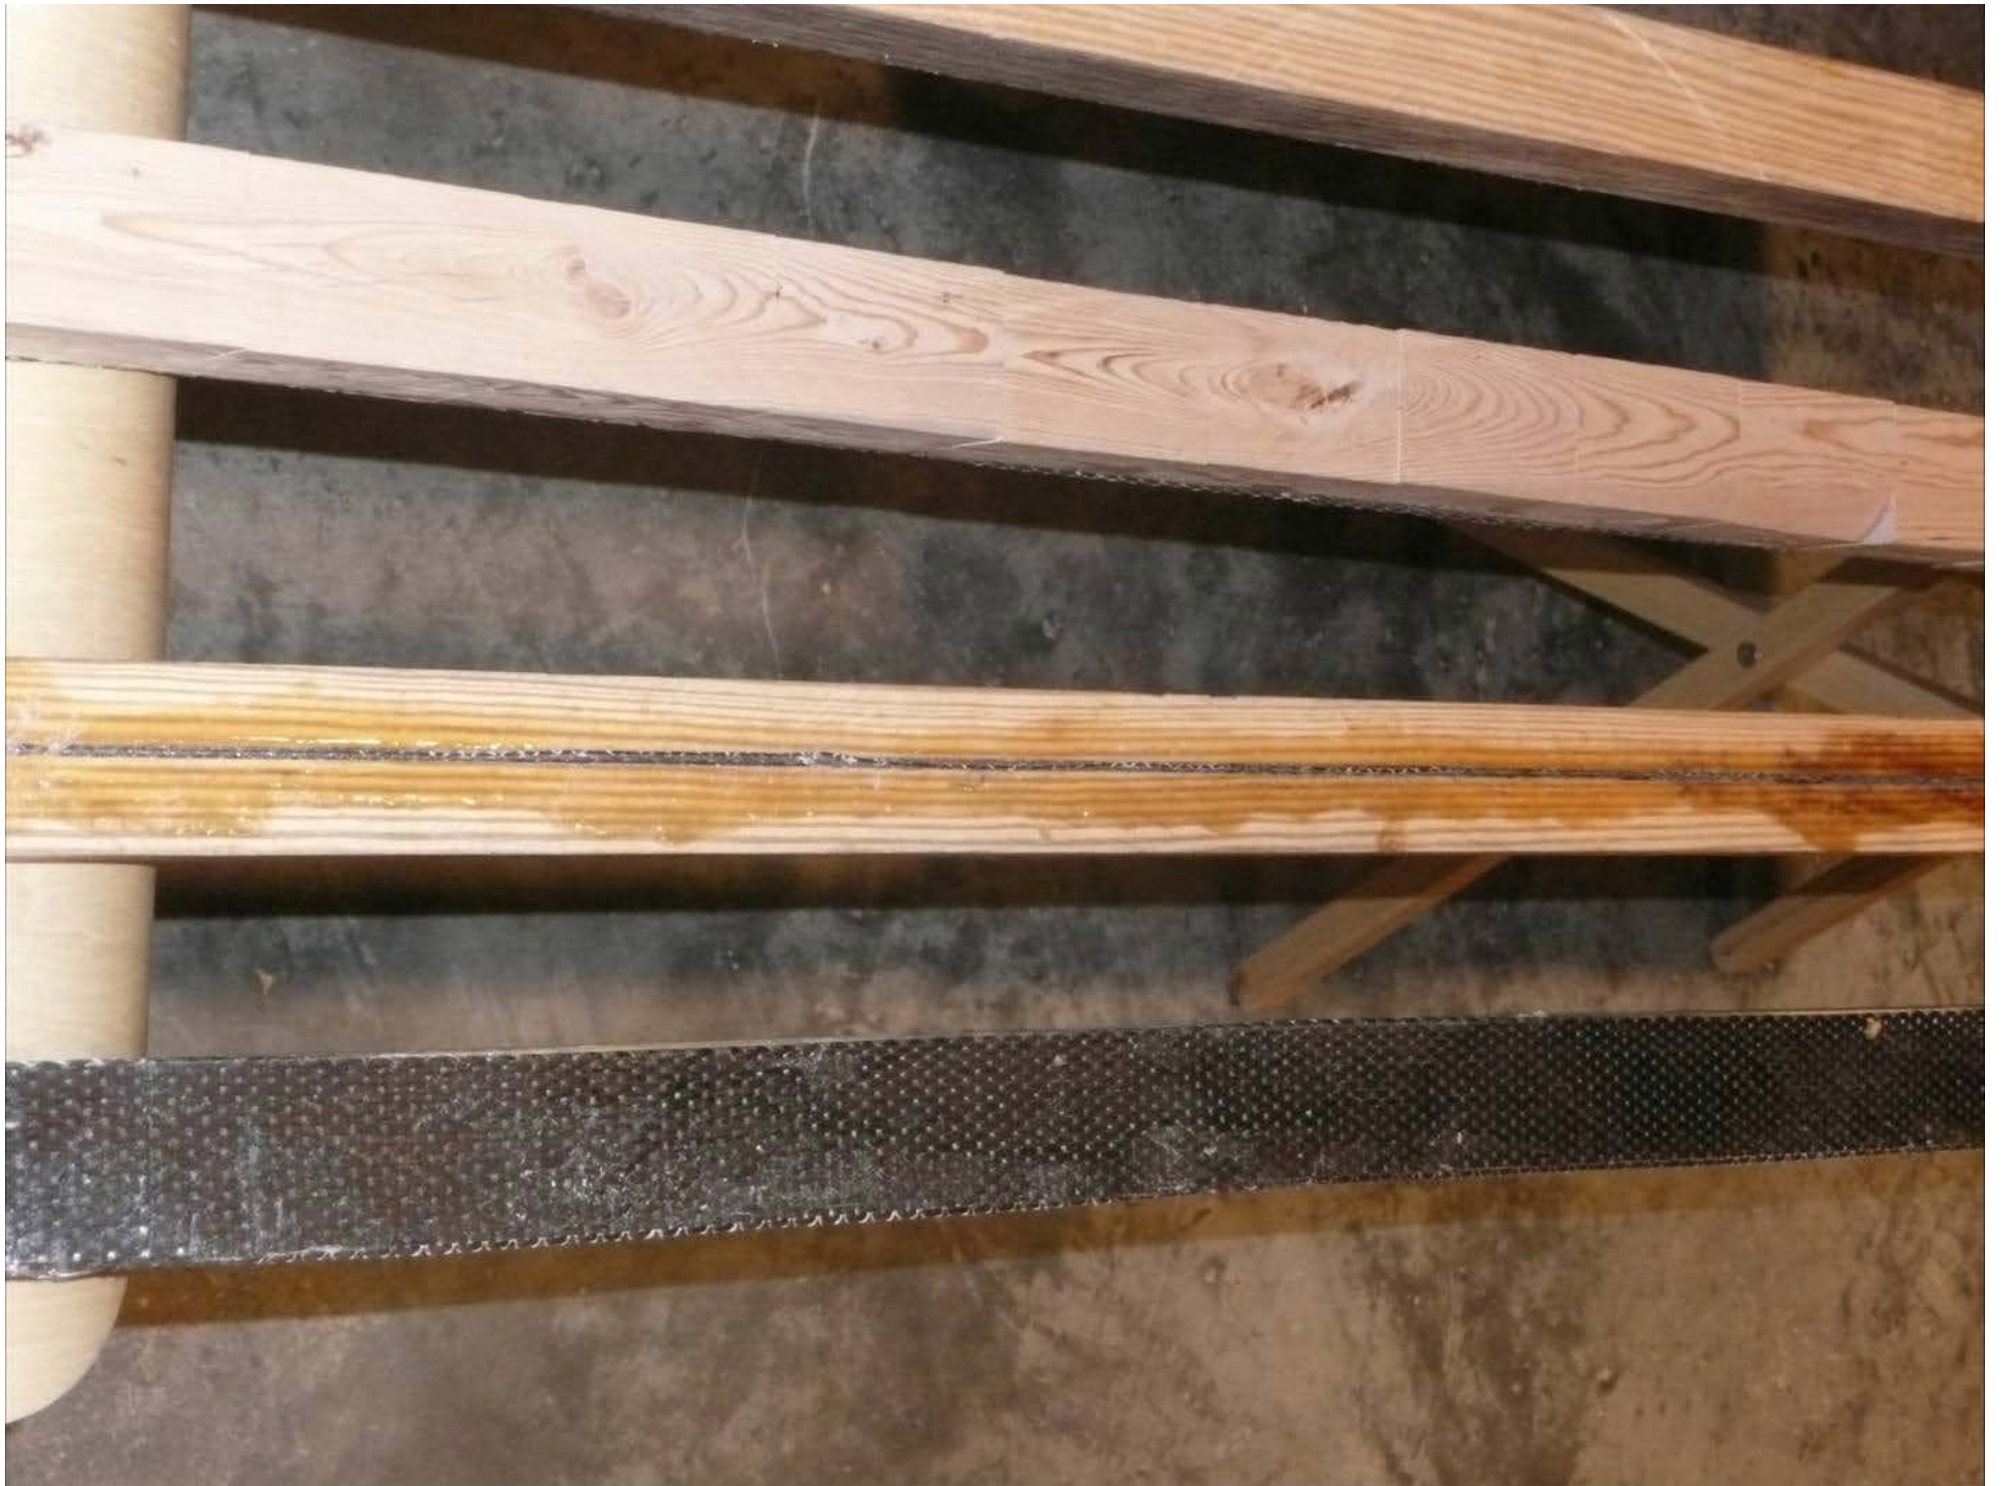
The upper stick is simple wood.

The next is a series of loose blocks bonded on one side with a carbon fiber tape with epoxy.

The next is wood with a slot cut halfway through and a carbon fiber tape folded in half and glued in the slot with Elmer's glue.

The bottom is wood with one layer of carbon fiber tape epoxied on one side.

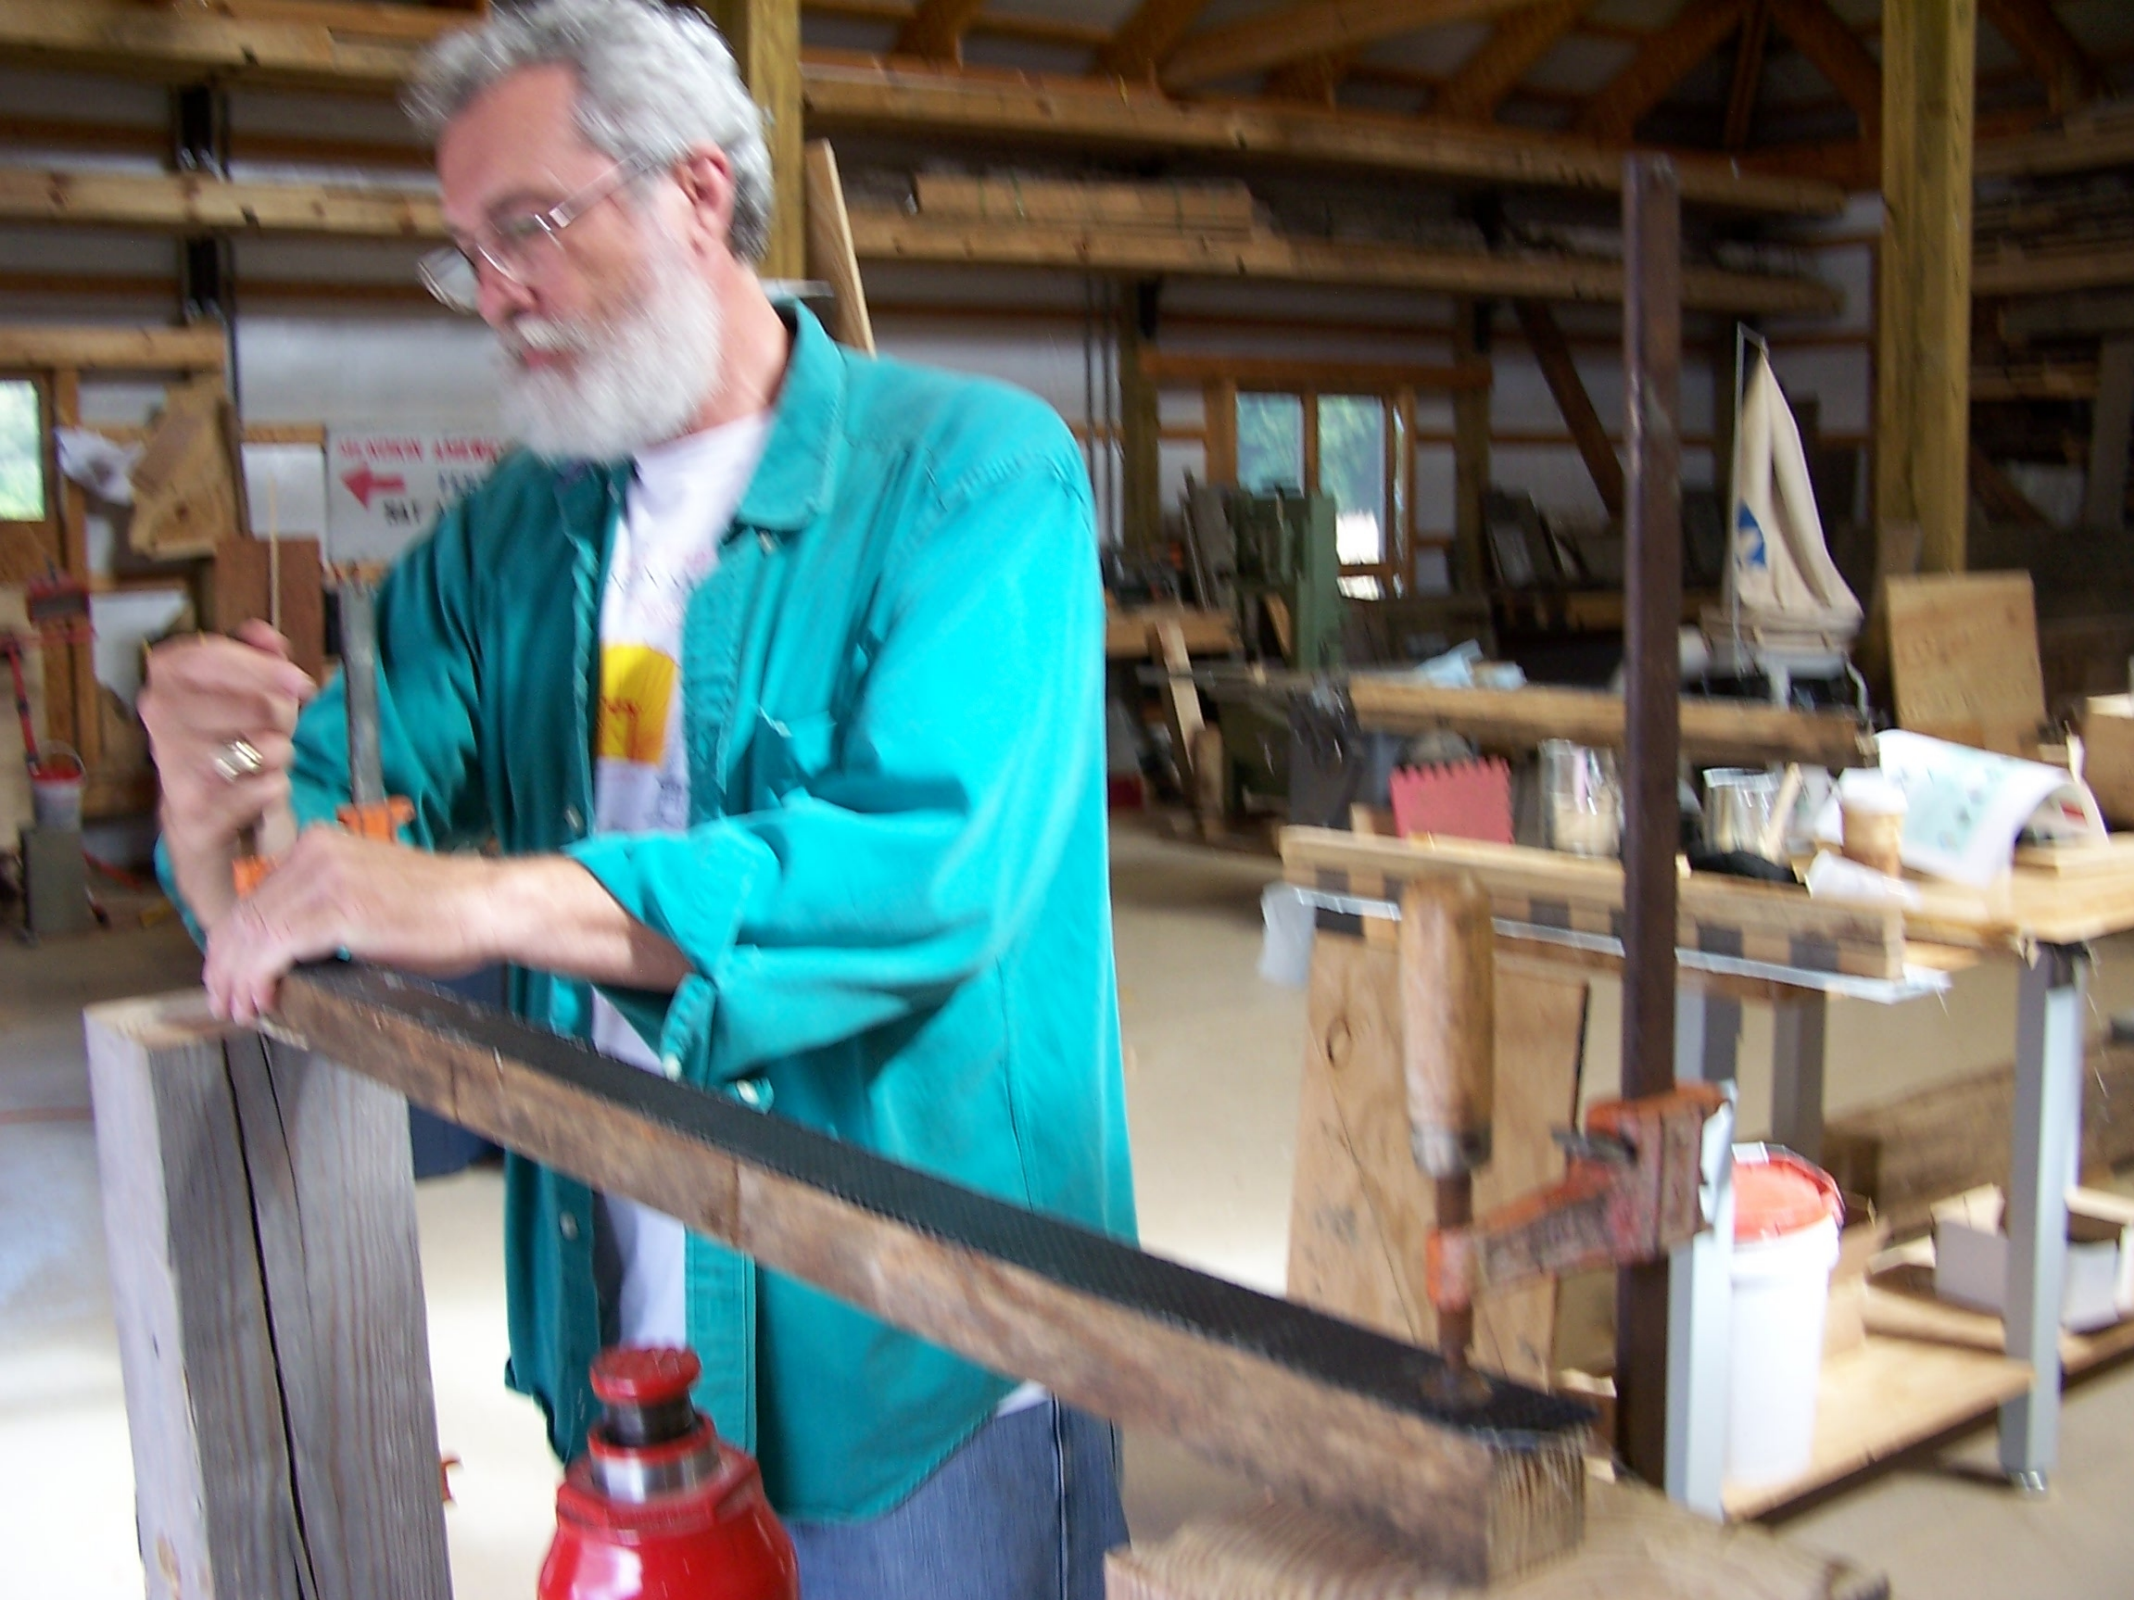
The loose blocks backed up with one layer of epoxy impregnated carbon fiber tape is stronger than the unaltered wood. It resisted much more than 1000#

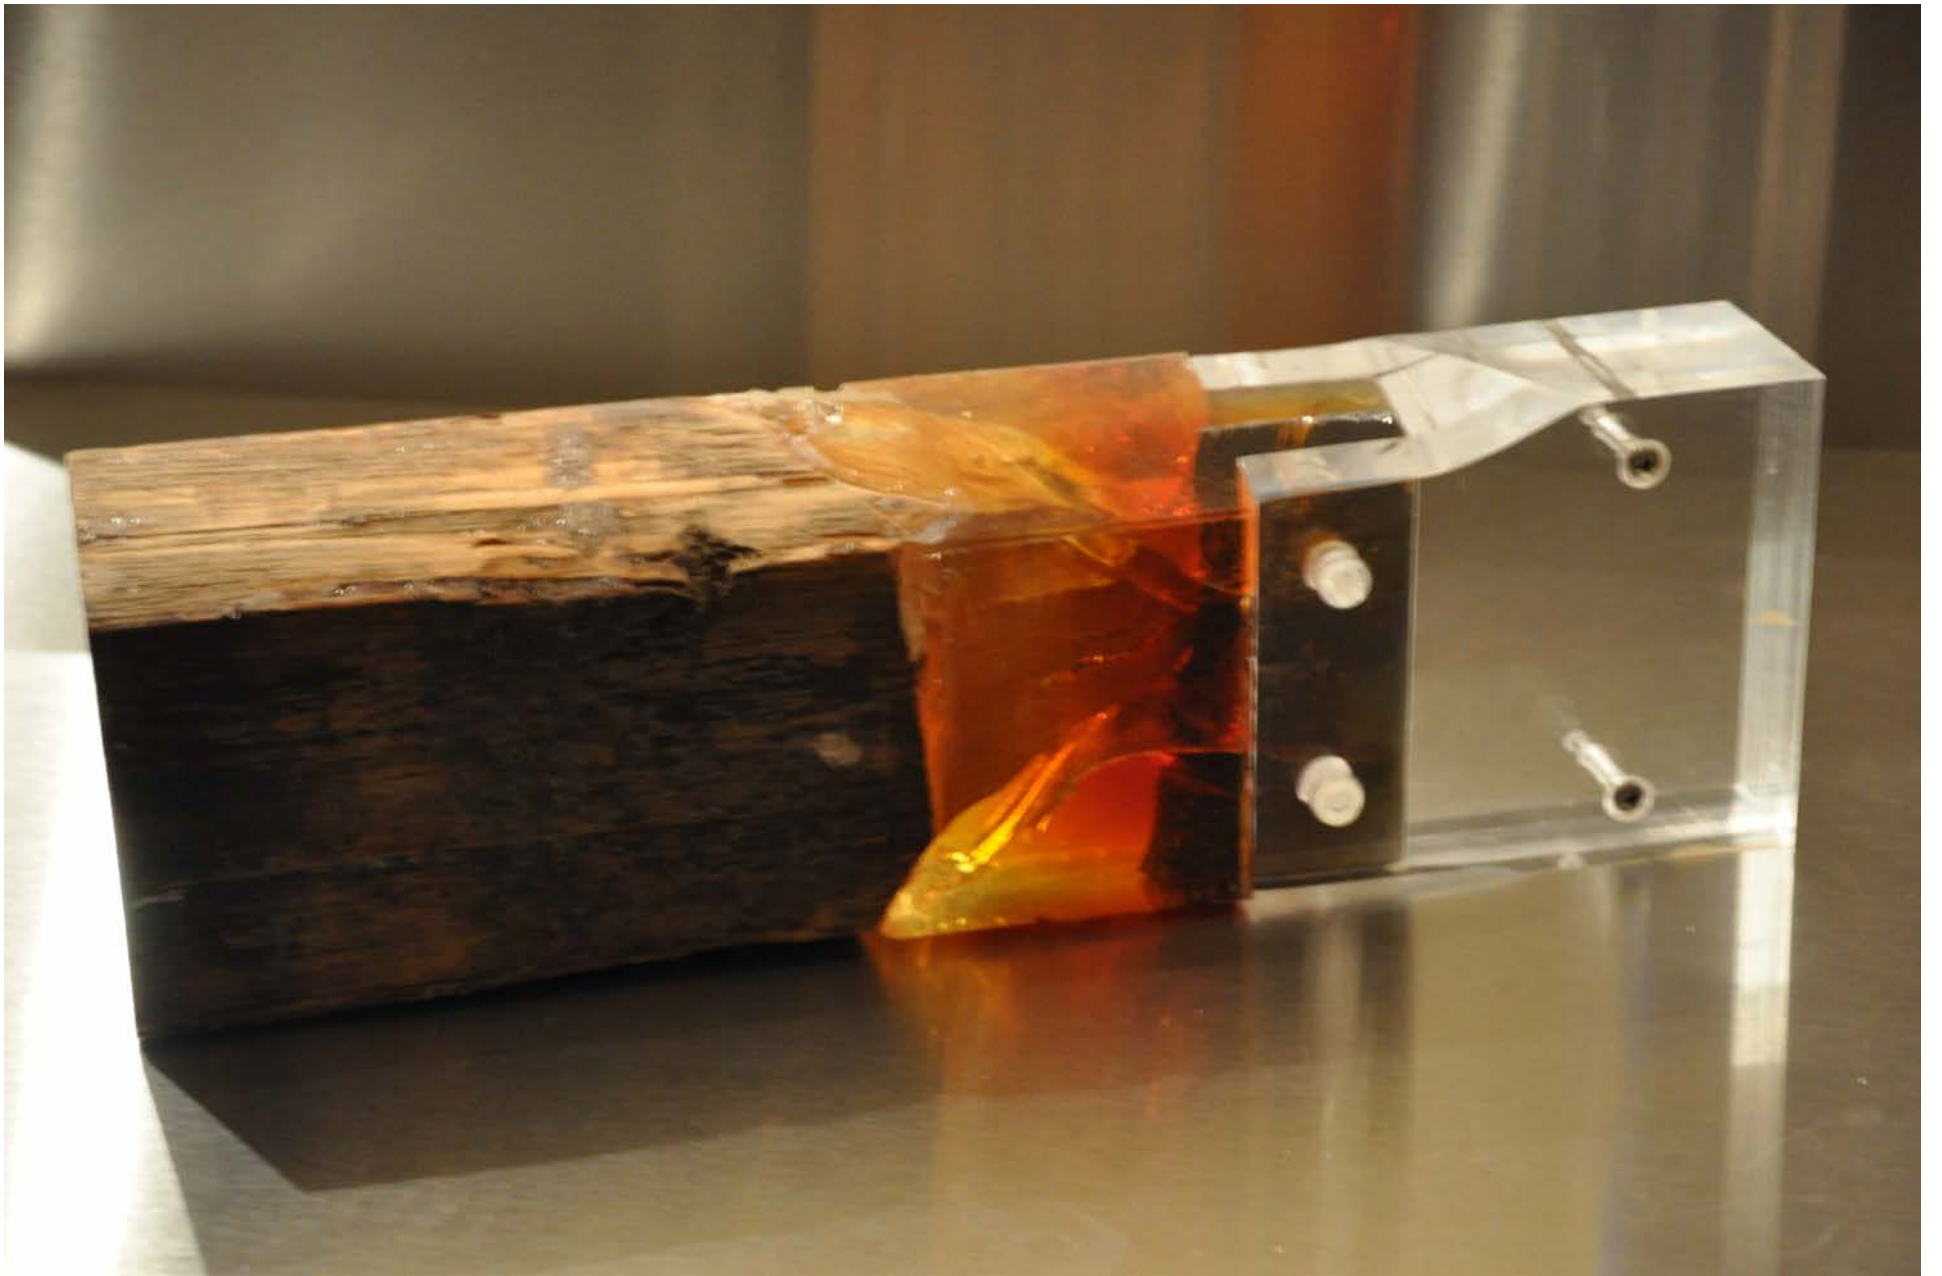
The first crude mockup of what a glass prosthesis might look like

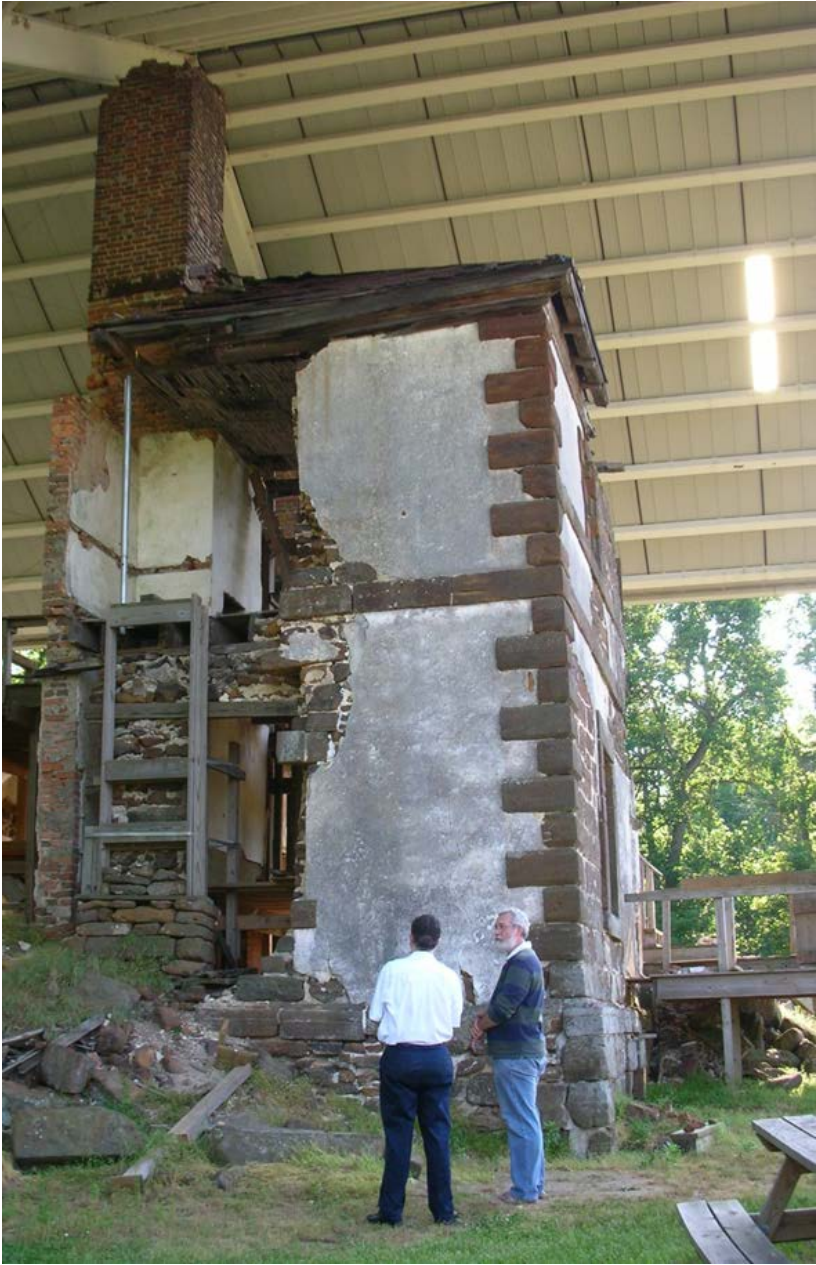
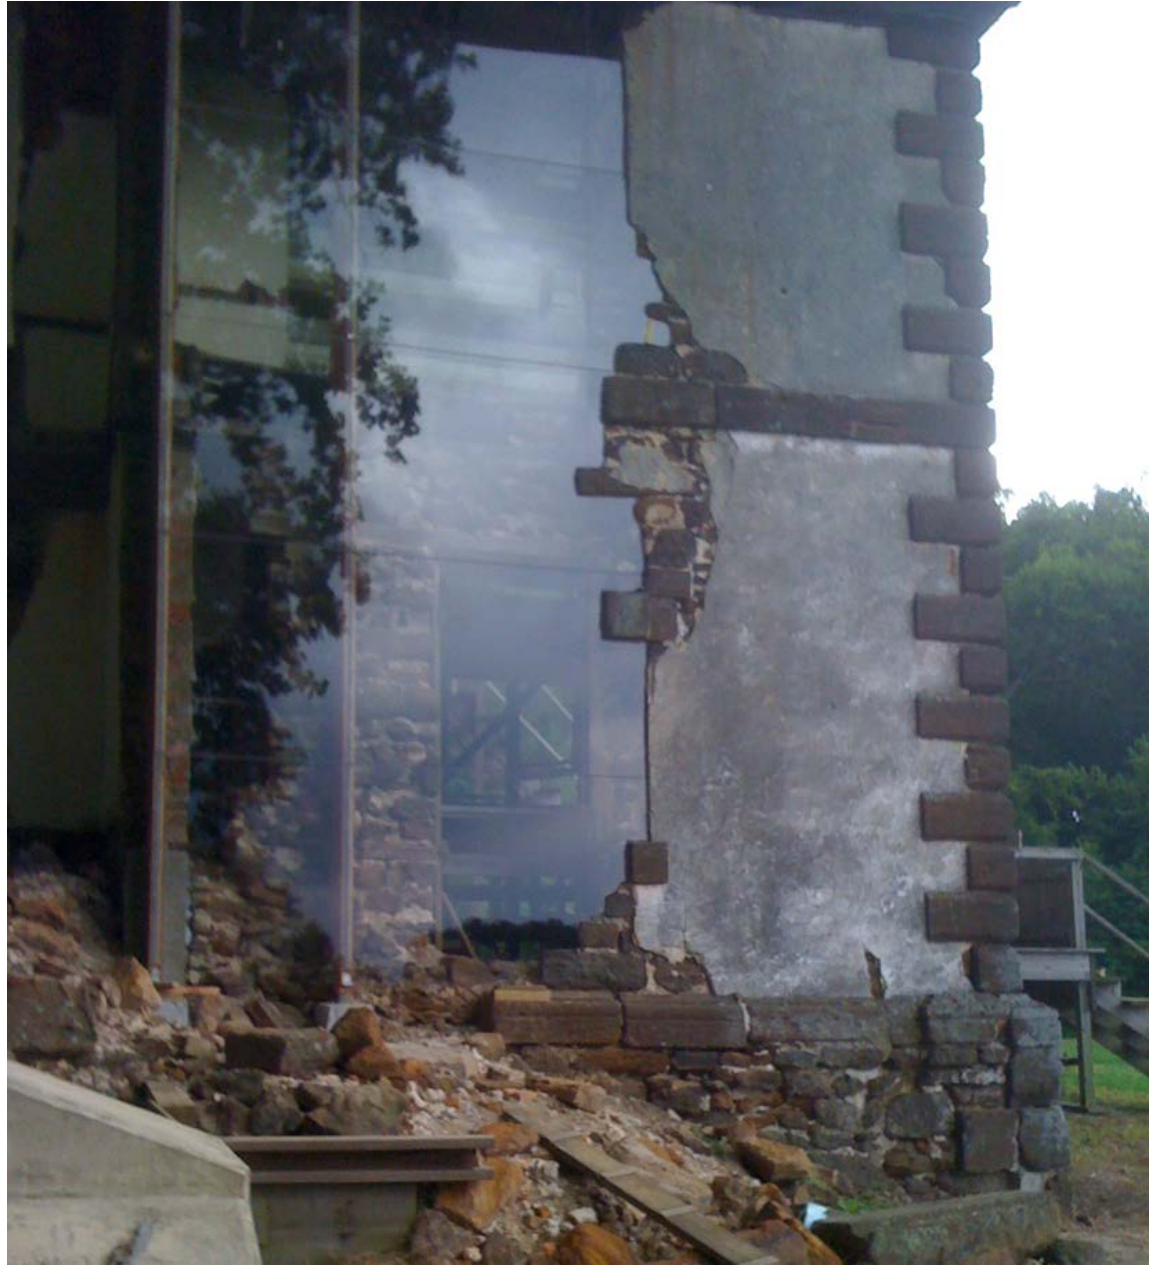
Rain was blowing through this gap in the wall and rather than hang tarps or build a plywood wall as was suggested, we proposed to make a plywood and plexiglass full scale mock-up of what a section of the glass wall might look like. It was the first time a number of folks actually understood the impact.

The mdo plywood and plexiglass were selected because they could be easily cut on site.

As the missing area now enclosed represented window, as well as wall, we applied a frosted material designed for computer generated signage to interpret the missing windows.

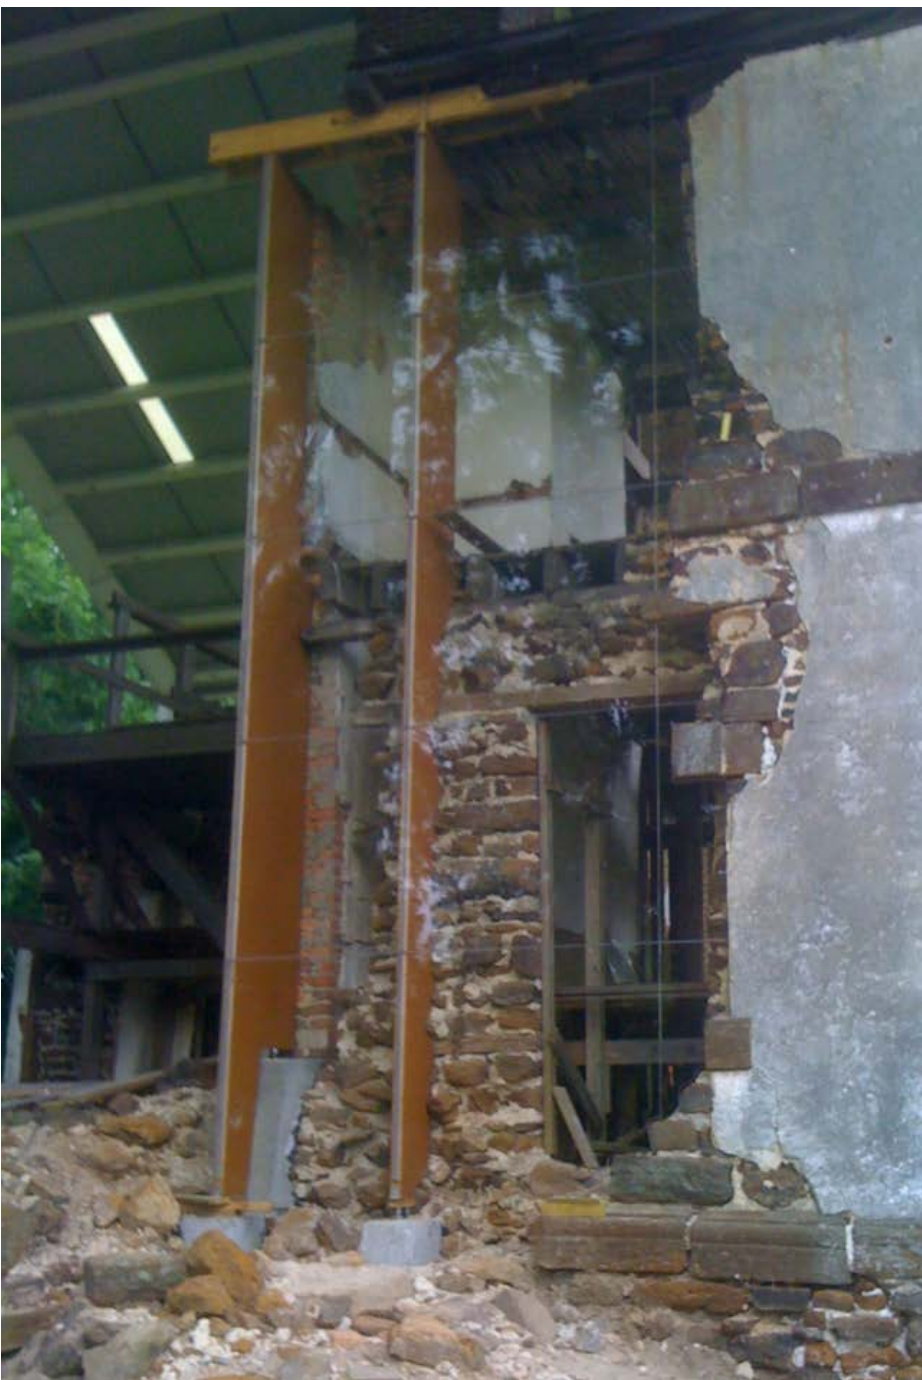
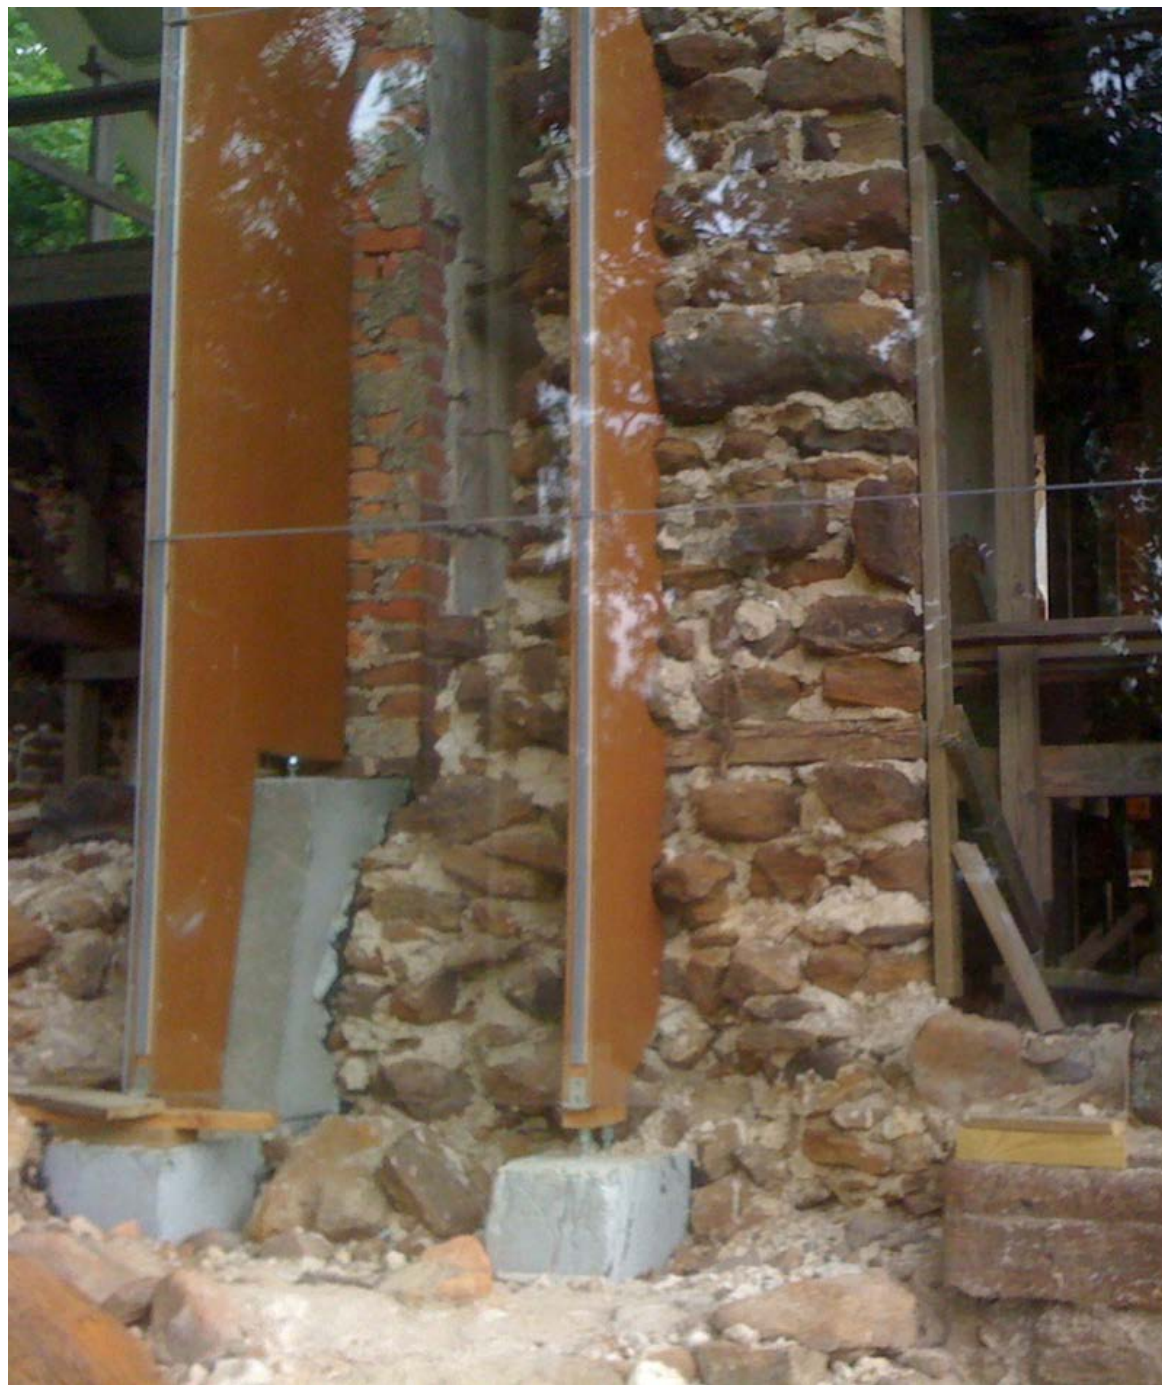
The concrete footings were separated from the historic rubble below with a layer of black mylar.
