Charles A Phillips, AIA, AIC-PA

Some Recent Projects

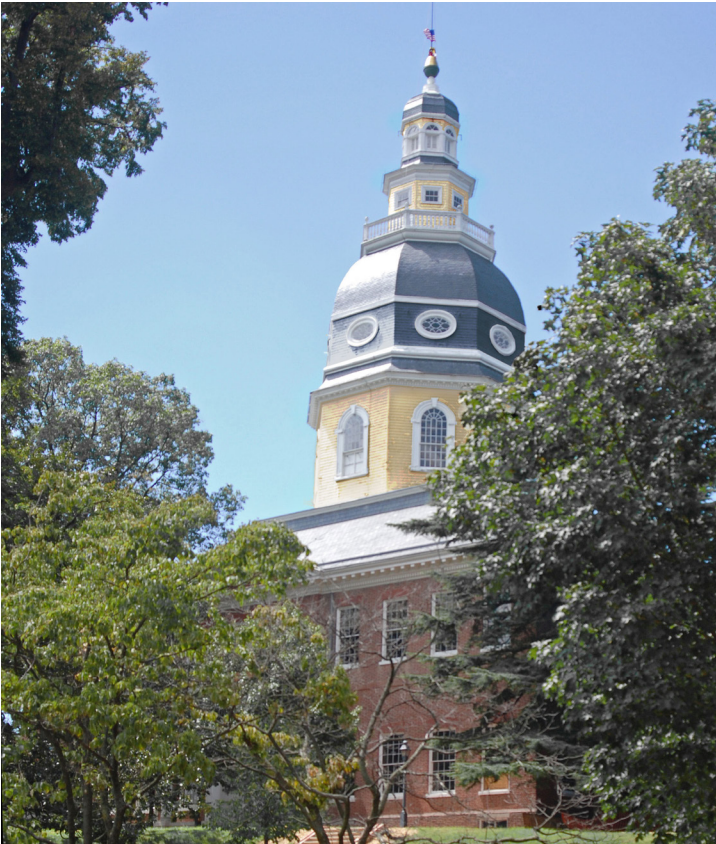
The Statehouse Dome Photoshopped to the original colors identified by Paint Microscopy. Happily they correspond with Charles Wilson Peale's 18th c. field notes.

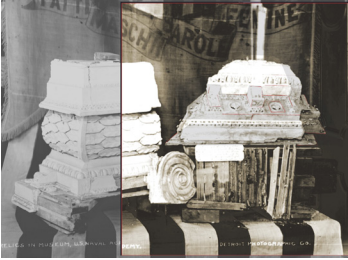
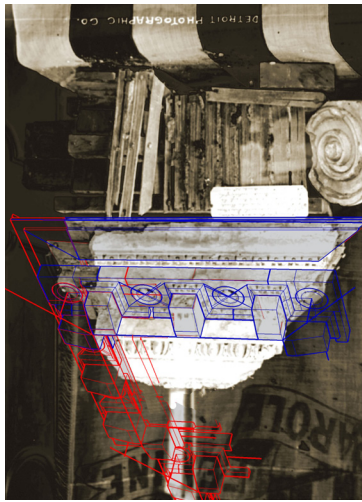
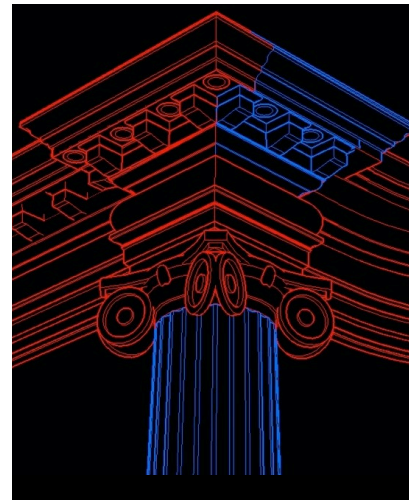
Old Senate Chamber Research

The blue section is the original fragment positioned properly over a blue original outer column.

By configuration it can only be the one on the false door end of the gallery. It can only be the face that faces the false door wall.

Therefore the gallery cannot end with a convex curve that would connect in the middle of this face.

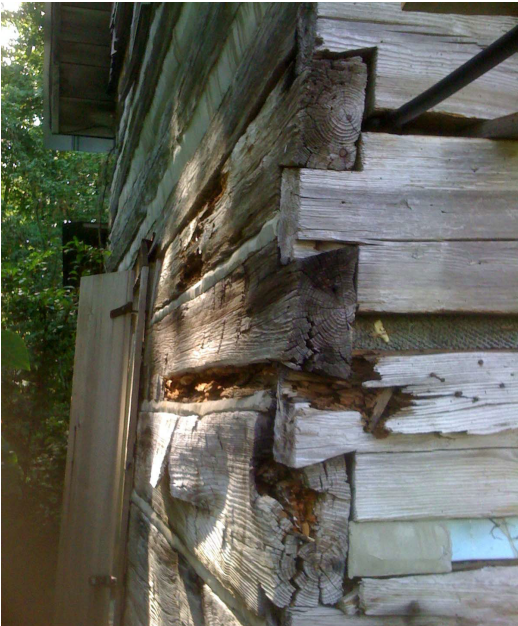
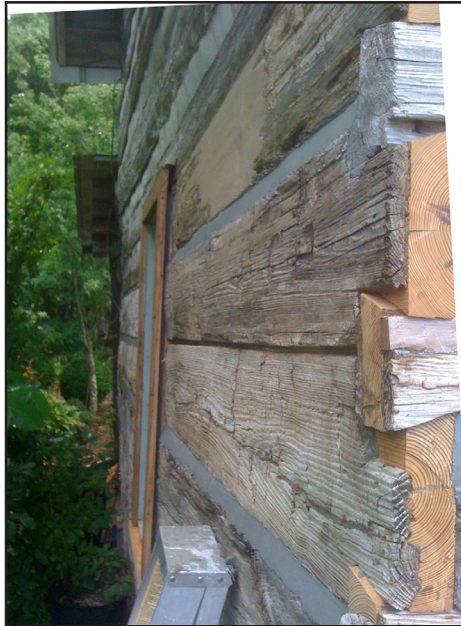
Grey Logs

Highlands, NC, involved the conservation of seriously deteriorated logs. The core of the logs was rotten mush. The faces, interior and exterior, were sliced off. These skins were treated with a preservative and consolidated while maintaining the original grey untreated appearance. They were then mounted on aged stable cores of a matching pine and re-installed in the building.

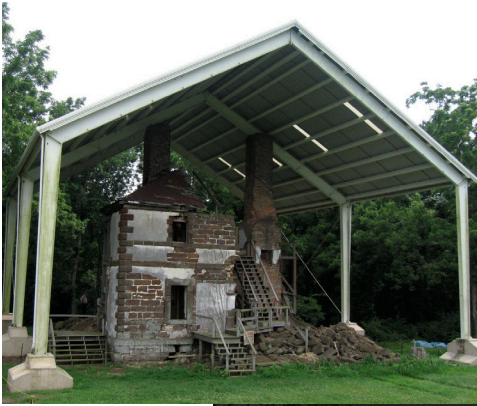
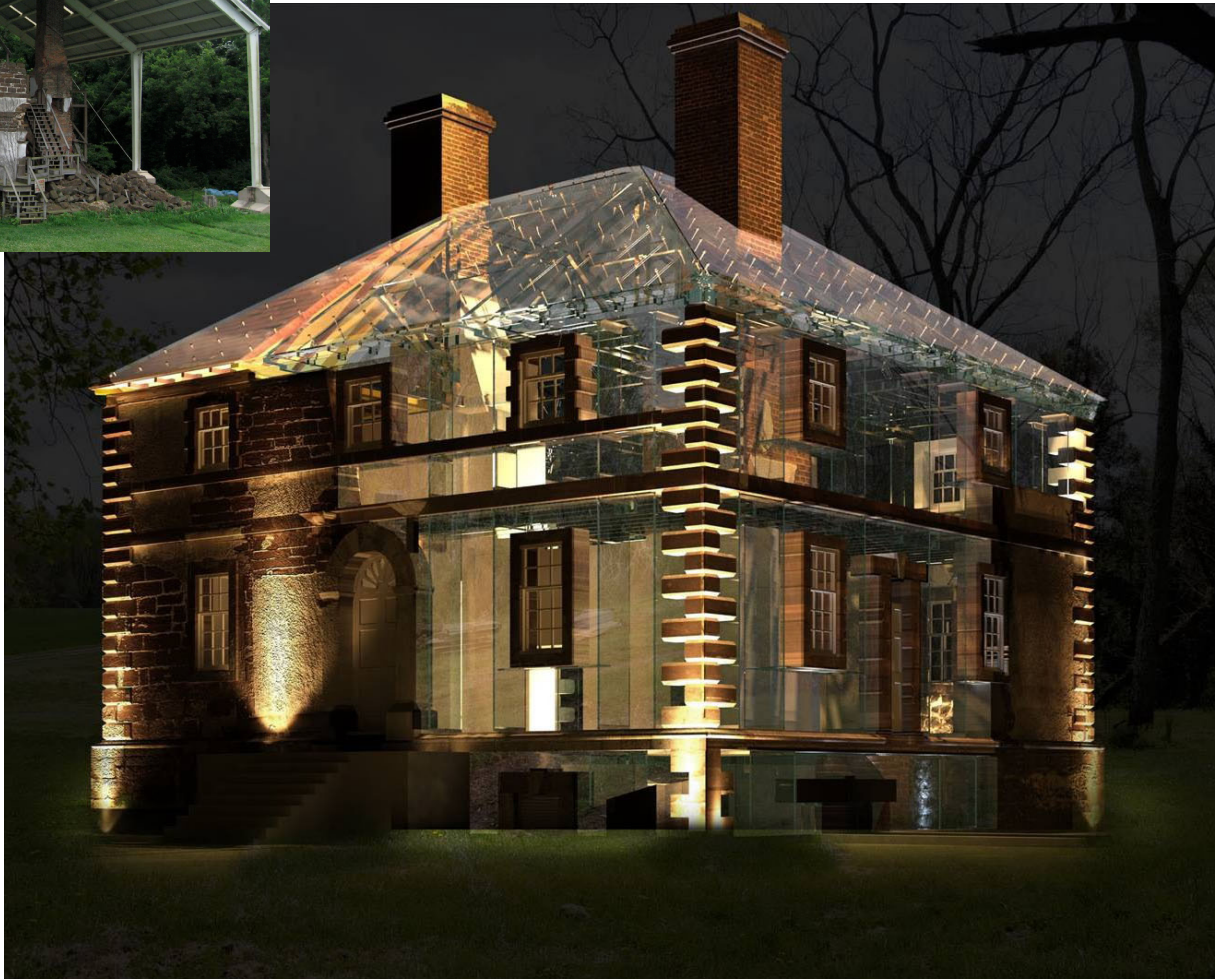
Innovative use of structural glass to reconstruct a ruin. The roof glass has integrated photovoltaics. Designed by Charles Phillips, Tim Macfarlane, and John Lee. Rendered by Declan Nevin.
