RECOMMENDATIONS FOR THE RESTORATION OF THE OLD SENATE CHAMBER

SUMMARY OF FINDINGS AND RECOMMENDATIONS
PREPARED FOR THE
MARYLAND STATE HOUSE TRUST
BY
THE OLD SENATE CHAMBER ARCHITECTURAL ADVISORY COMMITTEE
January 14, 2010

**REPORT TO THE MARYLAND STATE HOUSE TRUST
on the
OLD SENATE CHAMBER**

RECOMMENDATION AND SUMMARY OF FINDINGS

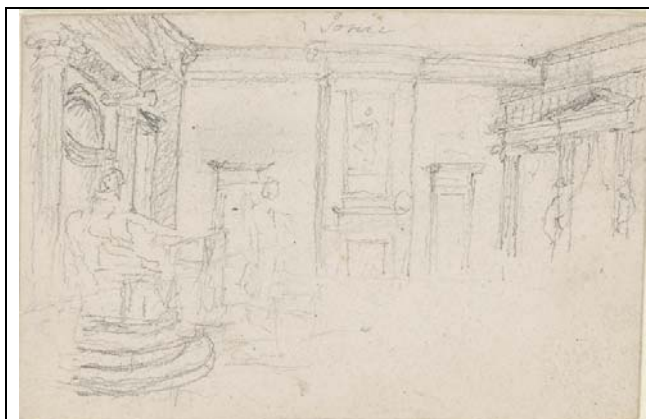
On-site sketch by John Trumbull, 1822
 Courtesy of Yale University Art Gallery

The general character of the Senate Chamber is depicted in John Trumbull's famous 1824 painting of Washington's resignation as commander in chief, one of the large historic scenes displayed in the Rotunda of the United States Capitol. The on-site sketches that Trumbull made in preparation for the painting provide more valuable clues to the early appearance of the chamber. Fortunately, the appearance of the center portion of the gallery is known through a rare 1868 stereoview photograph. Further evidence of the room's early appearance appears in an 1856 sketch by Frank. B. Mayer.

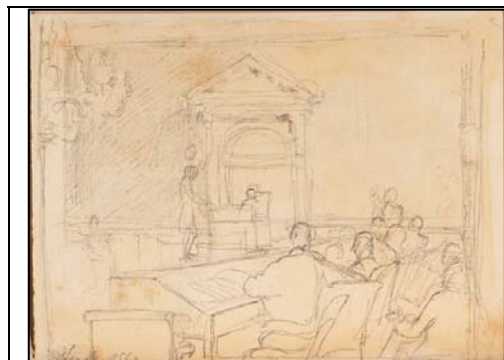
1858 Sketch by Frank B. Mayer
 Courtesy of Baltimore Museum of Art

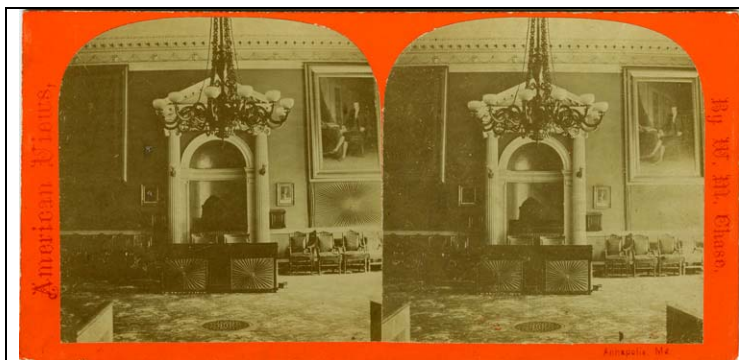
1868 Stereoview of Niche

The architectural focal point of the Senate Chamber was the niche and dais opposite the entrance, where the President of the Senate's chair and desk were placed. Like the gallery, the niche was treated with rich architectural embellishment. It was framed by pilasters and set off by a classical pediment supported on Ionic columns. The original appearance of this feature is also recorded in an 1868 stereoview photograph, as well as in the Trumbull painting and other historic images. By the time the photograph was taken, however, the windows on either side of the dais had been covered over for the display of large portraits.

- **Niche and Dais:** The niche itself along with its architrave moldings and flanking pilasters are original, indeed it is the chamber's only original trim. Investigations and the 1868 stereoview indicate that the pediment entablature did not break above the columns as was done with the 1905 entablature. Evidence was found showing that the original columns were almost free-standing rather than half-round as are the 1905 columns. Historic images show that the original pediment had a paneled soffit. The dais probably had only two risers rather than the existing three and was wider than the existing dais.

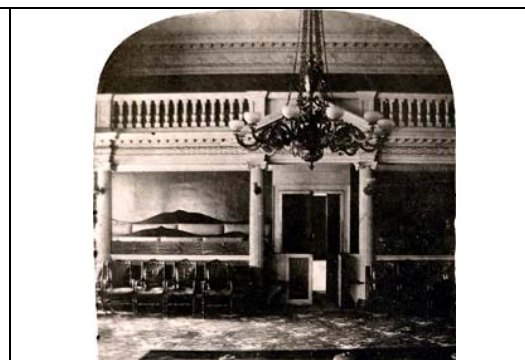
1868 Stereoview of Gallery

Wilson carried out the restoration to high standards for the time. His gallery and dais reconstructions were based on the 1868 stereoviews as well as other early images, including the Trumbull painting. The dais restoration included revealing the covered-over niche and the repair of its detailing, the room's only 18th-century fabric to have survived *in situ*. His design for the two doorways on either side of the chimneybreast followed local precedent as well as the Trumbull painting. His mantel design was based on local precedent and its installation required the reconstruction of the brick chimneybreast. No reliable image of the original window frames was available nor was there more than minimal physical evidence, so Wilson resorted to standard architraves for window trim.

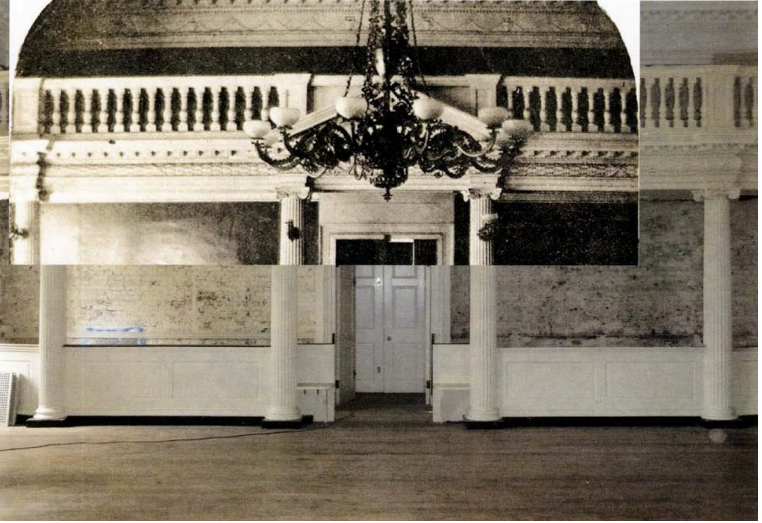
<p>1777-1779: Photogrammetrical comparison of the 1905 gallery with the 1777 gallery as shown in an 1868 stereograph. The use of the classical elements was extremely fashionable at the time, and the gallery was executed in the Ionic order. This photographic comparison reveals differences between the 1777 gallery and the 1905 reconstruction. Most notably, roughly a 12" discrepancy can be clearly seen in the placement of the outer left column. Analysis of the relationship of the girt pockets to the column location in the 1868 photograph will allow the original placement to be recovered. (Photo: John Greenwalt Lee Company, 2007)</p>	<p>1777: Builder of the State House, Charles Wallace, proposes to the Maryland General Assembly in January or February to erect a gallery and staircase in each chamber: <i>Gentlemen, I can erect a Gallery & Stair Case in each House of Assembly, agreeable to the Plan herewith sent for five Hundred Pounds: or if it should be more agreeable to the Assembly. I Will have them built & bring in the Carpenters Bills, charging nothing for my Trouble...Mem: Banisters to be continued all along the front!</i> (Maryland State Papers, Series A, MSA S 1004-18-3500, 6636-15-193A)</p> <p>1777: Ebenezer Hazard visits Annapolis and notes: The stucco Work in the State House is very elegant. ("Ebenezer Hazard's Travels Through Maryland in 1777." Maryland Historical Magazine LXI (1951) 54)</p> <p>1779/07/30: The State House was still unfinished as reported by the Committee appointed to enquire into the state of the Stadthouse: <i>The room intended for the Senate wants a coat of plaster, one of paint, and the lower floor; this Mr. Wallace says shall be ready by the last of August, the gallery and committee-room almost finished.</i> (Proceedings of the House of Delegates, July Session 1779, folio 131-132 Archives of Maryland MSA SC M 3196, 874)</p> <p>1779/12/27: The contract for the seats below the gallery is let. No specific details of size are included, but the seats below are for the use of public officials attending proceedings of the Assembly. (November Session 1779, Votes and Proceedings of the House of Delegates, pages 73 and 74)</p>

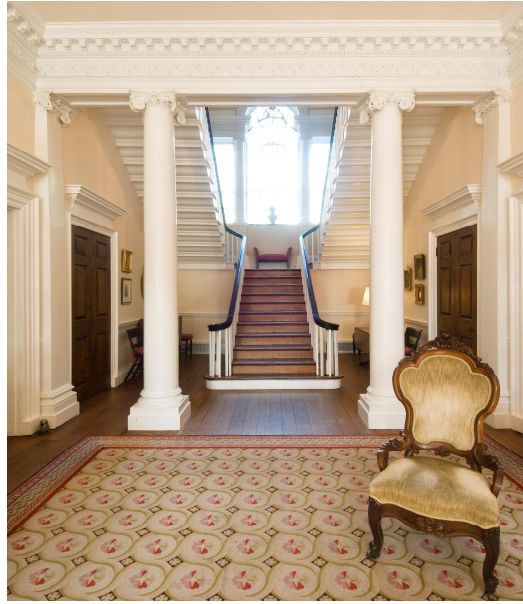
<p>The colonnade in the passage of the Chase-Lloyd House (1769-1774) in Annapolis offers a similar arrangement in the Ionic order. The columns, pilasters and entablature merit comparison, although the columns in the Chase-Lloyd House are not fluted. (Photo: Jeffrey E. Klee, Colonial Williamsburg Foundation, 2009.)</p>

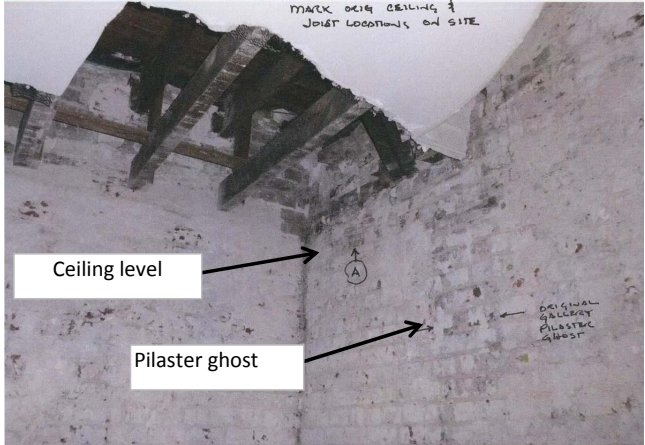
<p>1777-1779: Ghost evidence on the west wall of the room reveals the location of the pilaster that received the end of the gallery and the height of the gallery soffit. (Photo: John Greenwalt Lee Company, 2007)</p>

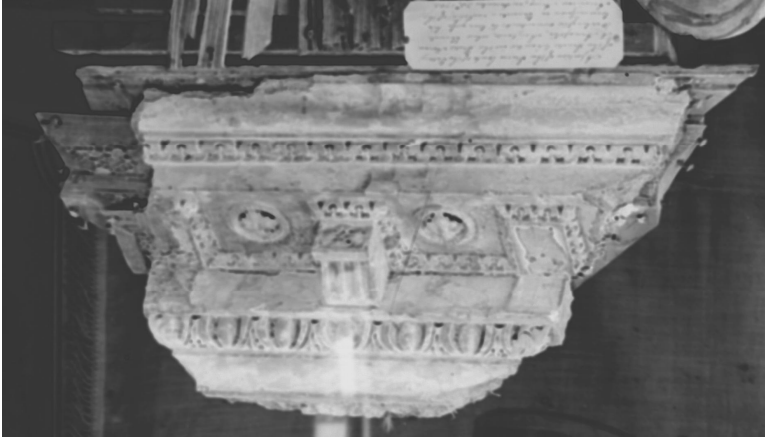
<p>1779: A fragment labeled as being from the entablature of the Senate Chamber gallery and preserved during the demolition of the gallery in 1876, shows the ornamental plasterwork to be equal to that in the finest Annapolis houses. This fragment was a breakout above a column. The photograph was taken in the late 1890s and is now in the Library of Congress. (Library of Congress det 4a15044 LC-D4-21356)</p>	<p>1779/12/28: The gallery is complete and exceeds the expectation of the committee: <i>The committee have examined the stadthouse throughout and are of opinion that man[y] parts thereof are finished with more elegance than was required by the contract, particularly the front door, great hall, and court, the senate house and house of assembly, the president's and speaker's seats, and the galleries.</i> (Proceedings of the House of Delegates, November Session 1779, Archives of Maryland MSA SC 3204, p. 78)</p> <p>1779/12/28: Charles Wallace submits a final petition upon retiring as Superintendent of the State House and agrees with the committee's assessment of his work: <i>Your petitioner has finished the State House (except four of the commonest Rooms and some ornaments in the front which the plan will show) and the galleries in a much more expensive and elegant manner than could be claimed from his contract or he believes was expected, and, as he hopes to give satisfaction to your Honors and reflect credit on the State.</i> (Maryland State Papers, Series A, MSA S 1004-18-5122, 6636-15-194)</p>	<p>1777: Ebenezer Hazard's description of Annapolis also mentions that in the Assembly Room of the city, "the orchestra is elevated in the Manner of a Gallery & the Musicians go into it by a private Stairs." This arrangement may have served as a model for the galleries in the State House and warrants further investigation. ("Ebenezer Hazard's Travels Through Maryland in 1777." <i>Maryland Historical Magazine</i> LXI ,1951, pp. 48-49)</p>

<p>Above: photograph of relic from entablature; right: detail from 1868 photograph: note missing modillion block and damage to ornamental plasterwork below it.</p>	<p>Wilson's sketch of the entablature of the gallery contains measurements that may have been taken from the relic at left. It differs in details from the 1868 photo, most notably in the form of the leaves of the cushion frieze, which are oak leaves in the 1868 photo. Trumbull's 1822-24 notation of "Frieze oak leaves" confirms this. A second, important difference between the relic and the sketch can be seen above the modillion course. The relic has a tall single fascia above the modillion course, while the entablature in the sketch has a shorter, split fascia in the same position. (MdHS MS 833 Box 6 Folder 4)</p>

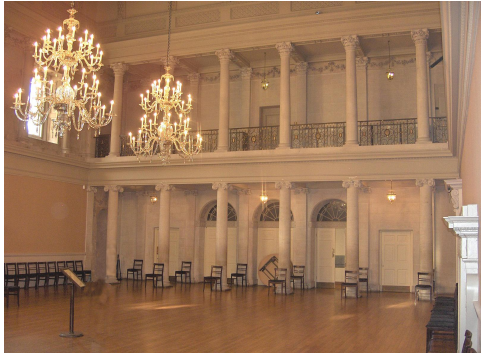
<p>Galleries executed in the classical orders were very popular in public rooms at the time the State House was built. Above, the gallery in the Tea Room at the Assembly Rooms at Bath, England, designed by John Wood the Younger in 1769. The double Ionic colonnade is the focal point of the room and provides a vantage point overlooking the activity on the main floor. (MHT Files: Galleries)</p>

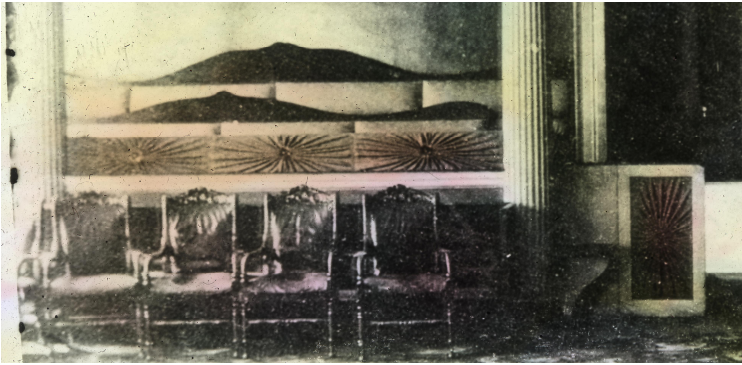
<p>Detail from the 1868 stereograph showing the lobby seating area constructed by John Shaw in 1792. (George Forbes Collection, MSA SC 180-02-0501)</p>

Room Feature	Architectural Evidence and Analysis	Images	Archival Evidence	Comments and Collateral Evidence
<p>Gallery</p> <p>Gallery, 1790-1799</p>	<p>1792: When the gallery was first completed there was no separation between the chamber and the area below the gallery, referred to as the lobby. Seating was available for visitors both in the gallery and lobby, and, as suggested above, John Shaw likely built a temporary viewing platform for Washington's resignation. In 1792, Shaw was contracted to construct a permanent viewing arrangement for the lobby, and Shaw billed for making "seats & floors for the lobbys, the front done with plain dado work to correspond with the room." The arrangement was still to be seen in 1868, when the stereograph of the gallery was taken. The construction is similar to a box pew, with a light, waist-high partition running between the columns. The reference to plain dado work requires the partition to be composed of flush-board paneling, as was used in the wainscoting for the room. The photograph shows the partition topped by bed and cap moldings similar to a chair rail. A Mr. Davis, who worked in the chamber before the 1876 demolition and was interviewed for the 1905 restoration, recalled that the partition ran straight to the walls where its cap mitered into the chair rail.</p> <p>The benches visible in the 1868 photograph have tall undulating backs that rise to the center and are covered with cushions in 1868. The seats are set in two tiers, explaining the reference to floors: stepped platforms were installed on either side of the door, providing improved sight lines for seated observers, while leaving uninterrupted floor-level passage from the rotunda to the chamber. Shaw also installed "2 seats for the door keepers & a baize door," which are clearly visible in the 1868 photograph. The door consists of two leaves, constructed of rectangular wooden frames with a stretched baize (a soft, felt-like cloth) panel in the center, which hang from short, flat panels that project toward the center of the space between the inner columns. The doorkeepers' seats are set on curved wooden brackets that run down the inner side of the center columns to the floor. The seats are secured to the inner side of the column shafts and run along the short panels.</p>

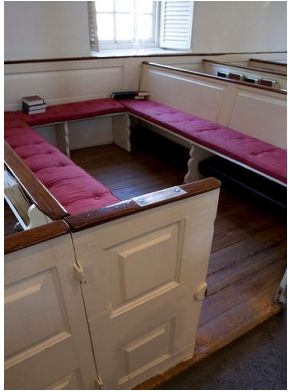
<p>A box pew in Christ Church Episcopal, Alexandria, Virginia, completed 1773, which George Washington attended. Note the light partitions, paneled in this case, and the raised floor of the box. This construction would have been similar to the work completed in the Senate Chamber lobby by Shaw in 1792. (MHT Files: Box Pews)</p>	<p>1792/00/00: John Shaw is paid \$115.00 for work done in the spaces beneath the gallery, to either side of the main door, referred to as the lobbys: <i>Making Seats & floors for the lobbys, The front done with plain Dado work To Correspond with the room... 2 Seats for the Door Keepers & a Baize door.</i> (MSA SC 5287-1-18)</p>	<p>The idea of having raised seating was included in the unbuilt State House plan by Anderson. In the longitudinal section, Room B has a tiered platform that occupies more than half the room and descends toward a niche and dais. A platform of this size would have accommodated members of the legislature, not just viewers, as was the case in the Senate Chamber. (Joseph Downs Collection of Manuscripts and Printed Ephemera, No. 92x93.10.)</p>

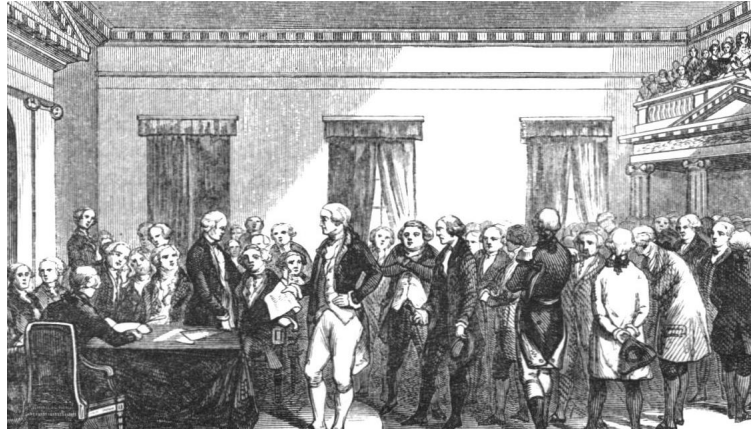
<p>1851: Above: Benson J. Lossing shows the gallery almost identically to Trumbull (<i>The Pictorial Field Book of the Revolution</i>, v. II, p. 842.)</p>

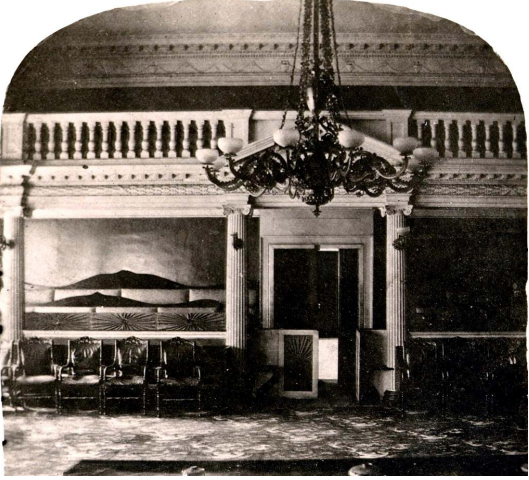
<p>1868: The earliest photographic view of the gallery is this stereograph showing the balustrade, pediment, lobby and door. (George Forbes Collection, MSA SC 180-02-0501)</p>	<p>1860/01/06: Message of Governor Thomas Holliday Hicks to the General Assembly emphasizes the preservation of the Senate Chamber: <i>The Northern portion of the main building, containing the Senate and Executive Chambers, needs extensive repair...I venture to suggest that an indispensable condition in such appropriation should be, that the Senate Chamber, with which are connected so many associations and Revolutionary memories; and which is justly admired for the beauty of its proportions and decorations, should in none of these respects, and in no way whatever, be changed or altered; that there should be only a renewal of what is useless or decayed, in an exact repetition of the part taken away.</i> (Document B, 16-17)</p> <p>1860/01/18 -- Report of the Committee on Repairs of the Public Buildings: <i>As the act did not contemplate any alteration in the Senate side of the building, the Committee has left it, as near as practical, in its original condition, but, whilst it would not advise of the lower floor it thinks that the second floor should be arranged in a way similar to that on side [sic] of the Hall of Delegates.</i> (Document G, 1-5)</p>

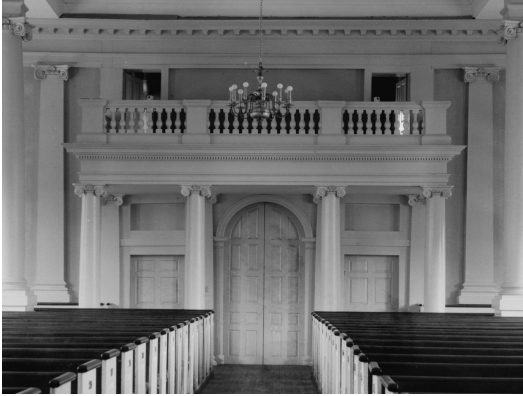
<p>The organ loft in Christ Church, Cambridge, Massachusetts, built c. 1760. Like the Senate Chamber gallery, the loft is supported by four Ionic columns and pilasters, has a full entablature and is topped with a balustrade. The loft has square ends. (Historic American Building Survey, MASS,9-CAMB,4-3)</p>

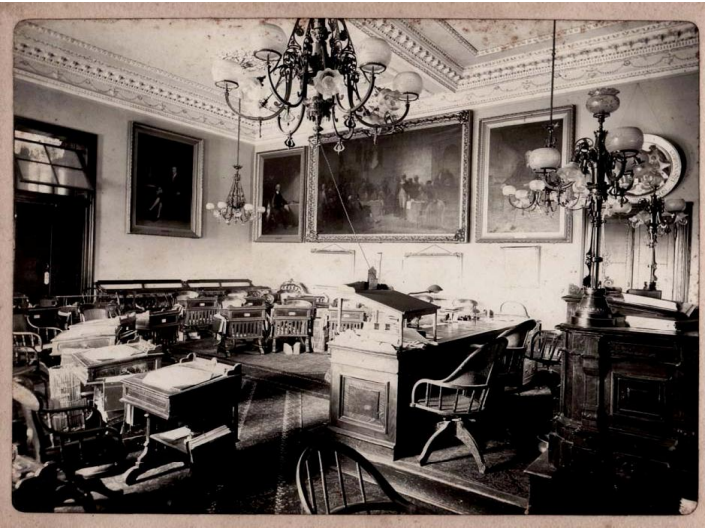
<p>1896: A view of the south and west walls of the Senate Chamber taken sometime in the early 1890s after the removal of the gallery during the 1876 renovation, when the chamber was completely recreated in the Victorian style. The divided ceiling is the result of a large steel beam inserted to allow the removal of the chains from which the second floor framing had hung since 1798. (MSA SC 5788)</p>	<p>1878/01/03: Due to its deteriorating condition, the Senate Chamber is gutted during a major renovation of the State House. The gallery is dismantled as discussed by architect George A. Frederick in a letter to the governor: I much regretted, in this room, being compelled to remove the gallery, which, for want of time, could not be replaced. It was in a ruinous and dangerous condition, and I would respectively [sic] advise, if determined to reconstruct the same, it be done of a material not as perishable as plaster. Careful measurements were taken and accurate drawings prepared of every part, so that nothing will prevent its exact reproduction if such should be decided upon. At the same time, I cannot help but feel, that while its absence may divest the room of some of its historical romance, its loss as far as the proportions and comfort of the apartment is concerned, is a decided gain. (Courtesy of the Maryland Historical Society, PAM 3998)</p> <p>1884: Within a decade calls are heard for the restoration of the Senate Chamber to its original appearance. Francis B. Mayer, who with J. Appleton Wilson completed a study on a potential restoration in 1894, leads the call: The restoration of this room to its original appearance is an obligation of duty we owe to ourselves and to the country. The mutilation of this hall is looked upon by all visitors as an act of vandalism. (Metropolitan Museum of Art Library)</p>

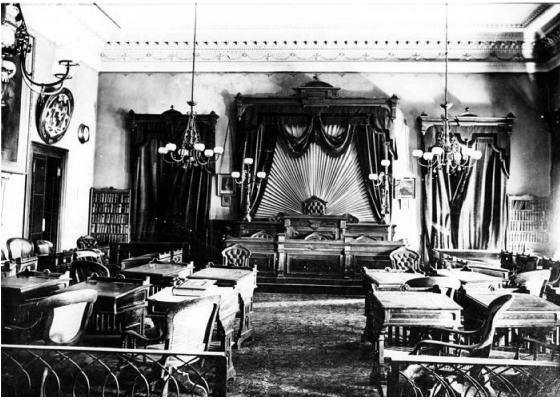
<p>1886: View north across the Senate Chamber toward the Speaker's dais installed in 1876. The photo is taken from a spot that would have been underneath the gallery and behind the partition added in 1792 and removed in 1876. Note the decorative iron railing installed to replace the early partition. The railing was manufactured by William H. Dufur and Co., a wire railing and ornamental wire works located at 36 N. Howard Street, Baltimore. (Image: MSA SC 1556-116; railing: Report of Select Committee to Investigate the Repairs upon the State House, MSA SC 5287-5; Dufur & Co: MHT File: State House Firms & Craftsmen)</p>

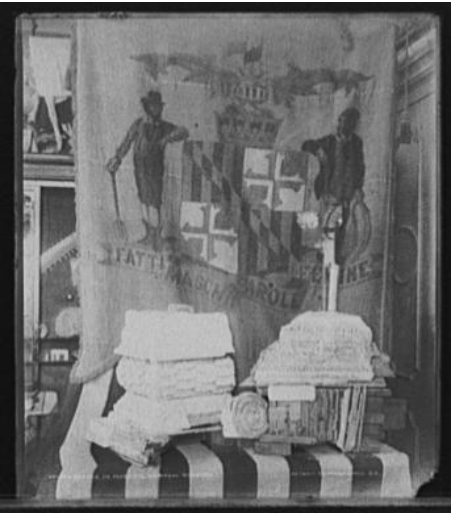
<p>Late 1890s?: Photograph published in 1901 by the Detroit Photographic Company and now in the Library of Congress, is captioned "21356, Relics in Museum, U.S. Naval Academy". The image shows fragments of ornamental plaster work related to the gallery, including fragments of a capital and of the entablature of the 1777 gallery. The third piece is of later date and matches the entablature of the 1905 gallery. It probably was part of a model made by Wilson to represent his proposed reconstruction. (Library of Congress det 4a15044 LC-D4-21356)</p>

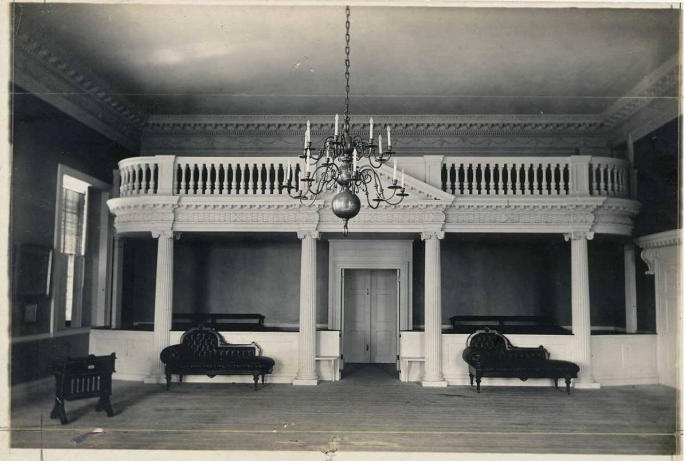
<p>1905: A view of the gallery as reconstructed by J. Appleton Wilson and Josias Pennington in 1905. The work proceeded based on the following evidence:</p> <ul style="list-style-type: none"> • Examination of two original columns, two original pilasters and fragments of ornamental plasterwork; • 1868 photograph of the gallery; • Nailing blocks for the pilasters found after the removal of wall plaster; • 1858 measured plan of the room made by Hayward and Bartlett showing location of pilasters and columns. <p>(George Forbes Collection, MSA SC 182-02-0866)</p>	<p>1903: George Frederick, architect of the 1876 renovation of the State House, defends his work in a letter in the December 26th edition of the <i>Baltimore Sun</i>: <i>The gallery, situated at the western end of the room, was hardly five feet wide, was finished with circled ends, and, as the Senate chamber only has a moderately high ceiling, was extremely low beneath and scarce high enough to stand upright upon it above. The entrance to it at its north end consisted of a doorway not over two feet wide and four feet six inches high, exceedingly inconvenient of ingress or of egress. The stairway leading to it, in its day equally incommodious for use, had long since been removed. The column shafts supporting it were of wood, as was its skeleton construction; but all of its outer face and finish was of a species of stucco or plaster composition and throughout was cracked and crumbling to pieces. It besides, had so often been whitewashed that the ornamental members—of which it was almost entirely composed—had lost all semblance of their original line or self.</i></p> <p>1905: April 3 letter from Pennington to Wilson: <i>Some few parts of the old gallery are found, the columns supporting same it being understood, are similar to those taken from the House of Delegates; several of these are in existence.</i> (Maryland Historical Society, MS 833, Box 6.)</p> <p>1905: May 17 letter in which Wilson and Pennington estimate that the Senate Chamber can be restored for \$4400.00: <i>We have spent a day at Annapolis and carefully examined the remnants of the old gallery, which are now in the Land Office.</i> (Kept with MSA S 1137)</p>

Wilson reused the salvaged column shafts in his gallery reconstruction. Although George Frederick had earlier noted that the gallery ends were curved, the 1868 stereoview of the gallery did not show the gallery ends. Wilson's convex curved ends thus are conjectural. This has raised the question as to whether the curved ends were concave or convex.

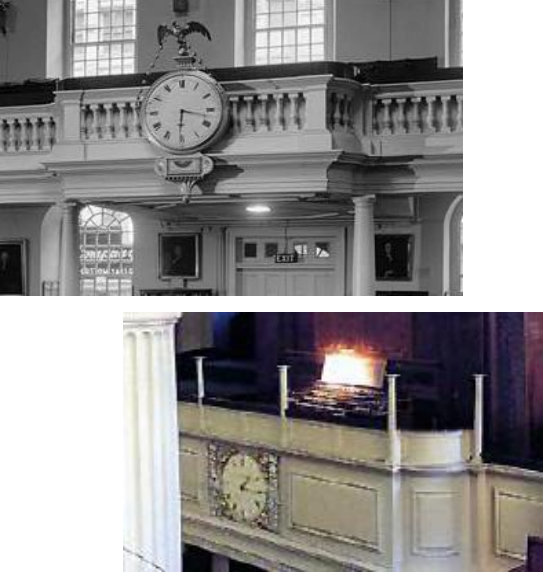
<p>Organ lofts from eighteenth-century churches throughout the colonies offer good comparisons for analysis of the gallery. These examples show varying treatment of the ends: top, Old South Meeting House, Boston, Massachusetts, 1729, interior c. 1783, square ends (Historic American Building Survey, MA-960-9); bottom, King's Chapel, Boston, Massachusetts, convex ends. (MHT Files: Galleries)</p>

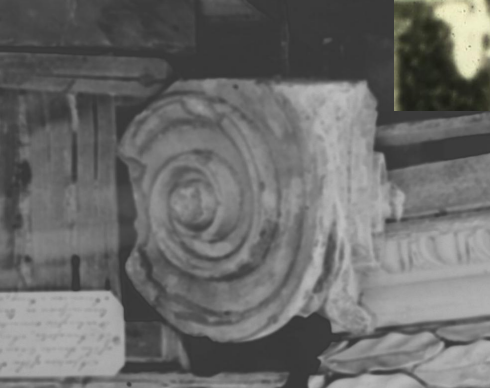
<p>The 1868 stereoview by Baltimore photographer William M. Chase (upper right) provides guidance on the principal features of the capitals. A photograph of the gallery relics, captured by the Detroit Photographic Company in the late 1890s (above left), demonstrates that the capitals were made of plaster, which may explain their loss. In both the relics photograph and Wilson's sketch (cell to right) it is possible to see that the volutes are decorated with fine foliate detailing that wraps partially along the spiral of the volute.</p>

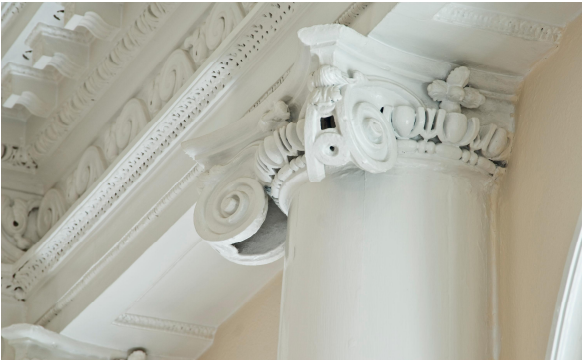
<p>The capitals of the Chase-Lloyd House are highly ornate, but the volutes lack the carved foliate details of the Senate Chamber capitals. (Photo: Jeffrey E. Klee, Colonial Williamsburg Foundation, 2009.)</p>

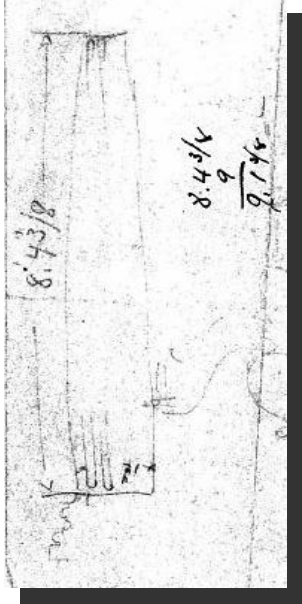
<p>1894: A sketch of a column shaft by J. Appleton Wilson. Wilson exaggerates the entasis of the shaft, but gives a height of 8 feet 4 3/8 inches, presumably taken from one of Daniel Randall's originals. A calculation written in ink adds 9 inches to the height for a total of 9 feet, 1 3/8 inches. The 9 inches represents the height of the base and plinth, which Wilson details in another sketch (see cell below). (MdHS MS 833 Box 6 Folder 4)</p>	<p>1903: George A. Frederick, architect of the 1876 renovation of the State House, defends his work in a letter published in the December 26th edition of the <i>Sun</i>, in which he provides detail of the gallery's construction: <i>The column shafts supporting it were of wood.</i></p> <p>1905: Wilson and Pennington present a final report on the restoration of the Senate Chamber on December 14: <i>Fortunately the two pilasters, two columns of gallery, and fragments of gallery entablature had been preserved, which gave us exactly the height of the gallery from the floor and enabled us to produce the entire front of both gallery and niche. This work has been produced exactly as far as possible. Many of the actual old pieces which were preserved have been reused and incorporated in the work, the remaining parts having been duplicated from castings.</i> (State House Building Commission, General File, MSA S 1740)</p>

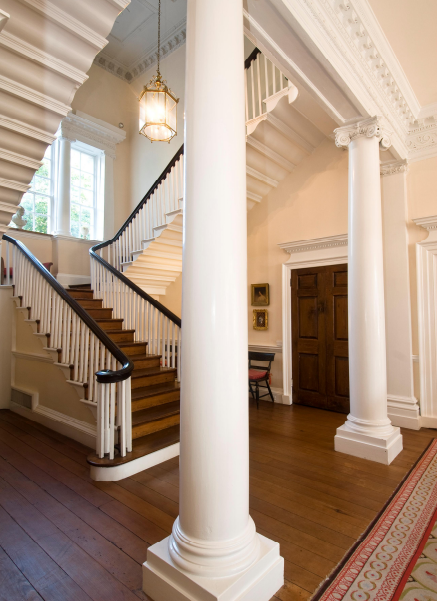
<p>The columns of the Chase-Lloyd House also exhibit slight entasis, but are not fluted. (Photo: Jeffrey E. Klee, Colonial Williamsburg Foundation, 2009.)</p>

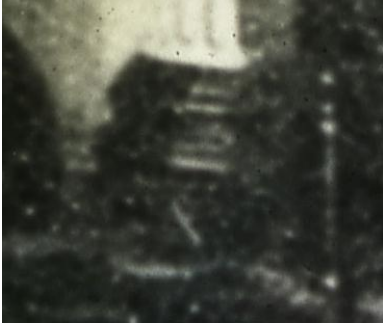
<p>The stereoview shows that the column bases of the gallery were painted black in 1868, allowing the profile of scotia between two tori to be legible. It was common to paint the plinths of baseboards black in the eighteenth century, and the bases may have been painted black originally.</p>

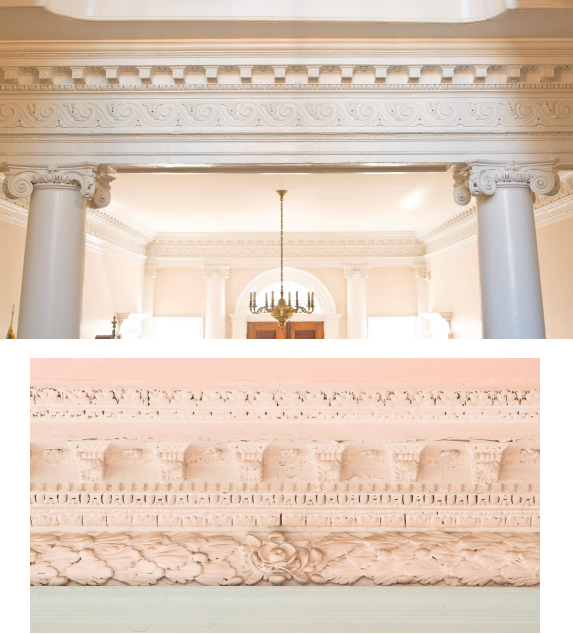
<p>The entablature of the Chase-Lloyd colonnade (top) is similar to the Senate Chamber gallery in many details: paneled architrave soffit, enriched split fascia and frieze, and an enriched modillion course. The frieze from the James Brice House (1767-73) has a foliate cushion frieze.</p>

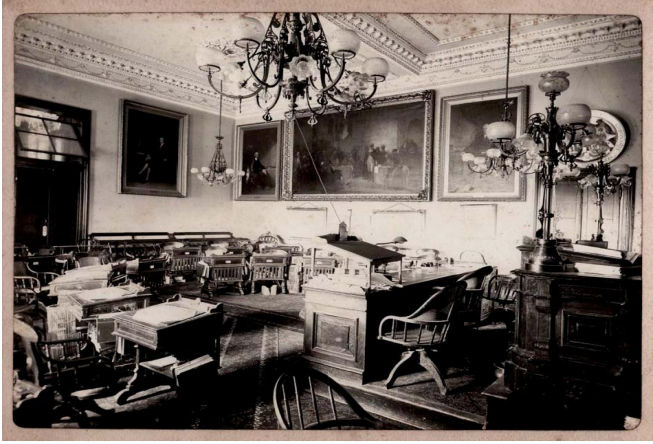
<p>1896: A photograph of the Senate Chamber published in 1896 provides the best view of the room during the period 1876-1905. The booklet was copyrighted by Mrs. E. Schafer, presumed to be Elizabeth, widow of Annapolis photographer Henry Schafer, who opened his Annapolis studio in 1888 and died in 1895. In this event, the photograph probably dates to the early 1890s. (MSA SC 5788)</p>	<p>1876: In December 1903, architect George Frederick states that he prepared drawings of the gallery (and possibly other details) prior to demolition in 1876. No trace of the Frederick drawings has been found. (Baltimore Sun, December 26, 1903; ProQuest Historical Newspapers)</p> <p>1894: J. Appleton Wilson and Francis B. Mayer undertake a detailed investigation to determine whether the Senate Chamber can be restored. Their report in the affirmative includes this recommendation for the chimney: <i>Rebuilding Chimney breast, only twelve inches projection, and replacing [i.e., reconstructing] mantel and fire place. The latter will be for appearance only, unless the flues remain in the wall, which is believed to be the case.</i> (Published in <i>Maryland Historical Magazine</i>, Vol. II No. 4, December 1907, pp. 326-35)</p> <p>1904: Even as the Maryland Senate was packing to move into their new quarters, sentiment was building for restoration of the Old Senate Chamber. In welcoming remarks to his colleagues on January 6th, Senate President-elect Spencer Jones made an emotionally charged call for restoration: It is with sadness that we... vacate the old Senate Chamber...Let us have it restored as near as possible to its original condition and sacredly preserve it as the holiest of all in this temple of our liberties... (Archives of Maryland, vol. 401, pp. 8-11)</p>

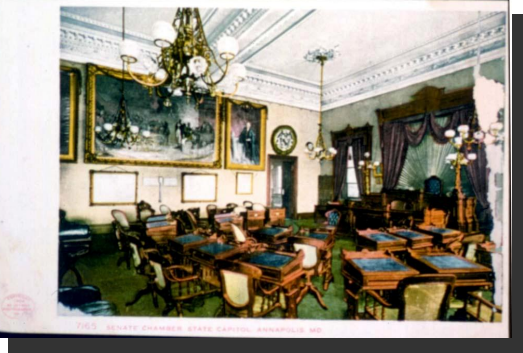
<p>Color postcard of the Senate Chamber as it appeared prior to the 1905 restoration, with the chimney, fireplace and hearth entirely removed. (MSA SC 2215-20)</p>

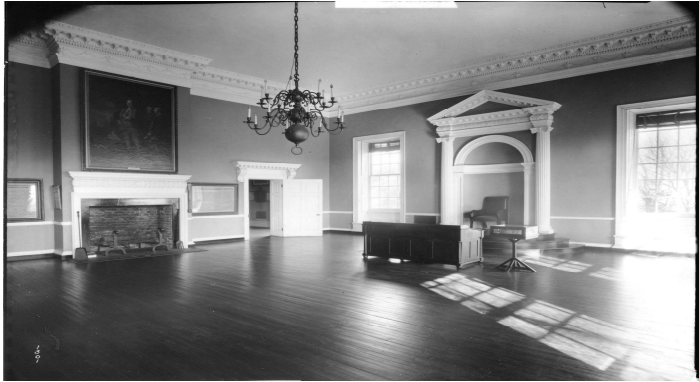
<p>1925: This photograph by E. H. Pickering offers a clear view of the chimneybreast and fireplace during the period 1905-1940, with Charles Willson Peale's portrait of Washington, Lafayette and Tilghman just fitting between the overmantel and entablature. (MSA SC 1890-02-3729a)</p>	<p>1905: On December 17, the Baltimore <i>Sun</i> describes the restored Senate Chamber, including a summary of changes to the artwork displayed: <i>In the...Senate Chamber the wall space is occupied by the gallery and chimney, and for this reason many of the pictures will be hung elsewhere. The painting by White of Washington resigning his commission, which formerly hung in the Senate, has been placed... above the first landing of the main stairway. The...signers of the Declaration of Independence adorn the walls of the old rotunda...the only picture to be hung in the old Senate will be that of General Washington and his aides—Lafayette and Tilghman...which formerly hung in the House of Delegates. This painting is by...Peale, and was provided for by a resolution of the Maryland General Assembly, passed November 23, 1781.</i> (Baltimore <i>Sun</i>, Dec. 17, 1905)</p> <p>1935: With completion of the new Hall of Records, attention turns to the documents displayed on the walls of the Old Senate Chamber. Important documents are removed from open display, leaving the room even more desolate in appearance. Washington's portrait remains hanging on the chimneybreast, and is now the principal concession to furnishing.</p>

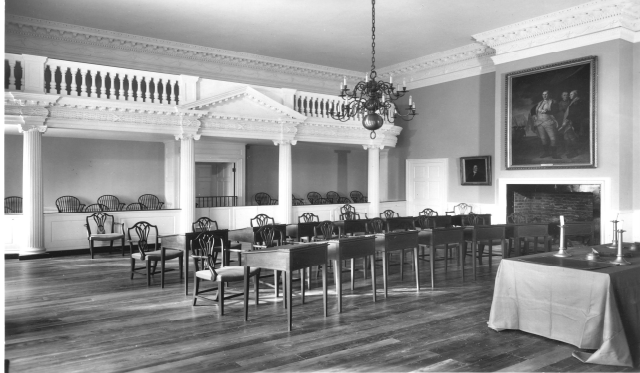
<p>1948: Photograph of the Senate Chamber taken in 1948 documents the room a few years after the 1940 modifications that included removing the overmantel. (Gov. William Preston Lane Collection, MSA SC 4082-1-82a)</p>	<p>1940: Plaster repairs to the chimney breast were included in a single line item for the first of two requisitions submitted by G. Walter Tovell, Inc. Dated August 10, 1940, the invoice includes a charge of \$300.00 for "Lathing and Plastering." This work was executed by subcontractor John H. Hampshire, Inc., sometime between late June, when the carpenters finished initial work, and early August, when the invoice was submitted. Painting the plaster walls and reconfigured mantel was subcontracted to John D. Beckley & Son and cost \$935, billed in the second and last of Tovell's invoices, dated September 20, 1940. (Old Senate Chamber Refurbishment Collection, MSA SC 2827, M 731)</p> <p>2006-2008: Following an initial investigation of the Old Senate Chamber to resolve failing plaster in 2006, a comprehensive examination was undertaken by the John Greenwalt Lee Company. Results for the chimneybreast and associated elements are presented in the proeject report titled "Interim Report on Archival and Architectural Evidence, Old Senate Chamber at the Maryland State House," pp. 202-215.</p>

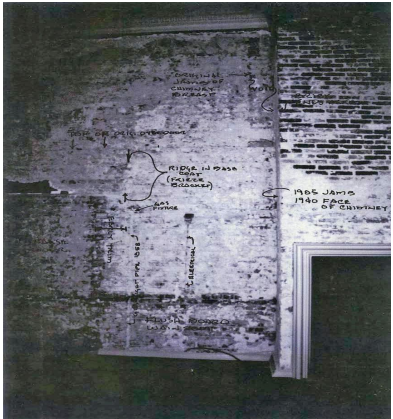
<p>Infrared photograph, used to detect subtle evidence of the left edge of the chimneybreast. (John Greenwalt Lee Company, 2008)</p>

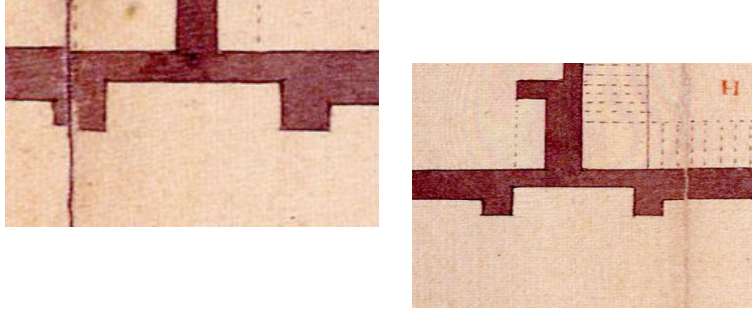
<p>1770: Details of the chimney breast and firebox for the Senate Chamber (left) and House of Delegates Chamber (right), from Joseph Horatio Anderson's plan drawing. As drawn (and compensating for a distortion caused by a distressed fold in the drawing), the firebox in the Senate Chamber measures approximately 7'-0" wide and 2'-0" deep, centered in a chimneybreast that measures approximately 10'-9" broad and projects about 12" into the room. In actual practice, the firebox may have been somewhat less broad and the cheek walls probably projected further into the room. Note that in both cases, the firebox extended back into the structural wall, presumably creating a recess that may still remain, buried behind the 1905 reconstructed chimney stack. (John Work Garrett Collection, The Johns Hopkins University, GAR 22; MSA SC 1556-10)</p>	<p>1779: On December 28th, the report of a committee appointed to inspect the progress on the State House included this detail: "although the chimneys are finished, yet the marble jambs and slabs are wanting." (House Proceedings, November 1779, 78-9)</p> <p>1780: On February 29th, a payment was recorded to Simon "Ratlack" (Retalick): "155. New Statdt House, paid do [Simon Ratlack] for 2 Iron Chimney Backs...[£]255." (Auditor General, Journal, MSA S 150-4, Peter Force Collection MSA SC 4391, page 167)</p> <p>1781: On April 12th, accounts include an entry, "155. The New Statdt House -- paid Allen Quynn for 1 pair Iron Cranes for the Senate Room...[£]18.0.0." (Auditor General, Journal, MSA S 150-5, Peter Force Collection B-2 MSA SC 4391, page 270)</p>

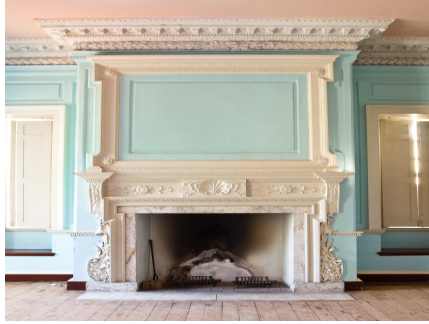
<p>The drawing room of the James Brice House (1767-1773) is one of the largest formal rooms in Annapolis and thus provides a useful benchmark for a range of issues--the level of ornamentation, the proportions and projection of the chimneybreast, and the size and depth of the fireplace. (Jeffrey Klee, Colonial Williamsburg Foundation)</p>

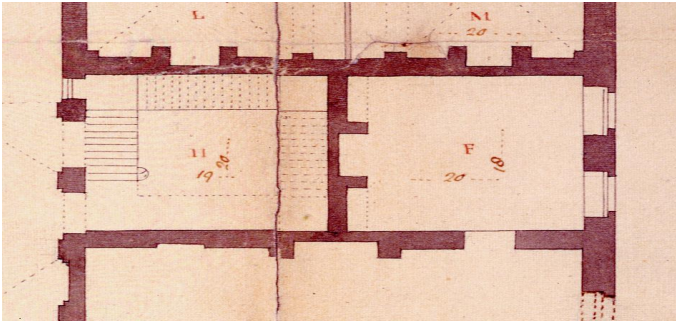
<p>1770: A detail from Anderson's first-floor plan illustrates the range in size and proportion for chimneybreasts and fireboxes in four rooms on the north side of the State House. The drawing should be considered a careful schematic rather than a precisely scalable construction drawing, but it is useful to note that fireplaces range from from approximately 24" to 28" in depth. (John Work Garrett Collection, The Johns Hopkins University, GAR 22; MSA SC 1556-10)</p>	<p>ca. 1792: John Shaw's account for work in the Senate Chamber lists "Altering the fire place (from Smoaking) ...[\$]6.00." (John Shaw Account Book, The John Work Garrett Library of The Johns Hopkins University, GAR 22)</p> <p>1798: John Shaw's accounts include an invoice dated July 10 and paid July 28, 1798, to Thomas Earle: "July 10 to taking two Chimney Jams down to the foundation and building them up again and taking the arch out and putting it in again and making good; to working 4 days and 1/4 for Myself at 12/6 pr day...2:13:1-1/2; to 4 working 4 days and 1/4 for Gassaway at 7/6...1:11:10-1/2; to 1 labourer 4 days and 1/4 at 3/9...0:15:11; to 500 hundred [sic] bricks at three pounds thousand...1.10.0... [total] £6:10:11. July 28 rec'd Contents of John Shaw [signed] Thomas Earle." (Maryland State Papers, Series A, MdHR 6638/81/1-5)</p> <p>1798: August 25. John Shaw's accounts for the State House include an invoice from William Grant, including charges for "2 Holdfasts for fixing a Back...0.2.0" and "2 Hooks for a picture...0.3.9." (Maryland State Papers, Series A, MSA S 1004-81-99/123)</p> <p>1798: George Barber is paid for "10 doz tiles @ 2/6...1.5.0; To freight of ditto...0.1.10-1/2; To freight of Iron...0.3.9; [Total] £1.10.7-1/2." A summation of Shaw's accounts assigns Barber's invoice entirely to the Senate Chamber. (Maryland State Papers, Series A, MSA S 1004-81-99/123)</p>

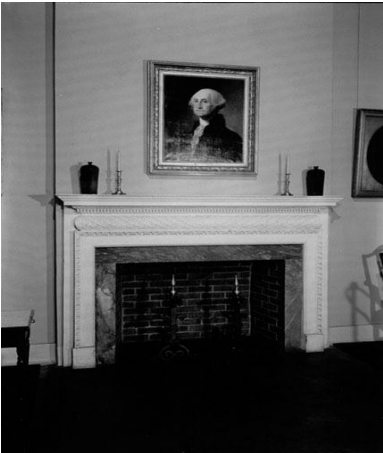
<p>The fireplace in The President's House (ca. 1780) in Philadelphia provides one illustration of a broadly proportioned opening but relatively shallow in depth to reflect more heat into the room. The mantel incorporates other features relevant to Revolutionary era Annapolis, with an carved backband on the surround and enriched cushion frieze below a relatively delicate dentil course-molded shelf. (Jack Boucher, HABS)</p>

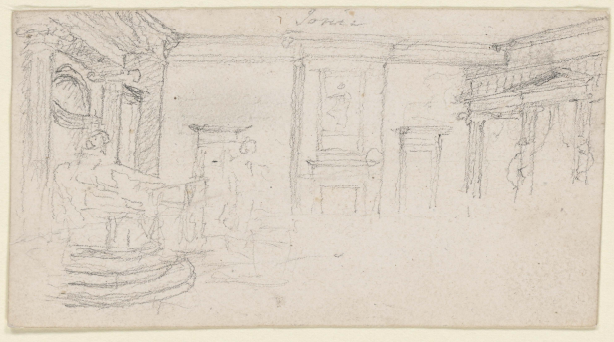
<p>1822: John Trumbull's sketch, made on-site, provides a general guide to the composition of the fireplace and mantel. The chimney breast scales to approximately 10 feet in width, while the fireplace opening scales to about 4 feet in both width and height. Trumbull's dimensional proportions are more accurate in the horizontal axis than the vertical, but regardless, his portrayal of the fireplace seems underscaled to the size and importance of the room. (Courtesy of Yale University Art Gallery, Gift of the Associates in Fine Arts, 1938.286a)</p>	<p>1801: Vouchers for work on the State House in 1801 include no. 13, the purchase from Jon. Pinkney of 14 yds. of "fearnought...for the fire places of the Senate & Ho Delegates" for £3.5.4. (William D. Hoyt, Jr., "Report on Research - The Senate Chamber," 1938, p. 5.)</p> <p>1818: An invoice dated December 12 records payment to Isaac Bradley of \$535.25 for 'altering the fireplaces in the Senate Chamber and the House of Delegates Room as per account.' (Governor and Council, Proceedings, 1817-1820. MSA S 107-33)</p> <p>1826: On April 21, 1826, Vachel Severe paid \$8.25 "for a new fire plate for The Senate Chamber, and 28 eyes for fenders." (Governor and Council, Proceedings, 1825-30. MSA S 1071--36)</p> <p>1831: An invoice with the heading "Mr. Andrew Slicer for State of Maryland" and dated July 14th records alterations to the Senate fireplace by T. Anderson: "To Soapstone for fire places in Senate and House of Representative Chamber... \$43.33; To 3 days work of 2 hands @ 3.50...10.50; To 2 passages & fare...6.00; To 1 weeks board of 2 men...6.00; [total] \$65.83." (Maryland State Papers, Series A, MSA S 1004 MdHR 6636-138-78)</p> <p>1831: A payment is recorded on July 25th "To Andrew Slicer -- for repairing the fireplaces in the Senate and House of Delegates Chambers...\$89.28." This payment probably includes the work by T. Anderson. (Report of the Treasurer of the Western Shore, p. 1222; MSA SC M61)</p>	<p>1831: An invoice dated July 13 records payment to Vachel Seveir "To an arch bar for council chamber 37 H [lbs] at 10 Cents is... \$3.70." This entry implies that iron arch supports were not used in the original phase of construction, a practice that was passing out of use for large fireplace openings by the 1770s in Annapolis. (Maryland State Papers, Series A, MSA S 1004 MdHR 6636-138-132)</p> <p>1847: On January 20th, a report is submitted itemizing work completed in 1846 on the State House; including the following entry: <i>The dilapidated floor in the Main Hall, has been substituted by a new and neat one of finely pressed brick of Sexagon form.</i> (Report of the Slect Committee on Public Buildings, General Assembly, Public Documents, Document U, 1846 Maryland Documents)</p>

- **Chimney Breast and Mantel:** As previously noted, the original chimney breast had been removed in 1858 for the installation of a new heating system. Physical evidence demonstrates that the original chimney breast was two feet broader than the existing 1905 projection. Moreover, historic images strongly suggest that the original mantel was typical of fine Annapolis mantels of the period with architrave surround, ornamented pulvinated frieze, and cornice shelf. There is no basis for the plain bolection surround of 1905, which was further simplified in 1940. More research is required to determine what might be reasonable dimensions for the mantel and fireplace opening.

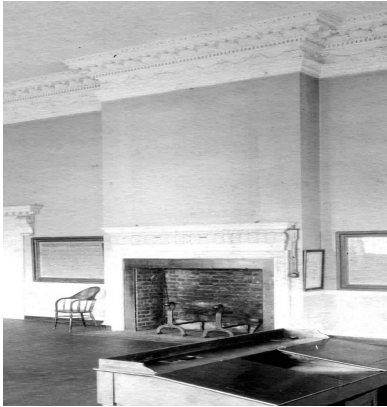
<p>ca. 1920-24: A comparison of the firebox in this photograph by Hayman with the firebox today demonstrates that the firebox remains unchanged from 1905. (Howard E. Hayman, Jr. Collection, MSA SC 1804--02-0043)</p>	<p>1905: On May 25, Wilson and Pennington present cost estimates and drawings to the Commission, including the first mention of hexagonal paving tiles for the hearth. (Letter dated May 17, 1905; Kept with MSA S 1137)</p> <p>1905: In their December 14 final report to the Governor, Wilson and Pennington summarize the evidence for the fireplace: <i>Mr. S. W. Brooks, who has looked after the fire in the past, says that four foot cord wood sticks were used in the fire place, which is confirmed by Hon. A. B. Hagner, who was familiar with the room from 1845, and who still remembers the great fire place and its hot fire of logs. We have made the fire place large enough to hold such sticks...The fireplace itself has been lined with the original bricks saved when some of the State House walls were removed. taken from the original pavement of the main entrance corridor of the building.</i> (State House Building Commission, General File, MSA S 1740)</p> <p>1905: An undated document in Wilson's hand, presumably his draft for the final report, includes further detail regarding the facing of the fireplace: Ex Governor Whyte says it was faced with black slate or marble...Many others as Wells & Davis & Brooks say it was faced with plaster painted black. As this was very customary, we have followed it. (Maryland Historical Society, Wilson Papers, MS 833, Box 6)</p>	<p>1905: Responding to a search for eyewitness memories of the fireplace and other details, Justice Alexander Hagner offered the following description: I have a pretty good recollection of the Old Senate Chamber from 1845, when I went to Annapolis to study law. I remember it very well when the great fire place glowed with long sticks of hickory and oak...but I have no recollection of there being any mantel piece ever there. On the contrary, I can only recall this fireplace as a huge rough looking, cavern without any sign of beauty or ornamentation & certainly having nothing like a mantel over it....There were similar fireplaces in the Governor's Chamber, over the Senate, and in the Ct of Appeals... (Maryland Historical Society, Wilson Papers, MS 833, Box 6)</p> <p>Justice Hagner's recollections of the Senate Chamber fireplace are of Hagner's description--the fireplace was large and deep--while disregarding his contention that the fireplace lacked mantel and ornamentation. It would be hard to disagree with Wilson's response. Hagner's account raises the possibility that the original mantel had been removed by the late 1840s, but his recollection of room conditions 60 years previously conflicts with Lossing and other accounts from the 1850s, as well as the suggestion of a mantel in Mayer's 1856 drawing. Hagner's account is further diluted by his statement that other important public rooms had been stripped of their mantels as well. Nevertheless, Hagner's account merits inclusion in the analysis of evidence.</p>

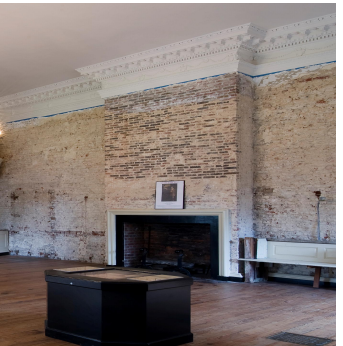
<p>The chimneybreast, fireplace and hearth in 2009, with plaster from 1905 and 1940 removed to reveal 18th century fabric. (Jay Baker, 2009)</p>

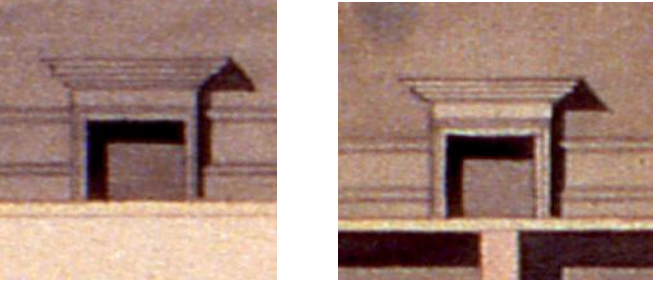
<p>1770: Anderson's transverse section of a proposed design for the State House provides elevations of three fireplace compositions, including mantels. Most applicable is the mantel in an important first-floor room that would correspond to the Senate Chamber (left); second floor mantels (right) are similar but with a slightly reduced level of detail, as is typical in 18th century architectural practice. (Courtesy, The Winterthur Library: Joseph Downs Collection of Manuscripts and printed Ephemera, No. 92x93.10; MSA SC 5405)</p>	<p>1798: John Shaw's accounts include an invoice dated July 10 and paid July 28, 1798, to Thomas Earle for "taking two Chimney Jams down to the foundation and building them up again and taking the arch out and putting it in again and making good." The work required 500 bricks and was completed in 4 1/4 days by Earle, a skilled artisan named Gassaway, and a laborer. (Maryland State Papers, Series A, MdHR 6638/81/1-5)</p> <p>1798: A list of expenses for the month of October 1798 includes: "To painting the Caseing of the pump the pilasters in the Council room & the Chimney in the Senate room...[£] 1.10.0." (Accounts of John Shaw, Maryland State Papers, Series A, MSA S 1004-81-99/123)</p>

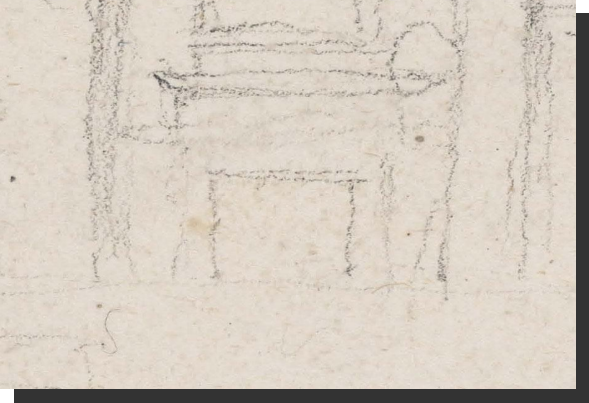
<p>1822: Trumbull's on-site sketch of the fireplace and mantel appears to be underscaled but suggests a boldly projecting shelf above an enriched frieze with no overmantel to provide a clear field for the large painting. (Courtesy of Yale University Art Gallery, Gift of the Associates in Fine Arts, 1938.286a)</p>	<p>1808: Expenses include an entry for November 1 for £5.17.6 paid to William Sewel for various tasks, including "To painting the Chimney peice [sic] of the Senate room...0.7.6." (Maryland State Papers, Scharf Collection, MSA S 1005-13917, MdHR 19,999-085-062)</p> <p>1831: Installation of "Soapstone for fire places in Senate and House...Chamber" in July would have altered the appearance of the firebox and/or the hearth, but no evidence has been found to suggest a change to the mantel at this time. (Maryland State Papers, Series A, MSA S 1004 MdHR 6636-138-78)</p>

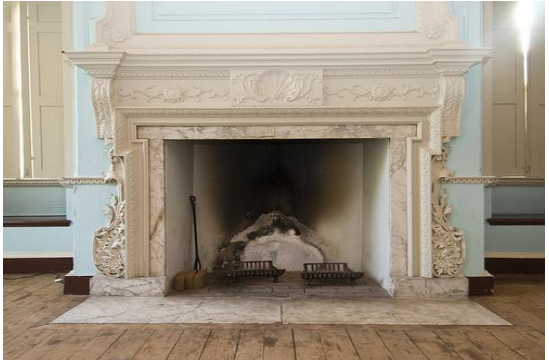
<p>The drawing room mantel in the James Brice House (1767-1773) provides a good illustration of the ways in which published designs in English pattern books were adapted and interpreted by Chesapeake craftsmen. Note the similarities in the shouldered enframing of the opening with carved backback, flanked by elaborately carved console brackets, all elevated on marble plinth blocks. While the Brice mantel does not include the carved cushion frieze, this feature is employed in the drawing room entablature. (Jeffrey Klee, Colonial Williamsburg Foundation)</p>

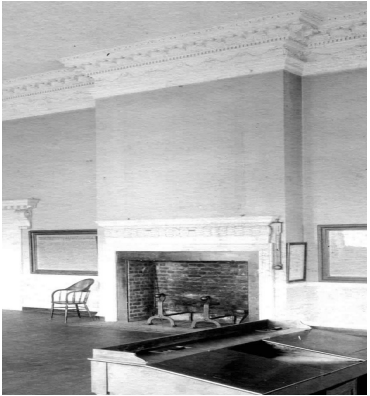
<p>1920-1924: A photograph by Howard Hayman captures the 1905 mantel with its elaborate overmantel. (Howard E. Hayman, Jr. Collection, MSA SC 1804--02-0043)</p>	<p>1905: On April 28, Justice Alexander Hagner offers his recollection of the OSC ca. 1845: <i>I have no recollection of there being any mantel piece ever there. On the contrary, I can only recall this fireplace as a huge rough looking, cavern without any sign of beauty or ornamentation & certainly having nothing like a mantel over it....There were similar fireplaces in the Governor's Chamber, over the Senate, and in the Ct of Appeals, & I am pretty sure neither fireplace had a mantel over it...If I were to venture an opinion upon the point...I should not hesitate to say there has never been a mantel piece in the Senate Chamber since 1845, When I came there.</i> (Maryland Historical Society, Wilson Papers, MS 833, Box 6)</p> <p>1905: On May 17, Pennington and Wilson provide the first cost estimates for the restoration, including \$100 "To provide plain, simple mantel, suitable for same [i.e. fireplace]." A quick sketch of a mantel is included on the back of a drawing prepared for the May 25 Commission meeting. (Kept with MSA S 1137)</p> <p>1905: An undated document in Wilson's hand, summarizes evidence for the mantel: The mantel was removed so long ago that all trace of it seems to have been lost. We have not been able to get trustworthy data in regard to it, except that there was a mantel of wood & it does not seem to have been elaborate. We have therefore designed one based on well known examples of that time & have used the same frieze which appears in the gallery & over the niche. (Maryland Historical Society, Wilson Papers, MS 833, Box 6)</p>	<p>For additional discussion of Alexander Hagner's recollections, see the "Comments" section for "Firebox and Hearth, 1905-1940" (above).</p>

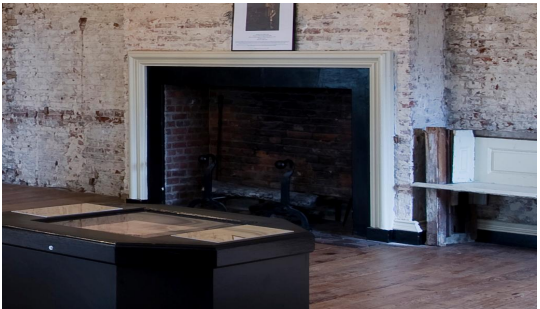
<p>Fireplace framed with the 1905 mantel designed by J. Appleton Wilson, as modified by the removal of the overmantel in 1940. (Jay Baker, 2009)</p>
