RECOMMENDATIONS FOR THE RESTORATION OF THE OLD SENATE CHAMBER

SUMMARY OF FINDINGS AND RECOMMENDATIONS
PREPARED FOR THE
MARYLAND STATE HOUSE TRUST
BY
THE OLD SENATE CHAMBER ARCHITECTURAL ADVISORY COMMITTEE
January 14, 2010

**REPORT TO THE MARYLAND STATE HOUSE TRUST
on the
OLD SENATE CHAMBER**

RECOMMENDATION AND SUMMARY OF FINDINGS

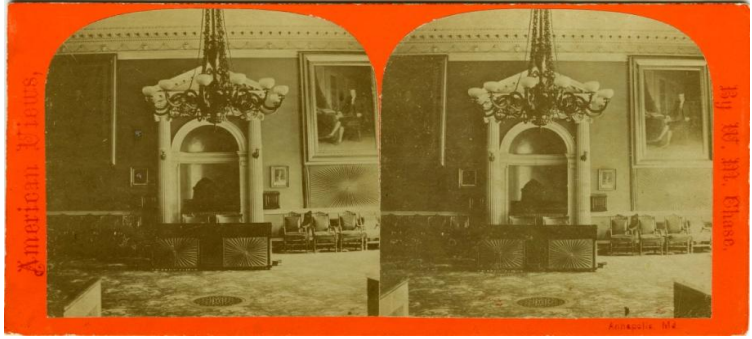
<p>1868: The only known photograph showing the original Senate President's Rostrum. In this view, taken from just inside the door, one can see the rostrum as the center point of the north wall. By the time this image was taken, the original windows on either side of the rostrum were covered over to allow more space for hanging portraits of the signers of the Declaration of Independence. The portrait seen to the right is Thomas Stone, painted in 1836 by John Beale Bordley. (Stereocard image of the Old Senate Chamber, William M. Chase, American Views series. Ross Kelbaugh Collection, MSA SC 5907-1-1.)</p>	<p>Archival evidence for the rostrum proves scant throughout its history. After its construction, and the committee's statement that it is more elegant than planned, there is little mention directly of the niche or dais. General references to paint and plastering, and orders for furniture for the President of the Senate are the main documents that exist in the 19th century, suggesting that the niche remained as originally built until its demolition in the 1870s. From that point, documentation consists of discussions concerning the replacement of the columns, pediment and dais. Visual evidence through 19th-century sketches and paintings of Washington's resignation, along with the earliest surviving photograph of the north wall, help to provide a visual record of the dais and niche.</p>

- **Niche and Dais:** The niche itself along with its architrave moldings and flanking pilasters are original, indeed it is the chamber's only original trim. Investigations and the 1868 stereoview indicate that the pediment entablature did not break above the columns as was done with the 1905 entablature. Evidence was found showing that the original columns were almost free-standing rather than half-round as are the 1905 columns. Historic images show that the original pediment had a paneled soffit. The dais probably had only two risers rather than the existing three and was wider than the existing dais.

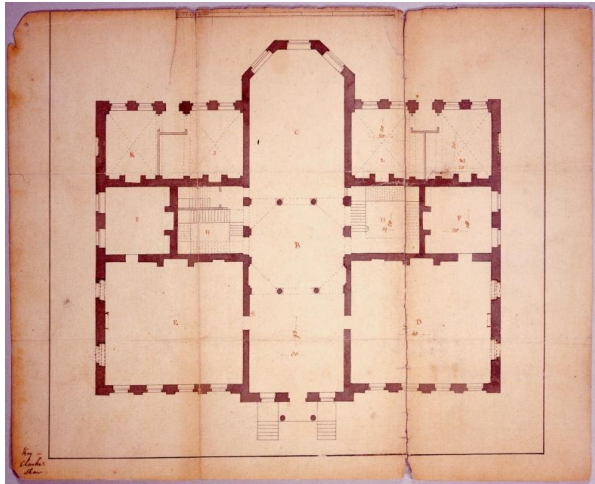
<p>1770: First Floor Plan of the Maryland State House (above), attributed to architect Joseph Horatio Anderson. On the right a detail of the Senate Chamber plan illustrates a schematic representation of a focal point for the room--a simple rectangular outline projecting approximately 16" from the wall and 42" wide. (John Work Garrett Collection of the Johns Hopkins University, GAR 22, MSA SC 1556-110)</p>

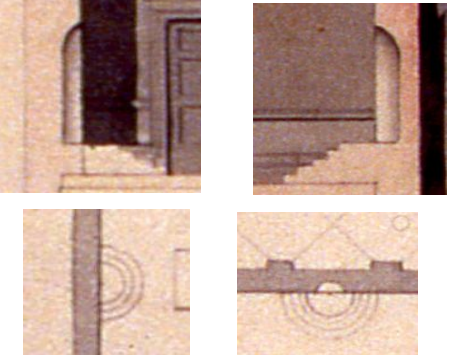
<p>1770: Plan and Sections of proposed design, by Joseph Horatio Anderson. While unbuilt, the drawings provide insights for Anderson's design intentions, including the use of a dais and niche in two main rooms. The left images correspond to room A; while the right images are from the larger room B.</p> <p>Platforms were often used to denote ceremonial space in early public buildings. Further embellishment was derived from elaborate furniture, usually an imposing chair, or from architectural enrichment. Either feature would focus attention on the ceremonial seat and its occupant. A niche or pedimented wainscoting were common in English courtrooms, but rarely seen in America. The use of such a bold composition here, with a recess framed by pilasters and set off by a classical entablature supported by Ionic columns, sets the tone for the richly detailed interior of the Senate Chamber.</p>

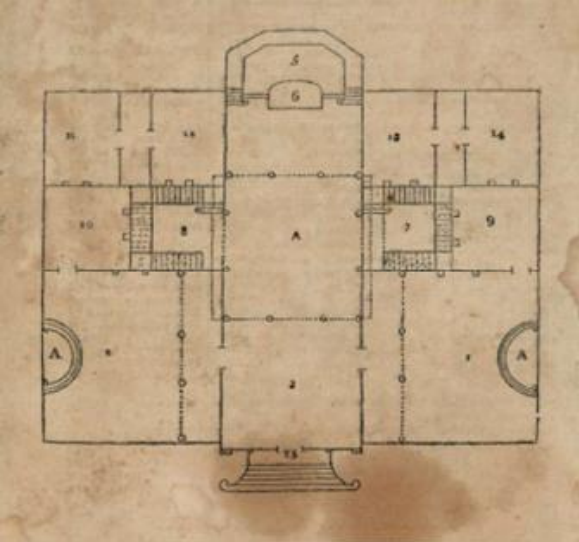
<p>1789/02: A plan drawing of the State House published in the February 1789 issue of <i>Columbian Magazine</i> clearly delineated the President's rostrum, comprised of the semi-circular platform, or dais, flanked two columns. The accompanying letter key identifies two rostrums "A" as "thrones for the speakers." <i>Columbian Magazine</i> 1789 (MSA SC 1556-1-121)</p>	<p>1779/07/30: The State House was still unfinished as reported by the committee in July: <i>The room intended for the Senate wants a coat of plaster, one of paint, and the lower floor; this Mr. Wallace says shall be ready by the last of August, the gallery and committee-room almost finished.</i> (Proceedings of the House of Delegates, July Session 1779, MSA SC M 3196, 874)</p> <p>1779/12/28: By year's end, the project was nearing completion: <i>The committee have examined the state-house throughout and are of opinion that man[y] parts thereof are finished with more elegance than was required by the contract, particularly the front door, great hall, and court, the senate house and house of assembly, the president's and speaker's seats, and the galleries.</i> (Proceedings of the House of Delegates, November Session 1779, MSA SC 3204, p. 78)</p> <p>1779/12/28: Charles Wallace submits a final petition upon retiring as Superintendent of the State House: Your petitioner has finished the State House (except four of the commonest Rooms and some ornaments in the front which the plan will show) and the galleries in a much more expensive and elegant manner than could be claimed from his contract or he believes was expected, and, as he hopes to give satisfaction to your Honors and reflect credit on the State. (Maryland State Papers, Series A, MSA S 1004-18-5122, 6636-15-194)</p> <p>1792: The State House Account book lists repairs to the Senate Chamber by John Shaw and includes a reference to "Painting the room & Blinds [for] 80.00." (John Work Garrett Library of The Johns Hopkins University, MSA SC 5287-1-18)</p>	<p>Visitors to Annapolis rarely failed to mention the elegance and standing of the State House. In 1777, visitor Ebenezer Hazard noted "The stucco Work in the State House is very elegant." Four years later, Abbé Robin, a chaplain with the French Army who was passing through Annapolis, praised the State House: <i>The state-house is a very beautiful building, I think the most so of any I have seen in America. The peristyle is set off with pillars, and the edifice is topped with a dome.</i></p>

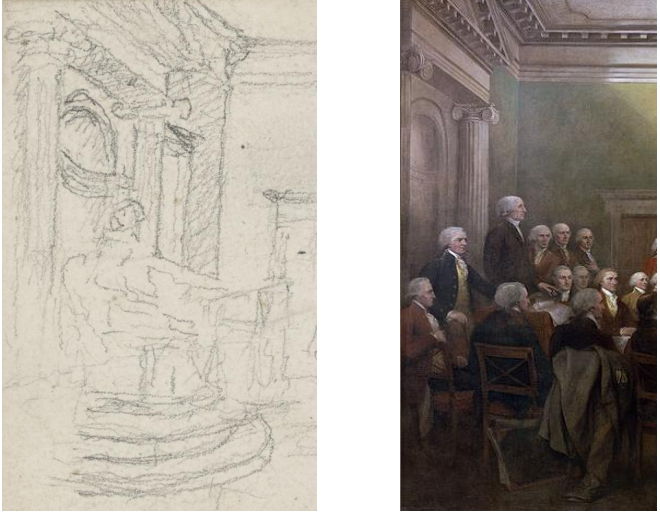
<p>Rostrum 1800-1858</p>	<p>1822-24: John Trumbull sketched the Senate Chamber in 1822 in preparation for his painting of George Washington's resignation. Prepared on site, the sketches are more useful than the painting as a visual clue to the 18th-century appearance of the niche and dais. One sketch illustrates the recessed niche with its neckbanding and molded architrave flanked by fluted Ionic columns. The corner of the pediment is just visible but shows a plain, unbroken frieze with a deep soffit. The fluted columns appear to be topped by volutes, both at the front and rear, indicating that the columns were barely engaged, if at all. The sketch illustrates the dais as having one step up to a raised platform (i.e. two risers), on which sits the President's chair. There may be another object resting on the platform with the chair; but Trumbull's rough pencil work leaves this unclear.</p> <p>A detail sketch (far right) is mostly likely of a column from the gallery, as the columns of the rostrum do not break forward. Due to the almost identical detail of the entablatures of the rostrum and gallery, the sketch is still a valuable tool for understanding the former. The details of the entablature include a pulvinated frieze carved with leaves and a modillion course along the cornice, all of which appear in the 1868 stereograph. A notation next to the detail states "Frieze oak leaves" - a detail also confirmed in the 1868 stereograph of the rostrum. Unlike the detail, Trumbull's finished painting incorrectly delineates a plain frieze below the pediment.</p>

<p>1822-24, works by John Trumbull: detail from the full room sketch of 1822, (Yale University Art Gallery, Gift of the Associates in Fine Arts, 1938.286a and 1938.286b), and detail from the finished painting of 1824, titled "General George Washington Resigning His Commission." (Oil on canvas, Rotunda of the United States Capital, Washington DC).</p>	<p>1824/12/20: The Marquis de Lafayette visits the State House on his tour of the United States. Historian William D. Hoyt, Jr., researching the chamber in 1938 reports that three Maryland newspapers note that the chamber "has been but little changed since Washington there resigned his commission into the hands of Congress." (Old Senate Chamber Refurbishment Collection, MSA SC 2827, M 731; Part 7, pp. 75-86)</p> <p>1825/05/07: <i>Ordered that the walls of the Senate, House of Delegates and Executive Chamber and Committee rooms be yellow washed, the ceilings and stucco cornice be cleaned, the woodwork painted.</i> Andrew Slicer was paid for painting the Senate Chamber on July 23, 1825. (Governor and Council, Proceedings, 1825-1830, MSA S 1071-36).</p> <p>1838/02/27: Funds are appropriated for repairing and painting the Senate Chamber. (Proceedings of the House of Delegates, 1837 Session, 304-5)</p> <p>1844: A long series of documents record a dispute between the Senate and the House of Delegates over payment for repairs to and furnishing of the Senate Chamber. (Proceedings of the Senate, 1844 Session; Proceedings of the House, 1844 Session)</p>

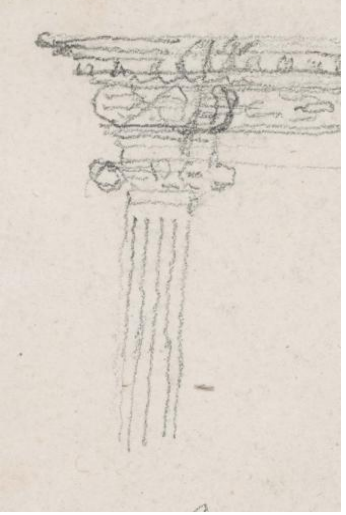
<p>1822-24: Trumbull sketched the column and entablature of the gallery on the reverse side of the full room sketch. (Yale University Art Gallery, Gift of the Associates in Fine Arts, 1938.286a and 1938.286b)</p>

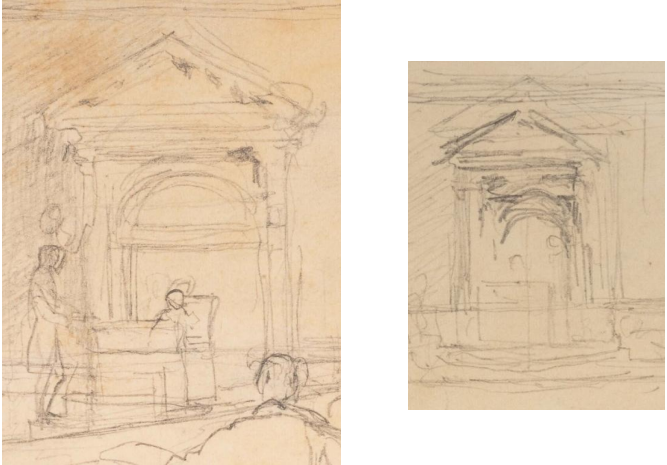
Room Feature	Architectural Findings and Analysis	Images	Archival Evidence	Comments and Collateral Evidence
<p>Niche and Dais Rostrum 1800-1858</p>	<p>1856: Artist Francis B. Mayer prepared a series of sketches in preparation for painting Washington's resignation; the rostrum appears in each as a prominent feature. While rougher than Trumbull's, these sketches still show the overall composition with recessed niche and moldings, flanked by the columns and a full pediment. The sketch suggests a deep soffit below the entablature and a modillion course along the pediment. The entablature, while depicted as being plain, does not appear to break out over the columns. The penciling in of a person one step above the floor but lower than the platform suggests a single riser to the platform. The smaller sketch (to the right) appears to be a rough first draft used for laying out the scene. It suggests the columns are fluted and also shows a single step and raised platform.</p>

<p>1856: Contemplating the execution of his own painting of Washington's resignation, Annapolis artist Francis B. Mayer prepared sketches of the Senate Chamber. (Sketch of the Old Senate Chamber entitled "Md Senate 1856." By Francis Blackwell Mayer, Courtesy of the Baltimore Museum of Art, Sketch Book 55, Page 5, 1936.198.)</p>	<p>1856/03/10: Funds were appropriated for <i>Richard R. Conner for painting done in Senate Chamber in 1851</i> (\$52.11). (Laws of Maryland, 1856 Session)</p> <p>1858/03/31: An article in the <i>Annapolis Gazette</i> reports on the major renovation work being conducted in the State House: <i>The Senate Chamber will remain intact.</i> (<i>Planters Advocate</i> MSA SM 3601)</p> <p>1858: As part of a project to install a new steam heating system, contractor Bartlett and Hayward executes a plan drawing of the Senate Chamber. This drawing was available in 1905 and consulted during the restoration. Its location since that time is unknown.</p>

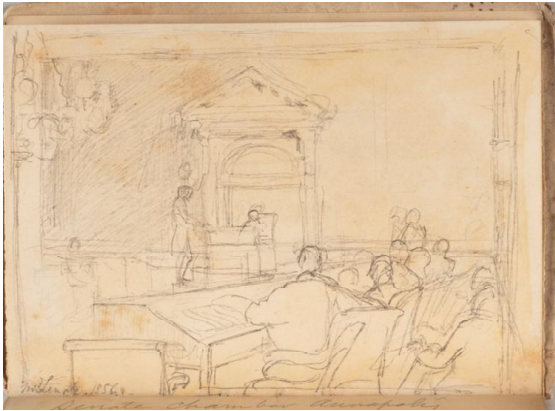
<p>A sketch of Old Senate Chamber by Francis B. Mayer, entitled "Md Senate 1856." (Courtesy of the Baltimore Museum of Art, Sketch Book 55, Page 5, 1936.198)</p>

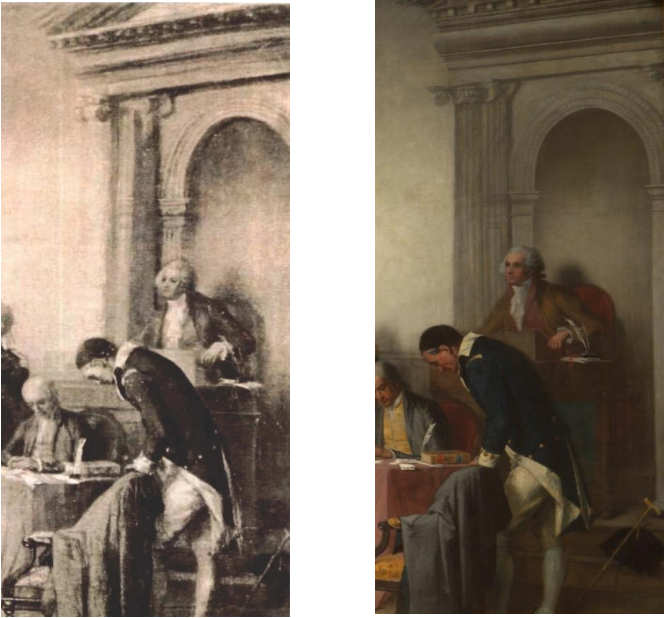
<p>Rostrum 1800-1858</p>	<p>1858: Edwin White's commission to paint George Washington provides another visual record of the rostrum during the mid-19th century. In this case, both White's artist study and his painting show the architecture of the rostrum in a rather impressionistic way. Like the others, he shows the flat entablature across the pediment, projecting out from the wall above the niche. The columns, however, appear almost flat with a suggestion of double volutes. White, too, portrays a single step below the raised platform.</p>

<p>1858: Edwin White receives the commission to paint a grand portrayal of Washington's resignation for display in the State House. (<i>Washington Resigning His Commission</i>, by Edwin White. Oil on canvas. MSA SC 1545-1112)</p>	<p>1851: Historian Benson J. Lossing expresses a growing sentiment regarding the Senate Chamber: <i>Never shall I forget the peculiar emotions which I felt while sitting in that room... The little gallery wherein stood Mrs. Washington and other distinguished ladies when the chief resigned his commission, is still there, and unchanged; and the doors, windows, cornices, and other architectural belongings are the same which echoed the voice of the Father of his Country on that occasion... Reflecting upon the events which consecrate it, that hall, to me, seemed the shrine wherein the purest spirit of patriotism should dwell, for there the victorious warrior for freedom laid his sword upon the altar of Peace – there the sages of a people just made free ratified a solemn covenant of peace, friendship, and political equality with the most powerful nation upon earth, wrung from its rulers by the virtues and prowess of men who scorned to be unrequited vassals.</i> (<i>The Pictorial Field Book of the Revolution</i>, v. II, p. 403)</p>

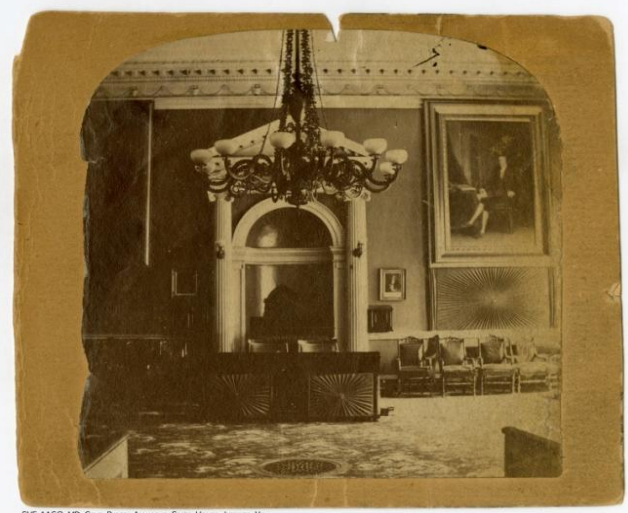
Room Feature	Architectural Findings and Analysis	Images	Archival Evidence	Comments and Collateral Evidence
<p>Niche and Dais</p> <p>Rostrum 1859-1875</p>	<p>1868: The two stereographs of the old Senate Chamber taken in 1868 by Baltimore photographer William M. Chase are our earliest photographic record of the room and its architectural features. One of the pair is a view taken from just inside the room looking towards the north wall with the rostrum in the center. Unfortunately, the chandelier obscures much of the pediment in this view, but the image still provides a wealth of information about the overall composition and specific architectural details. No documentation has been found of alterations to the rostrum and in this photograph, the gas sconces on the columns are the only changes visible to those elements.</p> <p>Enhanced technology provides the opportunity to study specific details in the photo, most notably the pediment, entablature, and column capitals. High resolution views have confirmed that the entablature is almost identical to the gallery. Close examination of this image confirms that the entablature of the rostrum has a pulvinated frieze decorated with oak leaves and does not appear to break over the columns.</p>

<p>1868: Fragment of stereocard image of the Old Senate Chamber facing the niche and speaker's dais. (Courtesy of the Maryland Historical Society, P 3.8)</p>	<p>1860/01/06: In his address to the general assembly, Governor Thomas Holliday Hicks emphasizes the importance of preserving the Senate Chamber: <i>The Northern portion of the main building, containing the Senate and Executive Chambers, needs extensive repair...I venture to suggest that an indispensable condition in such appropriation should be, that the Senate Chamber, with which are connected so many associations and Revolutionary memories; and which is justly admired for the beauty of its proportions and decorations, should in none of these respects, and in no way whatever, be changed or altered; that there should be only a renewal of what is useless or decayed, in an exact repetition of the part taken away.</i> (Document B, 16-17)</p> <p>1862/03/08: James Iglehart is paid "forty-seven dollars and one cent, for paints and work done on Senate Chamber and Hall of Delegates." (Laws of Maryland, 1862 Session, Chapter 192, pages 213-214. <i>Archives of Maryland</i>, Volume 532)</p> <p>1874/03/27: Accounts record payment of \$18: "to J. W. Kalmey for painting done in Senate chamber and House of Delegates." (Laws of Maryland, 1874 Session)</p>

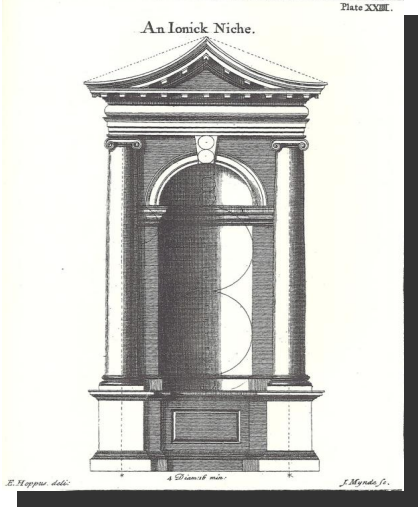
<p>An Ionic Niche from William Salmon, <i>Palladio Londinensis</i> or the <i>London Art of Building</i>, 2nd ed. 1738 (with editions to 1773), Pl. XXIII. "The London Art" was listed in William Buckland's inventory.</p>

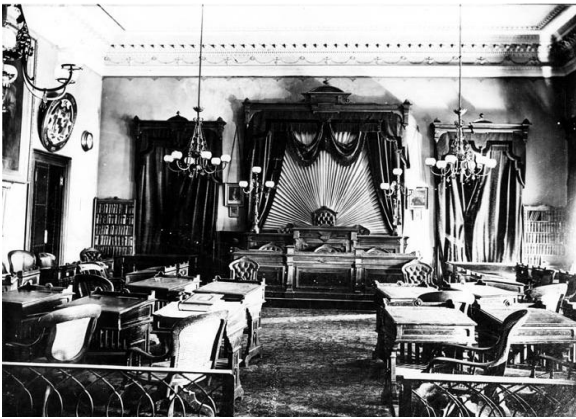
<p>c. 1886: View north across the Senate Chamber toward the President's rostrum installed in 1876. This image was taken after the room was gutted and recreated in the Victorian style. As part of the renovation, the niche was covered with Victorian fabric and a heavy valance. A large rectangular platform replaced the original dais. Other changes to the room included the removal of the gallery. (MSA SC 1556-116)</p>	<p>1876/03/30: The General Assembly approved an appropriation for repairs and improvements to the State House including painting and frescoing the Hall, Senate, House of Delegates, Governor's room, and the painting of the work necessary on the interior and exterior of the building. (Chapter 194, 1876 Laws of Maryland, 303-304)</p> <p>1878/01/03: Due to its deteriorating condition, the Senate Chamber is gutted during a major renovation of the State House. <i>All the plastering has been renewed, that of the Senate restored from drawings, measurements and models made from the original casts...All the walls have been painted in oil and the ceilings decorated in an appropriate manner in fresco...All the wood-work throughout has been painted, grained and varnished in imitation of walnut and ash.</i> (General Assembly, Public Documents, 1878 Legislative Session, Document A, 51-52, 76-80)</p>

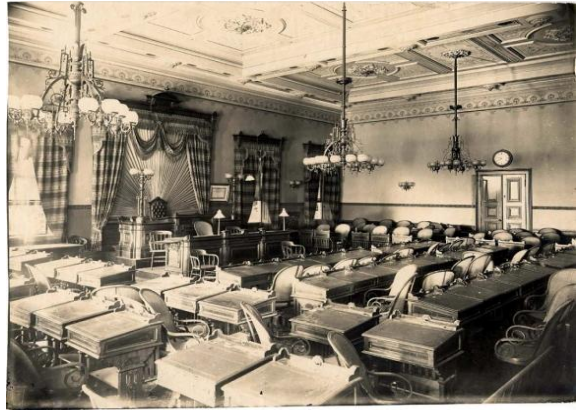
<p>c. 1886: View of the House of Delegates Room located across the rotunda from the Senate Chamber. In 1858, the room was enlarged to meet the needs of the larger assembly. In this view, the rostrum is similarly decorated with Victorian fabric draped to create the backdrop for the speaker's desk. (George Forbes Collection, MSA SC 182-02-160)</p>

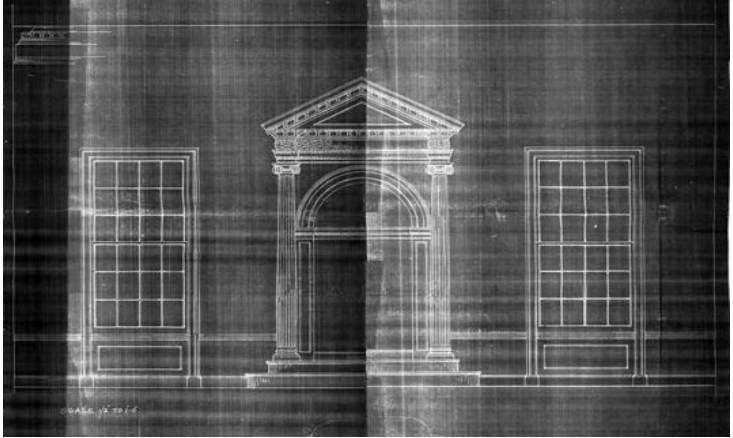
<p>1905: In preparation for a Commission meeting on May 25, J. Appleton Wilson prepared refined scale elevation drawings of the of the gallery and niche; a blue line print survives among his papers. As preparation for the restoration began, it was agreed that the recessed niche, and its surrounding moldings survived in situ but that the Ionic columns and enriched pediment would need to be reconstructed along with the dais. Wilson based his drawing mainly on the 1868 stereograph. (Maryland Historical Society, Wilson Papers, MS 833, Box 6)</p>	<p>1905/04/03: In a letter to J. Appleton Wilson, architect Josias Pennington detailed the state of the niche: <i>The niche back of the rostrum partly remains but the pilasters and projections of same beyond the face of the wall, have been removed.</i> [Hand-written note: "photo will make that OK."] (Courtesy of the Maryland Historical Society, MS 833, Box 6) Further down, Pennington noted: <i>The details are wanting of the pediment pilasters and such work as projected from the face of the wall.</i> Twice, Pennington discusses the pilasters as having been removed. Since there is no mention of the columns anywhere in this reference, he must be using the two terms interchangeably. No other documentation suggests the pilasters were removed in the 1870s work campaign.</p> <p>1905/5/17: A month later, Wilson and Pennington report on the findings of their investigation: The niche back of the Rostrum is also in such shape that it is evidently the original work. From the information obtained the drawings have been prepared showing the niche and the gallery as proposed for restoration. Wilson and Pennington estimated restoration of the niche and gallery would cost \$2500, painting of sash, woodwork and plasterwork \$500. (Estimate from Baldwin and Pennington to DeCourecy W. Thom, Secretary to the Advisory Commission in Reference to Restoration of the Old Senate Room in the State House - Annapolis, Md. Kept with MSA S 1137)</p>

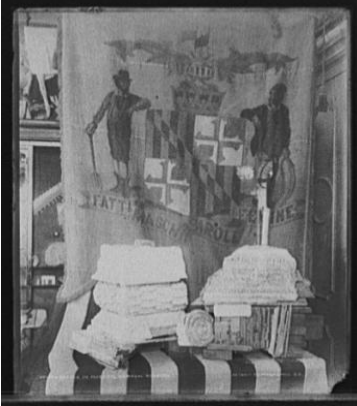
<p>1927: Wilson notes in his article for the <i>Maryland Historical Magazine</i> that there were a number of plaster fragments from the gallery available for study: Mr. Shafer of the Land Office, had been wise enough to save a candle box full of the plaster modillions and fragments of the entablature from the gallery front. These were carefully put together and compared with the photograph, which gave us exactly what we needed. The image, above, was published in 1901 by the Detroit Photographic Company and shows fragments of the ornamental plaster work related to the gallery. ("Restoration of the [Old] Senate Chamber," <i>Maryland Historical Magazine</i>, Vol. XXII, March 1927, pp 54-62)</p>

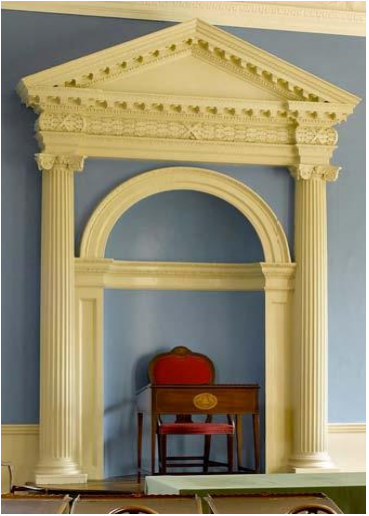
<p>The reconstruction of the missing pieces of the rostrum was based on photographs and existing fragments, all carefully researched by Wilson. Despite this, the reconstruction differs in several key ways from the appearance of the original as seen in the 1868 view to the right. The 1905 rostrum, seen above in a 2006 photograph, projects only minimally into the room creating a less monumental composition. The flanking columns are clearly engaged with the wall and the entablature breaks forward only at the columns creating a shallow soffit underneath the entablature. Wilson based the reconstructed dais on the only documentation known at the time and thus created a platform with 3 risers. (Photo: Gavin Ashworth, 2006)</p>

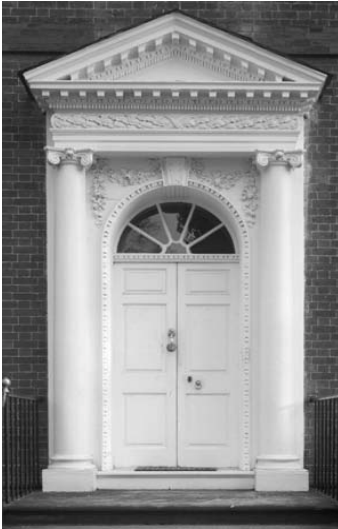
<p>The front door of the Hammond Harwood House (1774), one of the best examples of classical architecture in America. This pedimented entrance has numerous similarities to the aedicule niche design used for the rostrum in the Senate Chamber. This design, based on plate 23, of Abraham Swan, British Architect, illustrates a bold composition with an arched opening flanked by Ionic columns, a full entablature and pediment. The column capitals have full volutes at the wall and the pulvinated frieze has no break. (Photo: John Greenwalt Lee Company, 2008)</p>

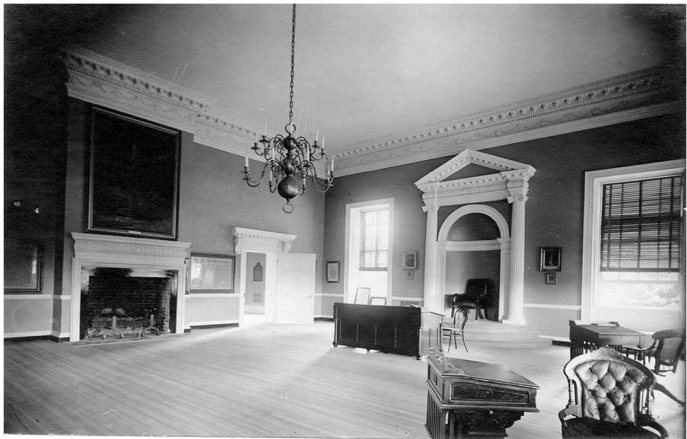
<p>c. 1905: The Old Senate Chamber shortly after completion of the restoration in 1905. While the overmantel and overdoor visible in this picture were removed in 1940, and the floor was replaced, the only change to the rostrum was a repair to the capital of the right column. (George Forbes Collection, MSA SC 182-02-0086)</p>	<p>1927: <i>The silken canopy on a large frame, which covered the wall behind the speaker's platform was then removed and behind it was found the niche in the thickness of the wall, the level of its finish giving us the height of the floor of platform above the floor of the room. The decoration of the niche had disappeared....how were we to know the proper treatment for the niche? We finally ascertained in some way which I have forgotten, that the small photograph had been made by Mr. W. M. Chase, 941 W. Franklin St. On writing to him he said he could find no negatives of the old Chamber but sent me a small photograph of the wall opposite the gallery which was he had discovered, in an old sample book. Of course this was exactly what we lacked, and gave us the columns, and entablature about the niche... I found a copy of the <i>Columbian Magazine</i>...which contained...a plan of the main floor. This plan showed...the "Throne" for the Speaker was all important and was shown as three risers above floor and of an oval shape, somewhat flatter than a half circle. This was carefully followed. ("Restoration of the [Old] Senate Chamber," <i>Maryland Historical Magazine</i>, Vol. XXII, March 1927, pp 54-62)</i></p>

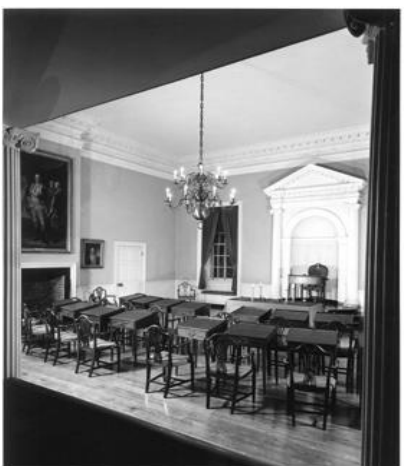
<p>c. 1948: The rostrum viewed from under the gallery, nearly duplicating the view recorded by artist Francis B. Mayer in 1856. (Photo: M.E. Warren. MSA SC 1890-01-3)</p>	<p>1940/08/10: Contractor G. Walter Tovell, Inc. submits the first of two reimbursement requests, including a charge of \$23.67 for "Removing Center piece [i.e. ceiling medallion] and patching same, also Modeling part of cap to right of speakers platform."</p> <p>1940/09/20: Tovell's second and final requisition included a charge for \$935.00 for painting the chamber, which would have included the niche and related ornamental work. (Old Senate Chamber Refurbishment Collection, MSA SC 2827, M 731, part 6, p. 14)</p> <p>2006-2008: Following an initial investigation of the Old Senate Chamber to resolve failing plaster in 2006, a comprehensive examination was undertaken by the John Greenwalt Lee Company. Results for the niche and associated elements are presented in the project report titled "Interim Report on Archival and Architectural Evidence, Old Senate Chamber at the Maryland State House," pp. 202-215.</p>

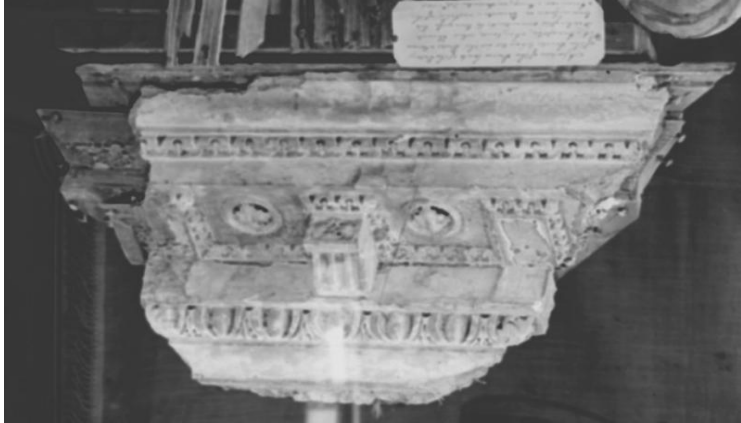
<p>A fragment labeled as being from the entablature of the Senate Chamber gallery and preserved during the demolition of the gallery in 1876, shows the ornamental plasterwork to be equal to that in the finest Annapolis houses. In fact, this plasterwork is very similar to the cornice in the Chase-Lloyd and Adams-Kilty houses. This fragment was a breakout above a column and thus is not part of the niche entablature. However, photographic evidence shows that the two entablatures were almost identical. Photograph published the Detroit Photographic Company now in the Library of Congress captioned "21356, Relics in Museum, U.S. Naval Academy". (Library of Congress det 4a15044 LC-D4-21356)</p>

<p>Wilson's sketch of the entablature of the gallery contains measurements that may have been taken from the relic at far left. It differs in details from the 1868 photo of the rostrum, most notably in the form of the leaves of the cushion frieze, which are oak leaves in the 1868 photo. Trumbull's 1822-24 notation of "Frieze oak leaves" confirms this. (MdHS MS 833 Box 6 Folder 4)</p>

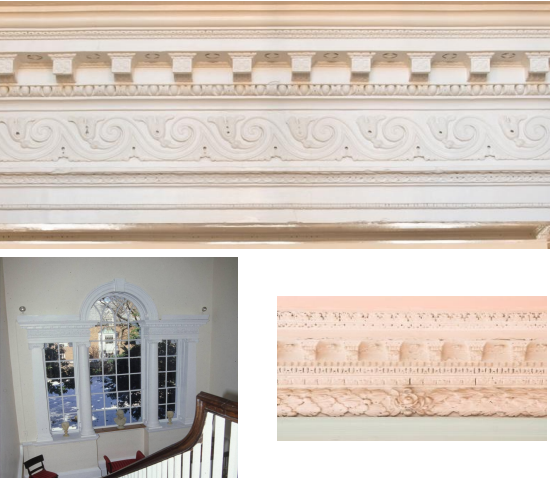
<p>The entablature of the Chase-Lloyd colonnade (top) is similar to that of the niche in many details: paneled architrave soffit, enriched split fascia and frieze, and an enriched modillion course. The Venetian window (lower left), the focal point of the large public landing in the Chase-Lloyd House, features a full entablature with a pulvinated frieze, decorated with leaves. A similar cornice in the James Brice House (lower right), features a foliate cushion frieze. (Top and right photos: Jeffrey E. Klee, Colonial Williamsburg Foundation, 2009; lower left photo: Orlando Ridout V, 2000.)</p>

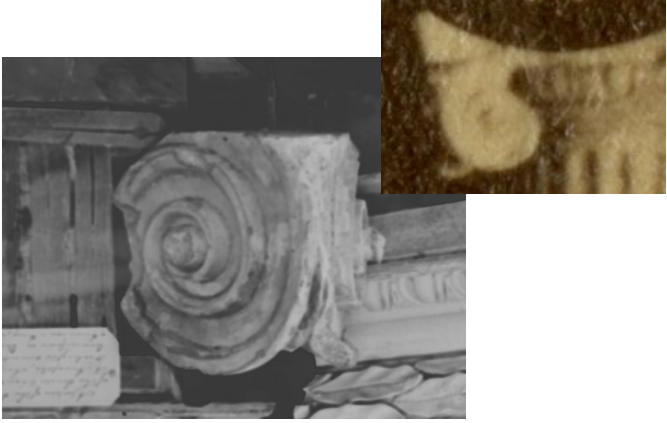
<p>A photograph of the gallery relics, captured by the Detroit Photographic Company in c. 1895 demonstrates that the capitals were made of plaster. The capitals of the niche were likely of the same material. The original location of the fragmentary volute is not known and it may have come from a capital of the niche as easily as one from the gallery: evidence points to both features as having been almost identical. In both the relics photograph and Wilson's sketch it is possible to see the volutes are decorated with fine foliate detailing that wraps partially along the spiral of the volute.</p>

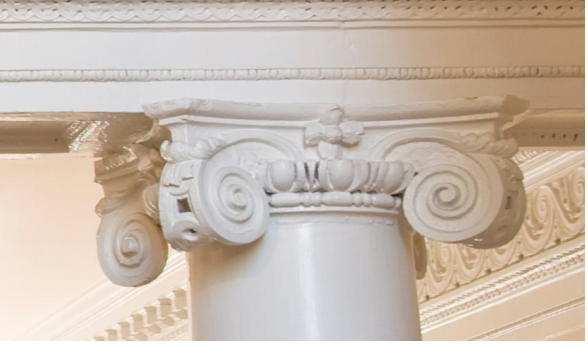
<p>The capitals of the Chase-Lloyd House are highly ornate, but the volutes lack the carved foliate details of the Senate Chamber capitals. (Photo: Jeffrey E. Klee, Colonial Williamsburg Foundation, 2009)</p>

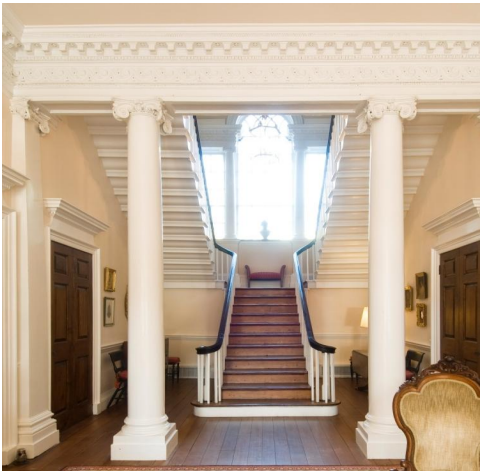
<p>The columns of the Chase-Lloyd House also exhibit slight entasis, but are not fluted. (Photo: Jeffrey E. Klee, Colonial Williamsburg Foundation, 2009)</p>

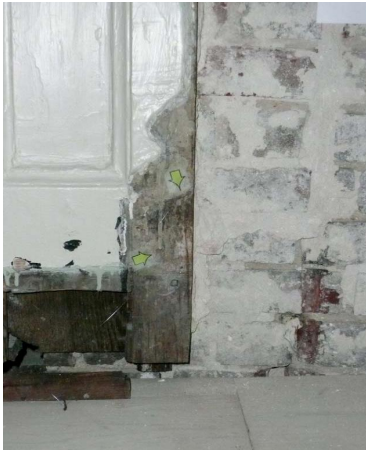
<p>Column Bases</p>

<p>J. Appleton Wilson noted the 1905 restoration recreated the columns based on photographs. Removal of the 1905 east column revealed a relatively clear outline of the base molding. This evidence, in coordination with Wilson's notes and measurements from the original columns on the gallery, will help to resolve the height and location of the base as well as the level of the dais and step.</p>

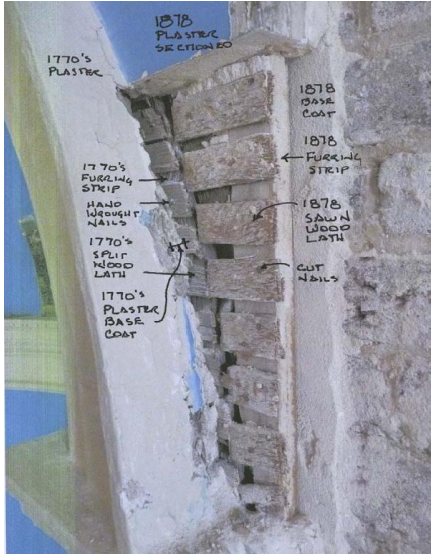
<p>The furring strip, riven lath and base coat of 1770s plaster survive behind the decorative carved architrave and wooden pilasters surrounding the recessed niche. As the only surviving 18th-century material in the Senate Chamber, further investigation of the niche is crucial to the restoration.</p>

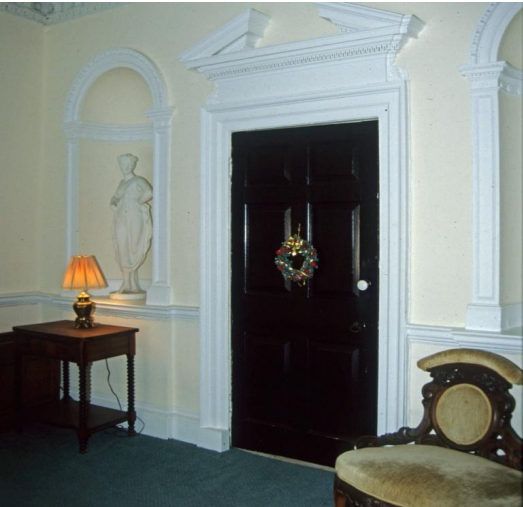
<p>The second-story landing of the Chase-Lloyd House (1769-1774) is a continuation of one of the finest public spaces in Annapolis. Two niches flanking an elaborately detailed door are framed with enriched architrave trim and a necking band framing the half-dome. These recesses do not extend to the floor but otherwise are nearly identical to the aedicule niche in the Senate Chamber. (Photo: Orlando Ridout V, 2000).</p>

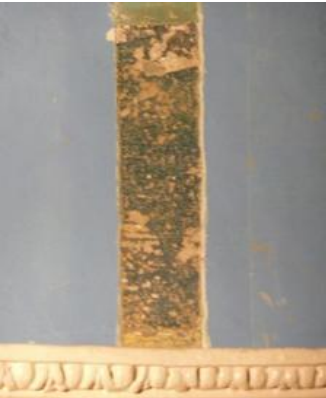
<p>(photo: John Greenwalt Lee Company, 2008)</p>

<p>Niche and architrave, paint</p>	<p>Paint investigation has identified numerous layers of finish in the recessed niche. Fragments of original wall plaster indicate that after an initial layer of whitewash, a decorative finish, consisting of a creamy yellow paint randomly stippled with a glaze to mimic the appearance of stone, was applied.</p> <p>The next layer has been identified as a plain yellow coat, evidently chosen to match the faded faux-stone finish. This was likely in 1825, when documents indicate the room received a yellow wash. Throughout the later 19th and 20th centuries, numerous blues, greens and whites followed.</p> <p>Evidence indicates that the trim in the Senate Chamber was originally painted a grayish, stone color providing a subtle-two tone appearance.</p>

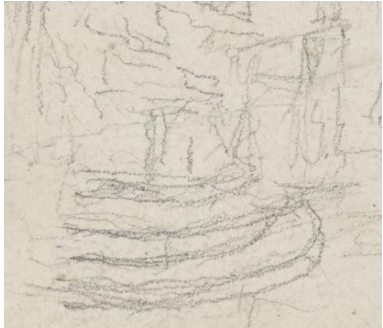
<p>Four images of the dais steps from larger works, clockwise from upper left: Benson Lossing, Edwin White, John Trumbull, and Francis Mayer (for full images and citations, see above).</p>	<p>1905: Niche The niche itself was intact & a photograph gave the rest in connection with fragments which were preserved. The height of platform was shown on floor of niche. Shape of platform from draw in Columbia [sic] Magazine. Undated and unsigned. Probably J. Appleton Wilson's notes re: "Reasons governing the Committee on restoration of the Senate Chamber at Annapolis for the interior detail." (Maryland Historical Society, Wilson Papers Collection, MS 833 - Box 6)</p>

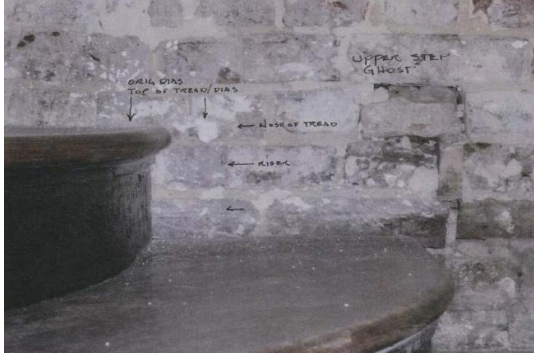
<p>Photo: Removal of 1876 plaster and lowering of the 1905 dais reveals ghosting of original dais. (John Greenwalt Lee Company, 2008)</p>

<p>Photo where dais has been: lowered by one riser to approximate original height. John Greenwalt Lee and Company, 2008.</p> <p>The dais is the least clearly understood element of the rostrum. The original dais survived until the 1876 renovation work in the Senate Chamber, when it was demolished along with all the projecting elements of the rostrum. It is depicted in all of the various sketches of the 19th century, but is not visible in the 1868 stereograph. The 1905 restoration constructed a semi-circular platform with three risers, based on the schematic representation in the Columbian Magazine plan. Contrary to the evidence of the this plan, Trumbull, White, and Mayer all depict the dais with two risers—Mayer most clearly so. Only Losing dissents, depicting only one riser. During the phase I investigation in 2008, potential evidence was identified that supports the notion that the dais was lower. Ghosting from the bases of the original columns is visible on the pilasters at a lower level than the 1905 bases. Also, indications on the north wall suggest the dais was originally larger in diameter.</p>
