Old Senate Chamber

Gallery Evidence Investigation (Round One: November 2010)

John Greenwalt Lee Company Investigative Team:

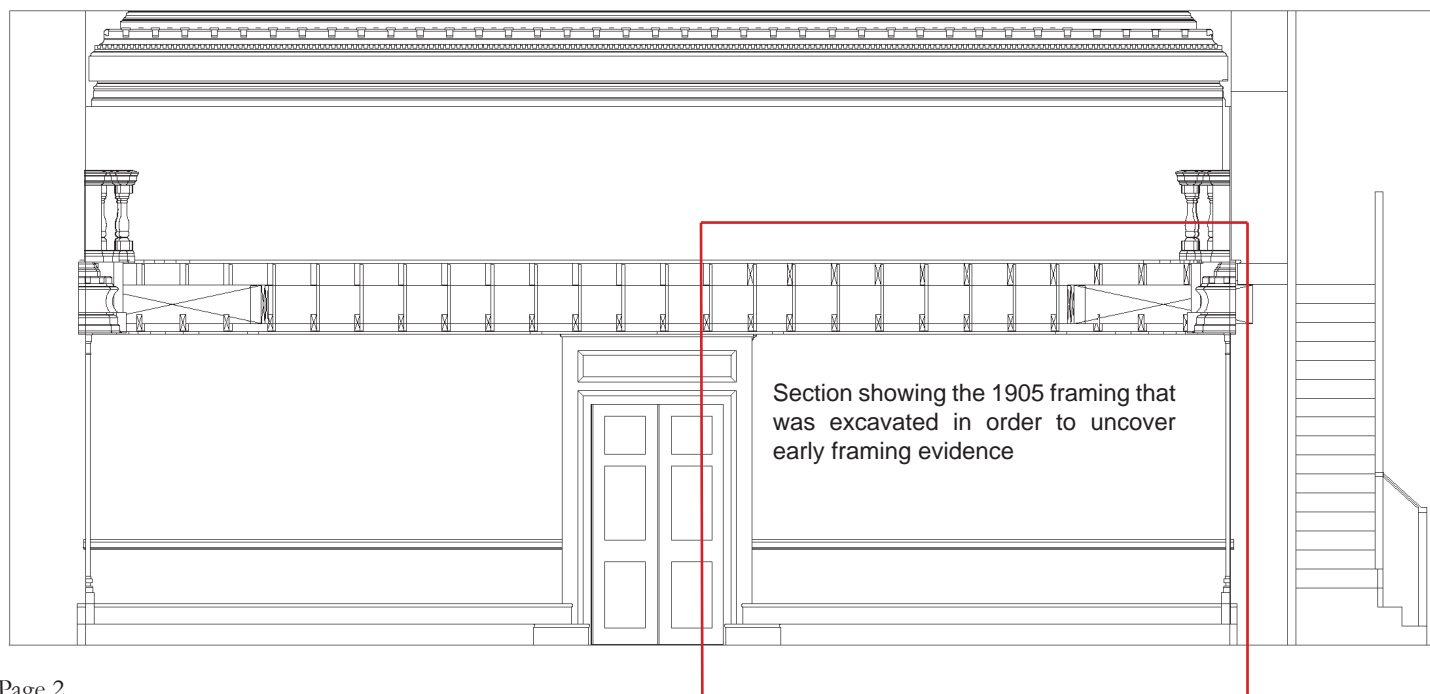
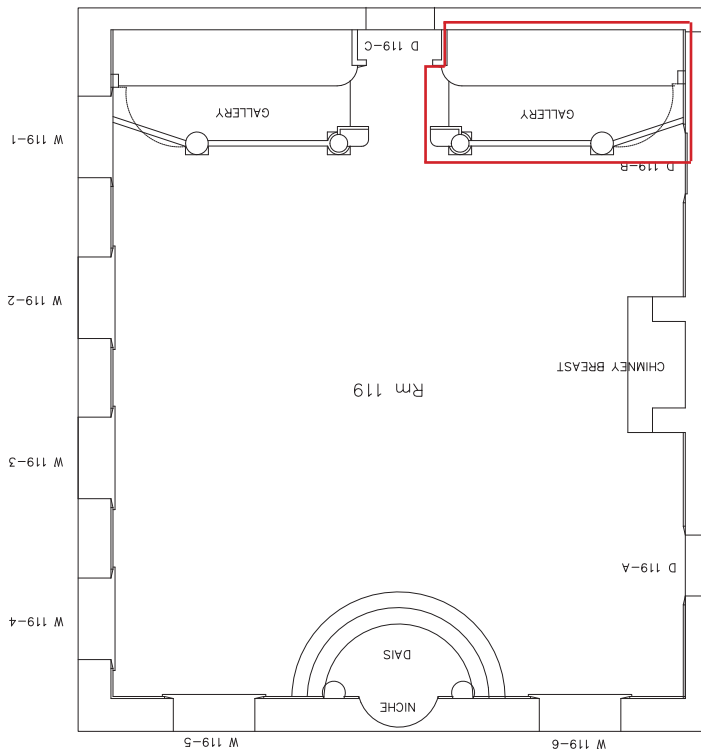
The red outlines approximate the boundaries of the work. The entablature of the 1905 gallery was excluded from the selective demolition. The wainscot between the columns, the seating risers, the ceiling of the lower level and enough of the floor of the balcony to easily expose the back wall for clear investigation was included. The connection with the side wall was opened to the extent possible, short of cutting back the entablature.

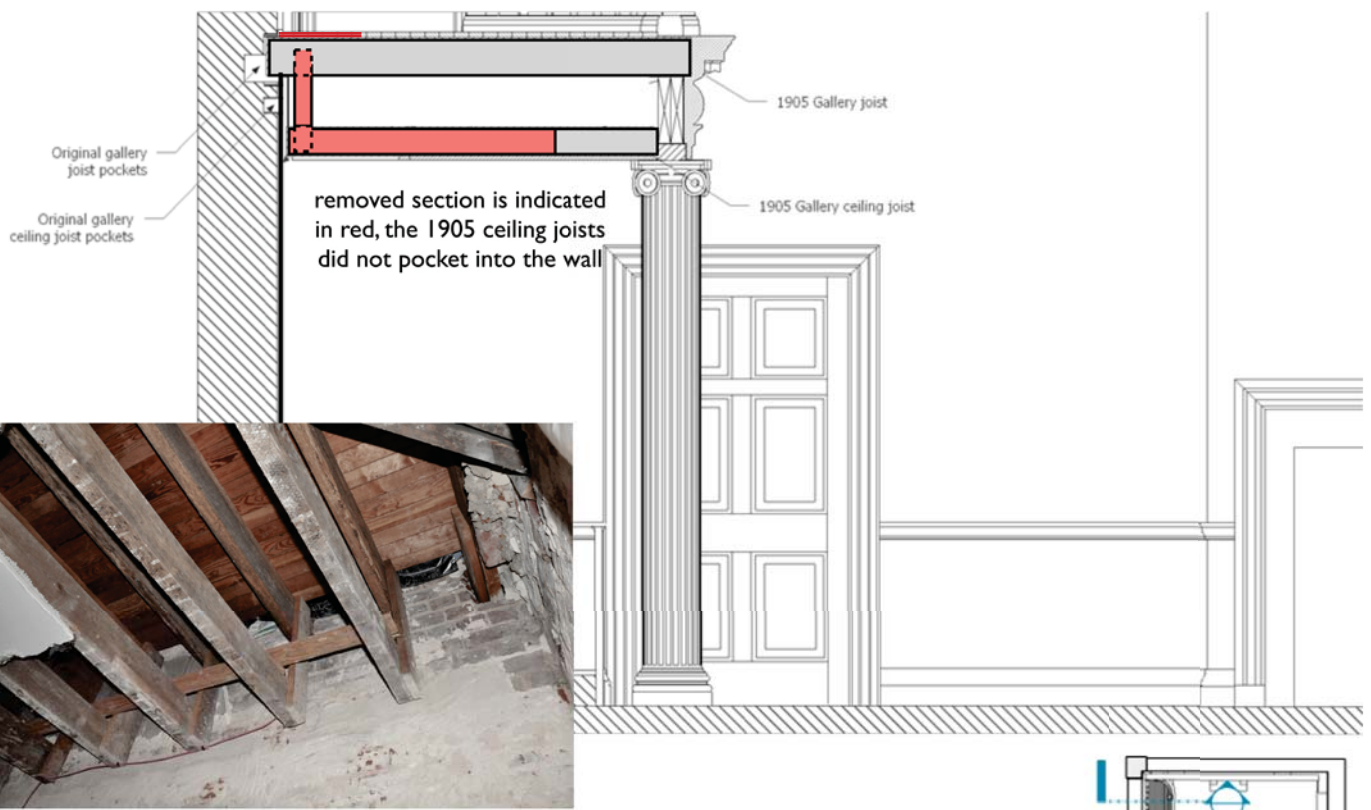
After removing a significant portion of the underside ceiling, the ceiling joists were also cut back to provide a better view of the back wall. These joists were hung from the floor joists on the wall end and thus, after removal, there were no scars on the back wall to confuse the pattern of the original framing. To that end, the 1905 floor joists were not removed, allowing them to clearly mark their own positions and again add clarity to the evidence. Work proceeded carefully and methodically attempting to insure that evidence was not damaged in the process of finding it.

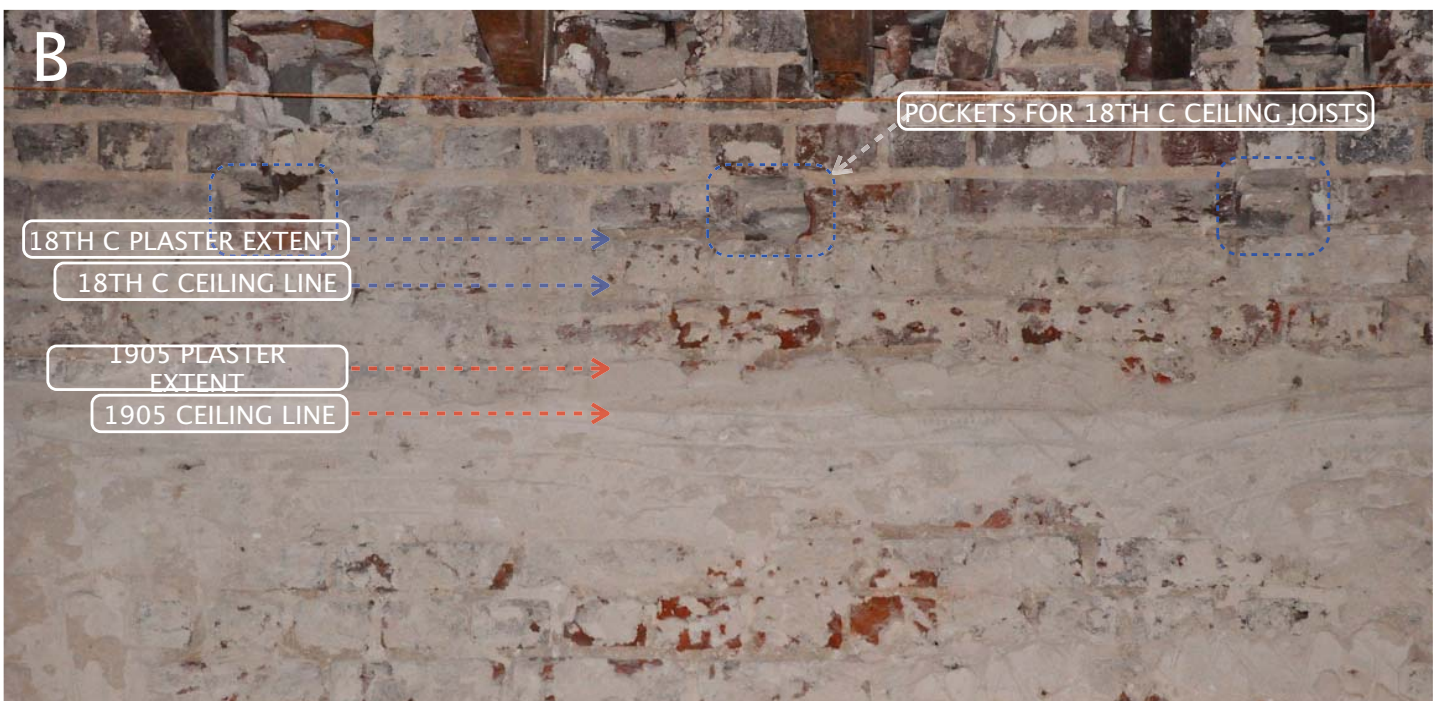
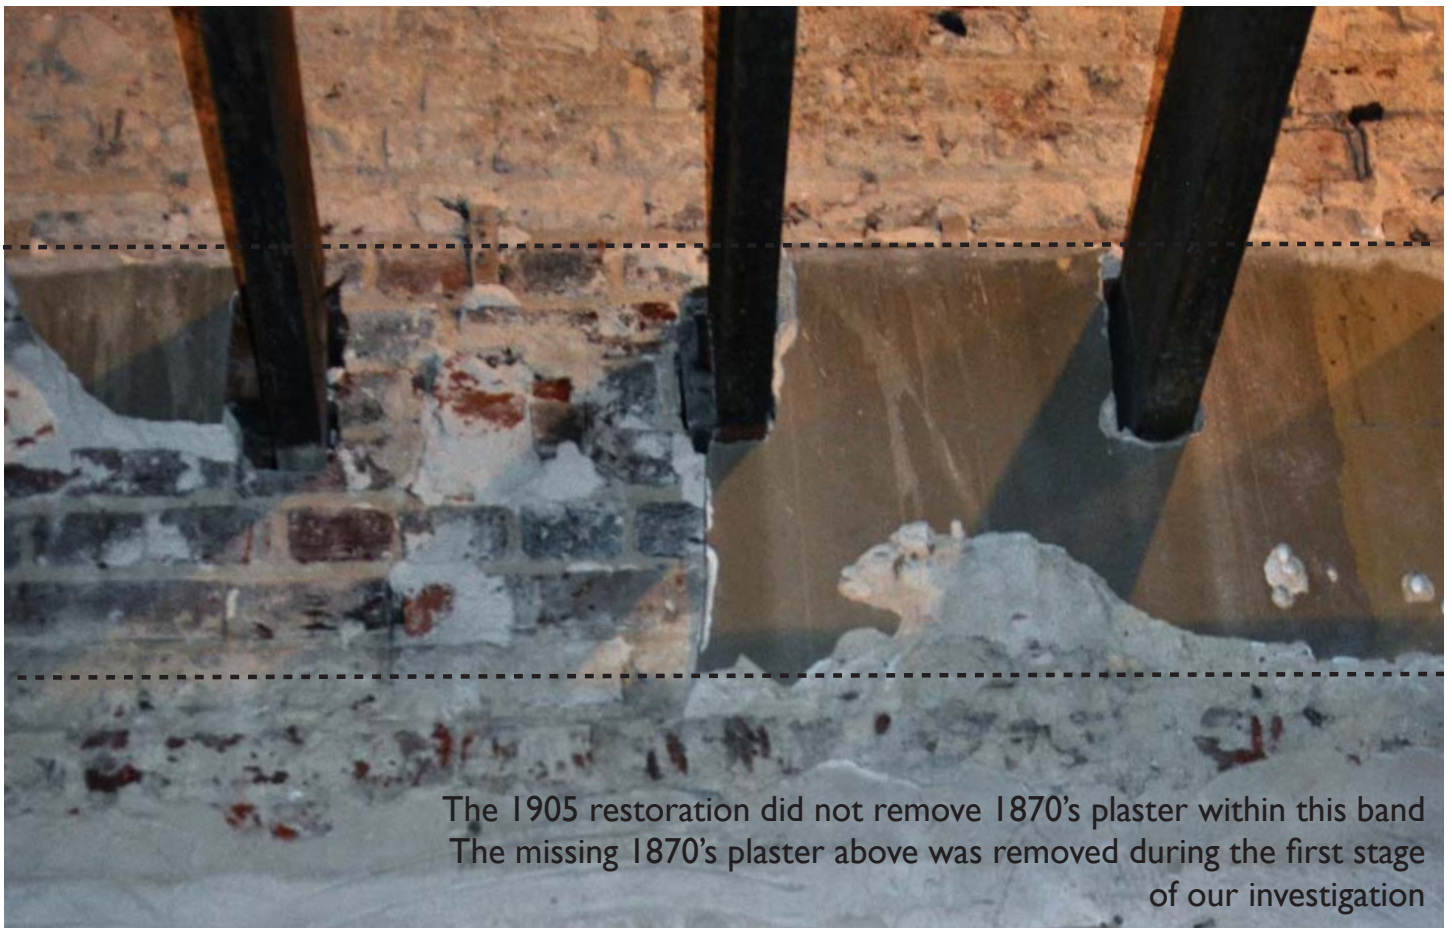
The ceiling line and top of 1905 plaster was established as the ceiling was being removed and while the joists were still in place to clearly define the location (A). With the 1905 ceiling joists out of the way and the remains of 1870s plaster removed, establishing the 18th c. ceiling and top of plaster was straightforward (B).

The original ceiling location does not raise the architrave, thus the beam of the architrave is exposed as an architectural element, visible and decorated on both sides and paneled below. This creates a coffered effect, a typical classical detail. In contrast, finishing the ceiling flush to the top of the column capitals, as was done in 1905, would have been unusual in the 18th c.

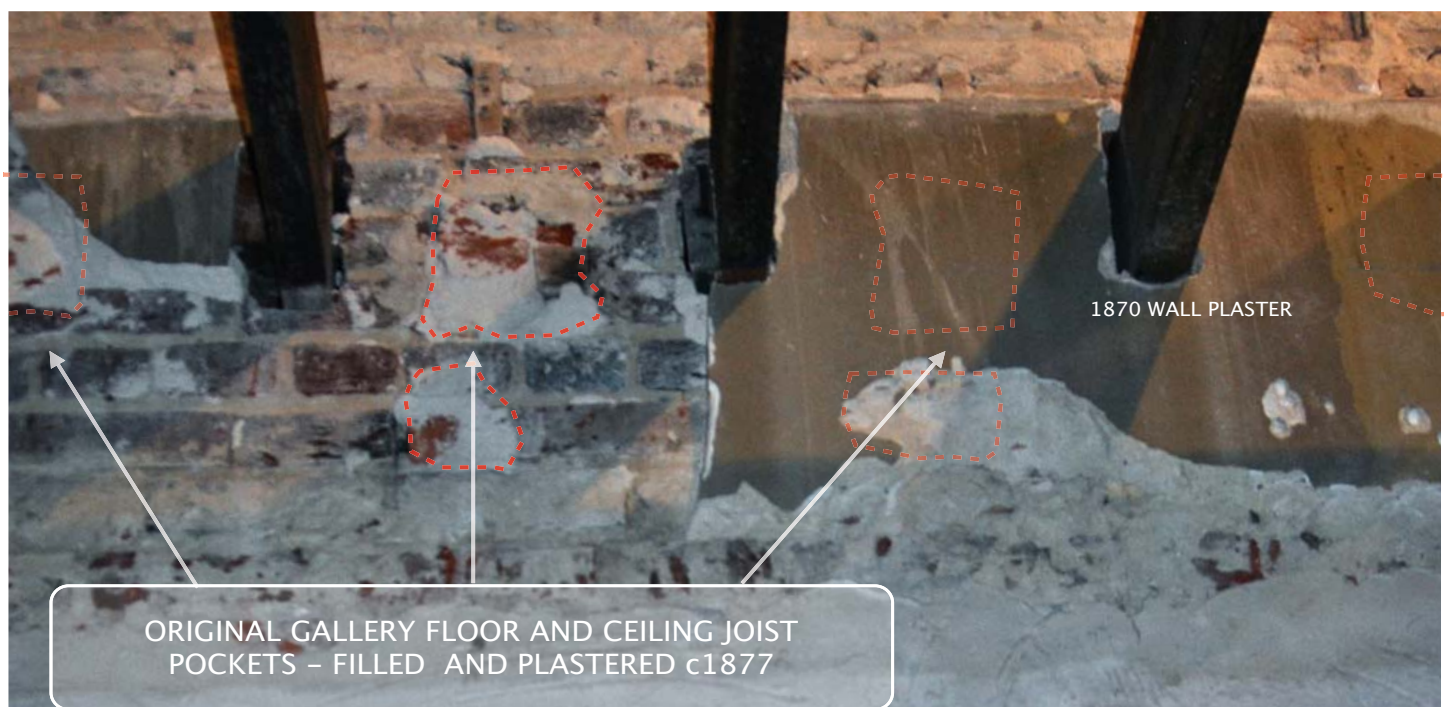
The 1905 reworking of the room punched holes through remnants of 1870s plaster directly into the masonry wall to hang the gallery joists. (In other words, the 1905 gallery was constructed without consideration for the earlier evidence and they just happened to hit

the edges of some of the original joist pockets, which had been filled with plaster and brick bats in the 1870s). The entire space between the bottom of the 1905 gallery ceiling and the 1905 gallery floor above still had 1870s plaster when we began our initial investigation.

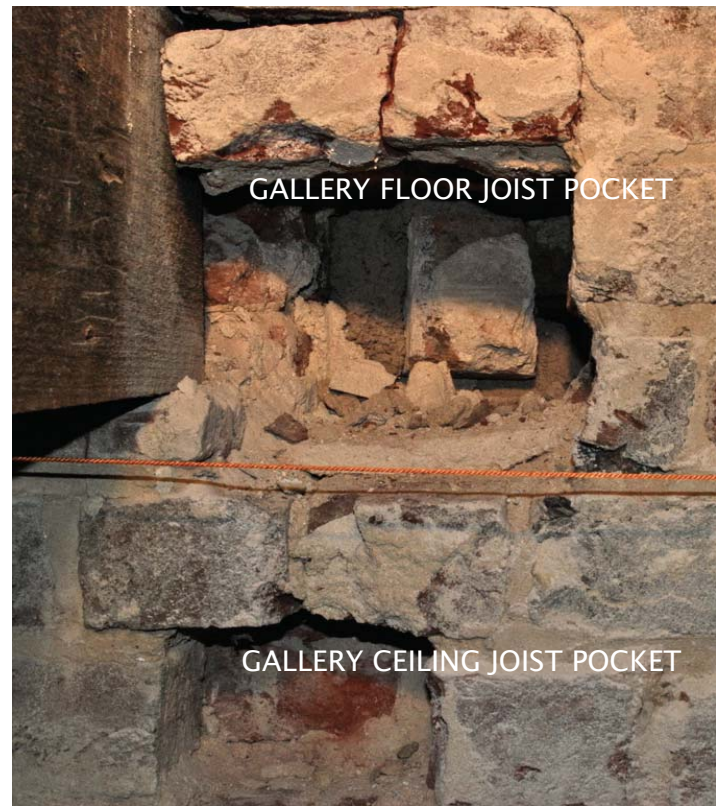
PHOTO OF ORIGINAL PLASTER FRAGMENT RECOVERED FROM AN OPENED JOIST POCKET

In the Old Senate Chamber the 1870s plaster and brick bat infill was removed revealing only one fragment currently identified as significant: plaster with a nice series of paint finishes. It has not yet been microscopically analyzed. A visual inspection shows it to have many of the colors found in the early Senate fragments but it has a sand texture for the first finish. None of the other early fragments have a sand finish. The pocket in which it was found appears to have also been open to the Great Hall/ Rotunda of the State House and may indicate the early finishes there. Sanded finishes were not unusual in fine 18th c. houses, especially in entry halls. The Brice House has a yellow sand finish entry while the other formal spaces had smooth finishes.

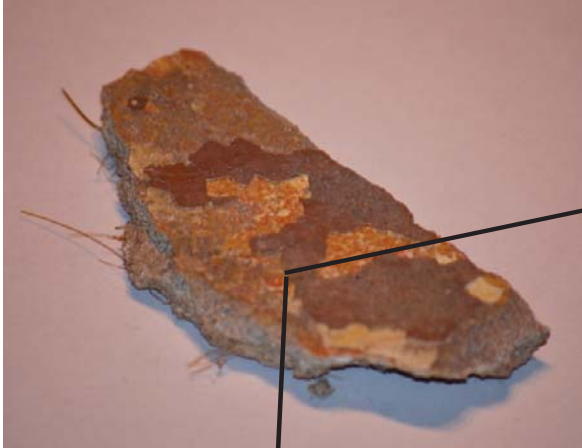
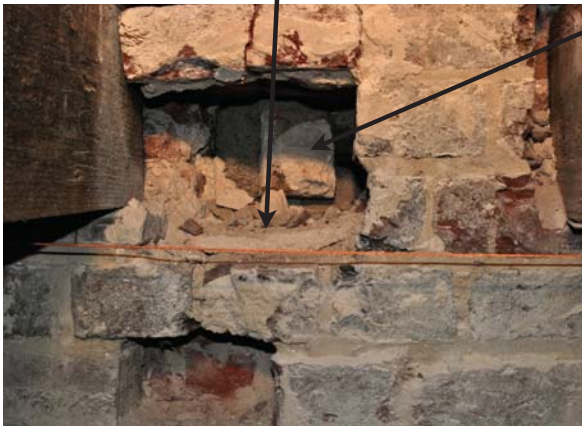
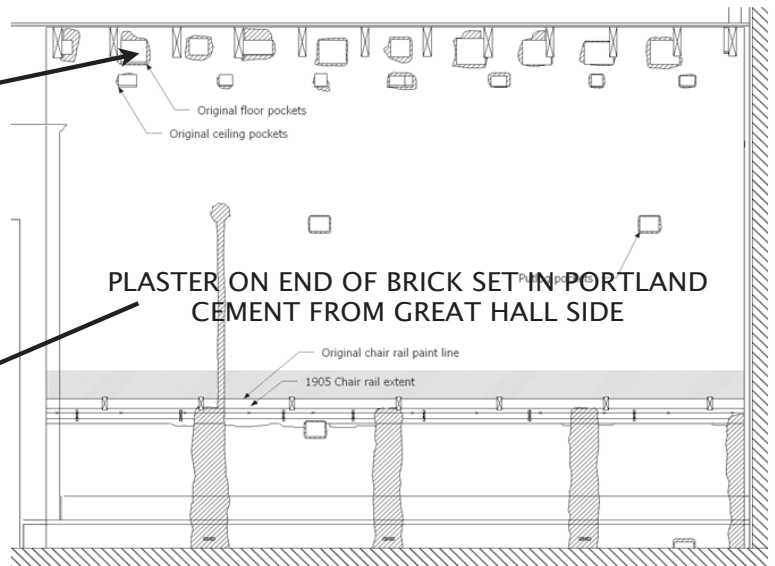
THE FINISHES ON THE LOOSE 18TH C PLASTER
FRAGMENT DO NOT VISUALLY RELATE TO THE
CURRENTLY KNOWN FINISHES FOR THE OSC,
AND THEREFORE MAY BE FROM THE GREAT HALL
(IT APPEARS TO START WITH A SANDED FINISH)

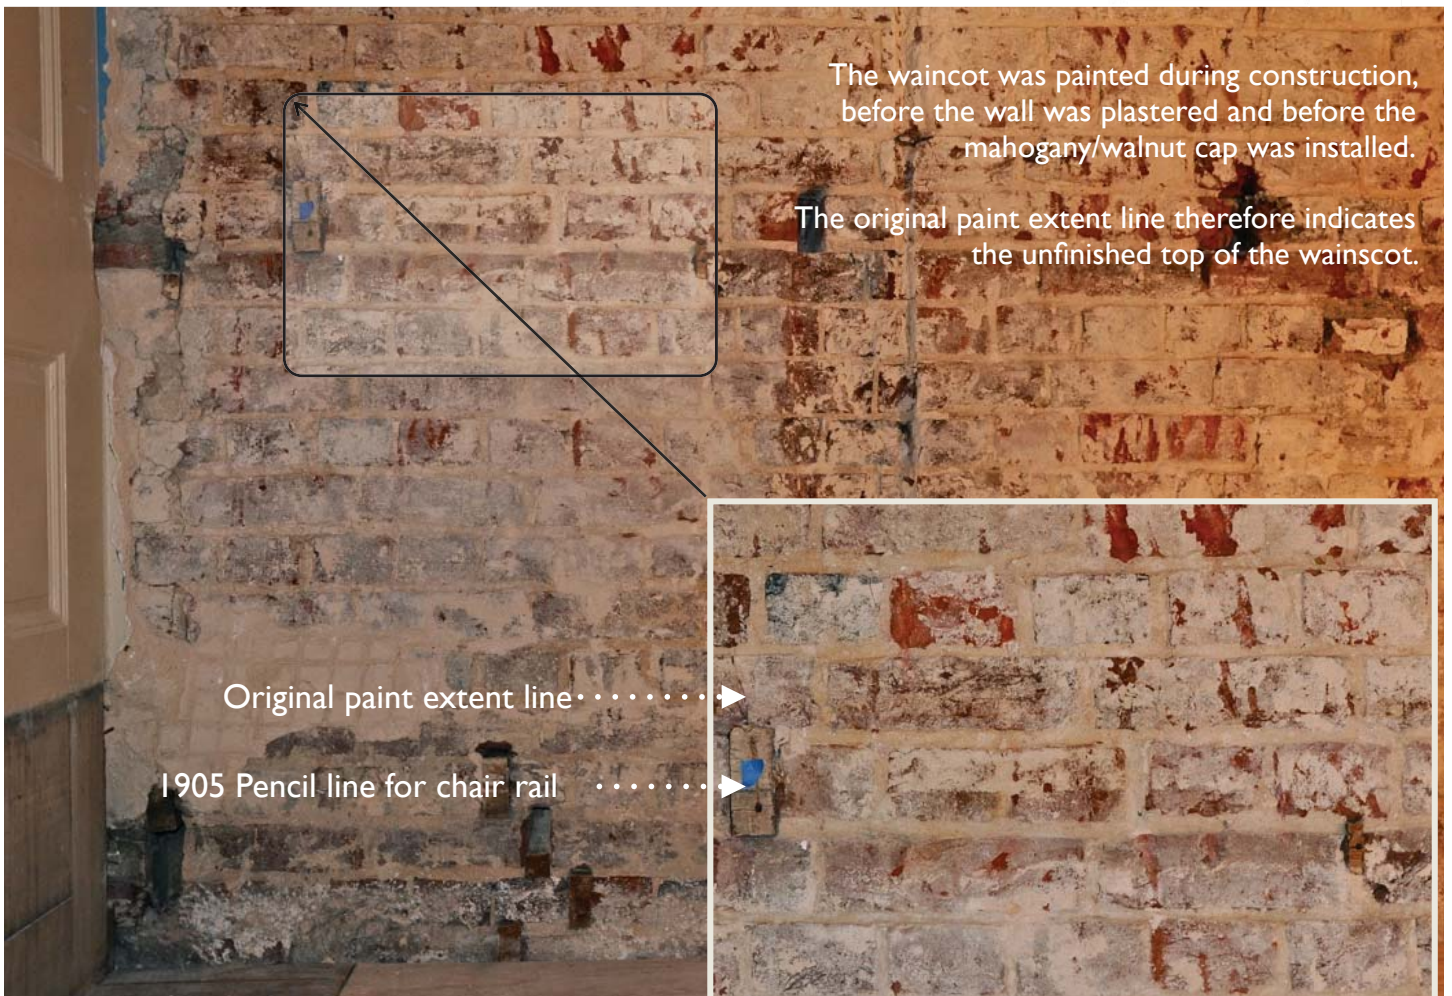
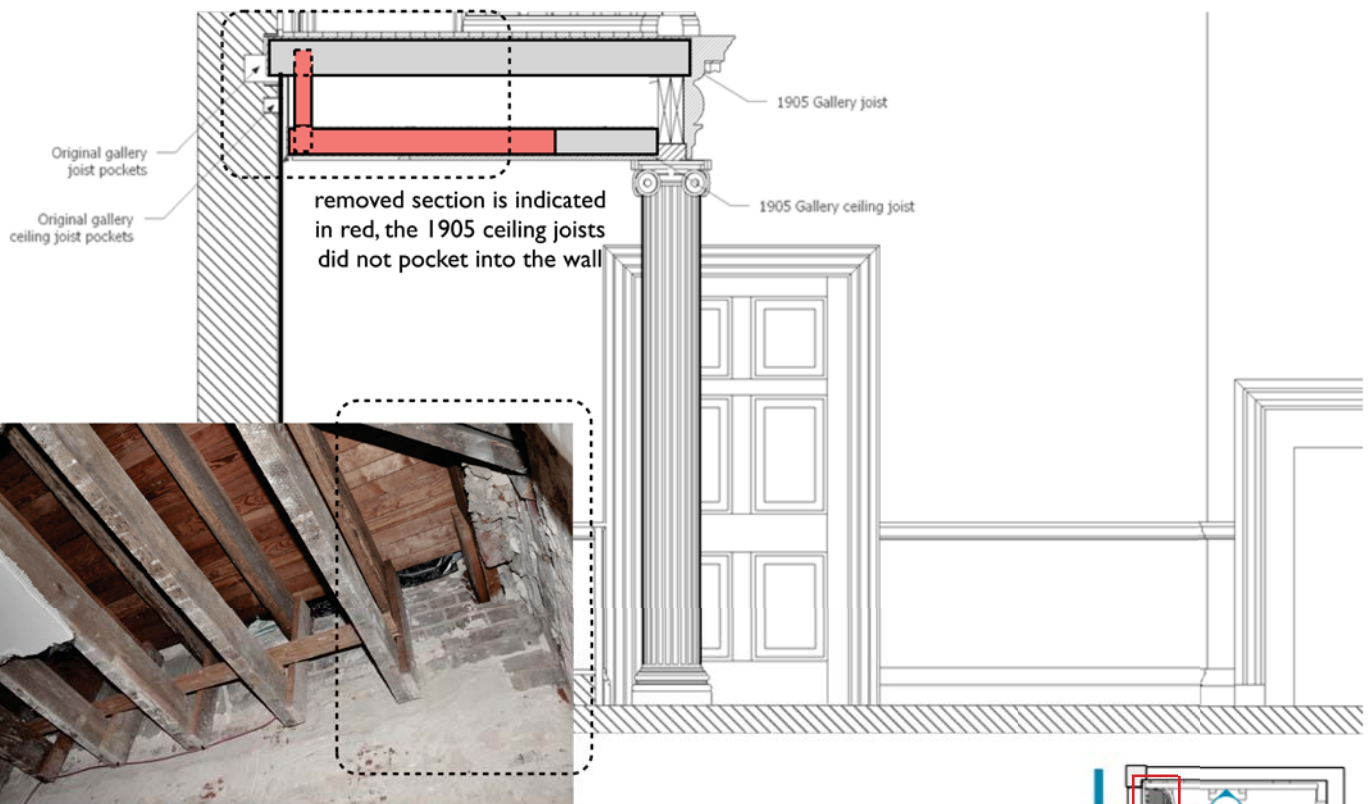
The wainscot was painted during construction, before the wall was plastered and before the mahogany/walnut cap was installed.

The original paint extent line therefore indicates the unfinished top of the wainscot.

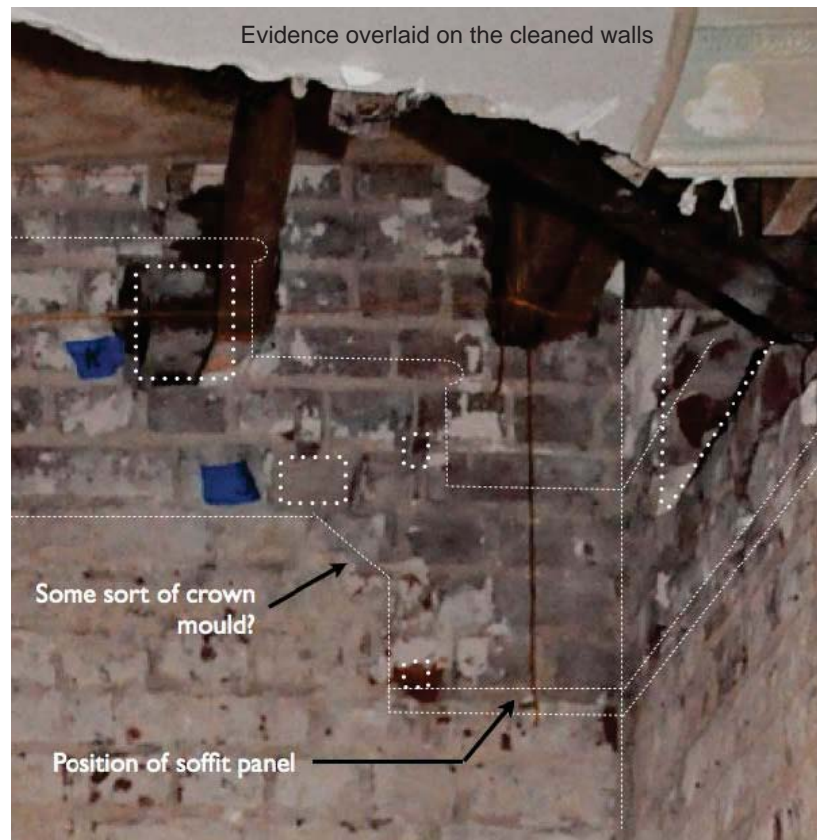
Probably the most unexpected finding was that the false entablature beam returning to the back wall masked two steps down from the balcony floor to the doorway in the masonry wall. As we slowly unpacked the 20th c. brick fill below the current door, it became clear that the historic masonry opening was noticeably lower than the current balcony floor and over a foot lower than the original floor. Then we noticed that there were no 18th c. floor joist pockets in the back wall within two feet of the door. This, coupled with the way the ghost of the floor section drops as it approaches the door, helped the evidence fall into place. The entablature beam ran to the back wall as a hollow plaster and wood armature, providing plenty of space into which to fit the descending stair. The panelled soffit is carried on the pilaster. Classical grammar requires that the edge of the soffit align with the neck of the pilaster making the pilaster almost square.

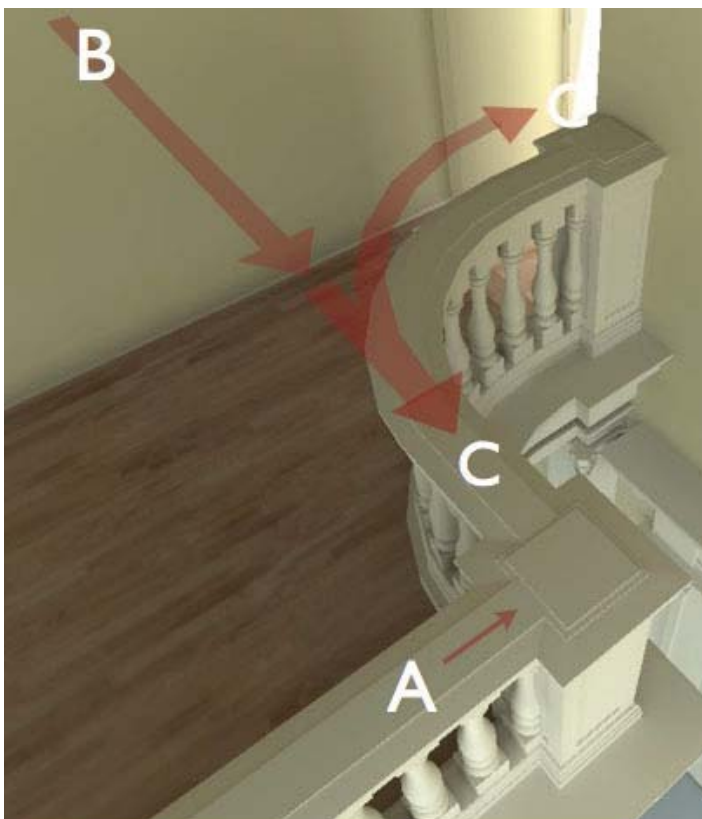
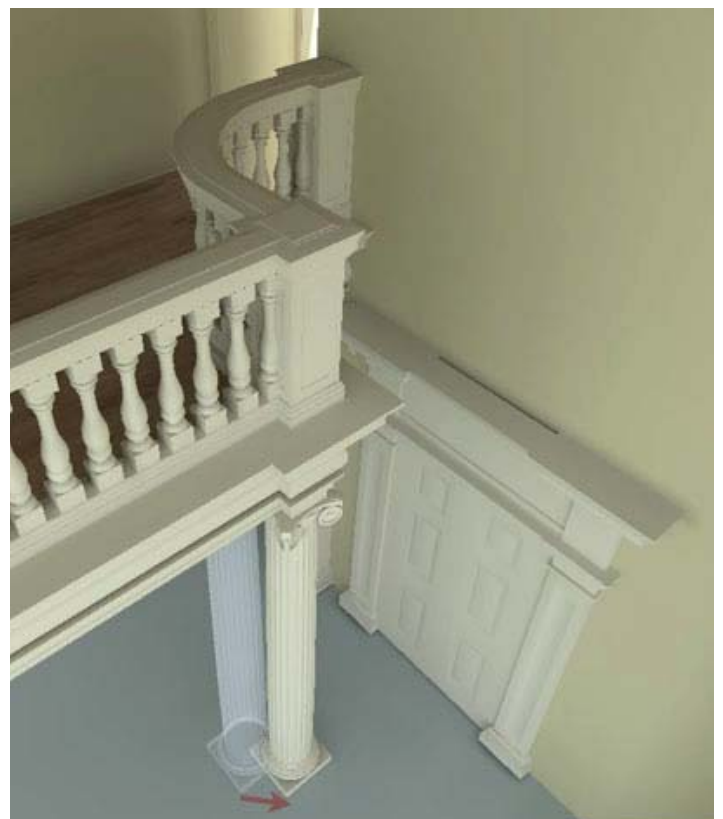
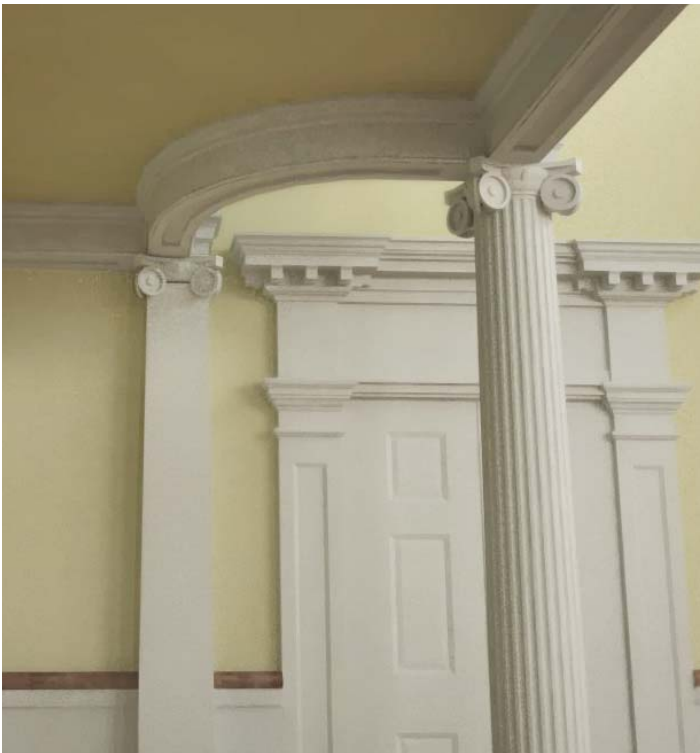
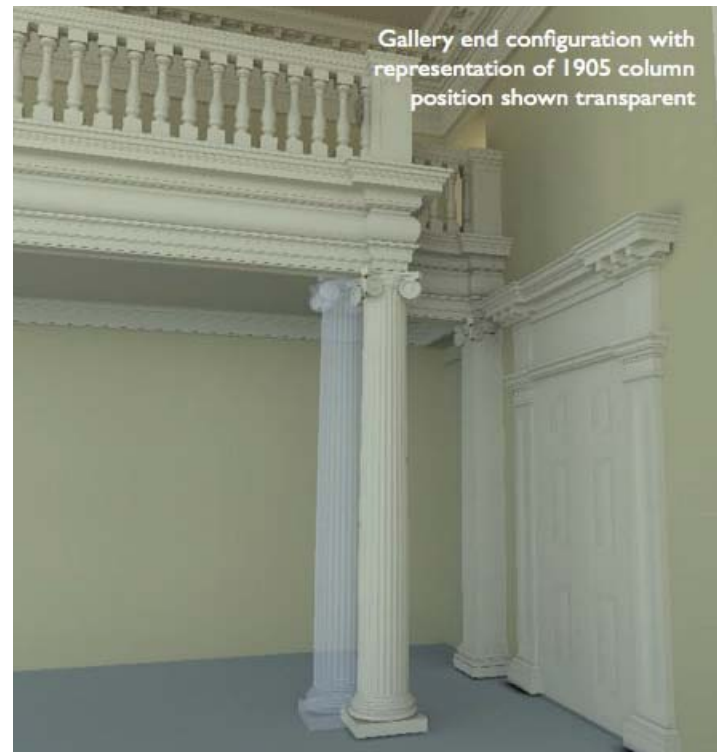
Positioning the Columns

Based on the original location of framing members indicated by the joist and girder pockets, we reconstructed the layout that would define the position of the end column. It is typical to have a timber/joist occur at the end of the beam that sits atop the row of columns. Knowing from the 1868 photograph that the 1905 column should be closer to the end wall, we located the joist pocket just to the right (toward the end wall) of that column position and placed a computer joist in the pocket. Then by placing another joist centered above the pilaster on the end wall, the primary framing at the end was established.

A concave curve is the most likely ending for the gallery. (See following pages to understand the awkwardness that would be caused by applying any of the convex options). Allowing for the necessary pedestal above the almost square pilaster, an arc was struck that defined the face of the entablature and the position of the pedestal above the end column. In the far upper left drawing, the blue column base is the 1905 column location and the red base is the reconstructed location.

This position and the concave ending elegantly accommodate the false door and overdoor without creating any conflicts or areas that would be impossible to paint or clean. Likewise on the opposing wall, the concave entablature would swing past the window. The proper column position also creates a more commodious balcony footprint.

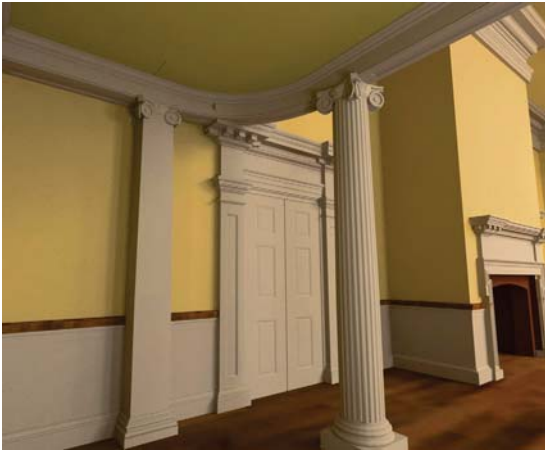
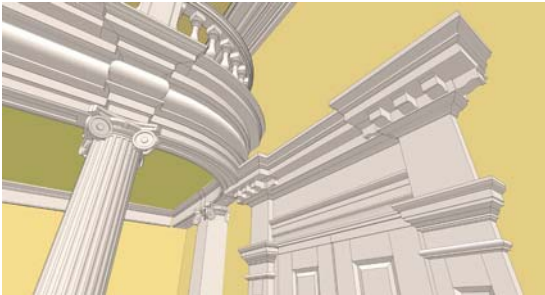
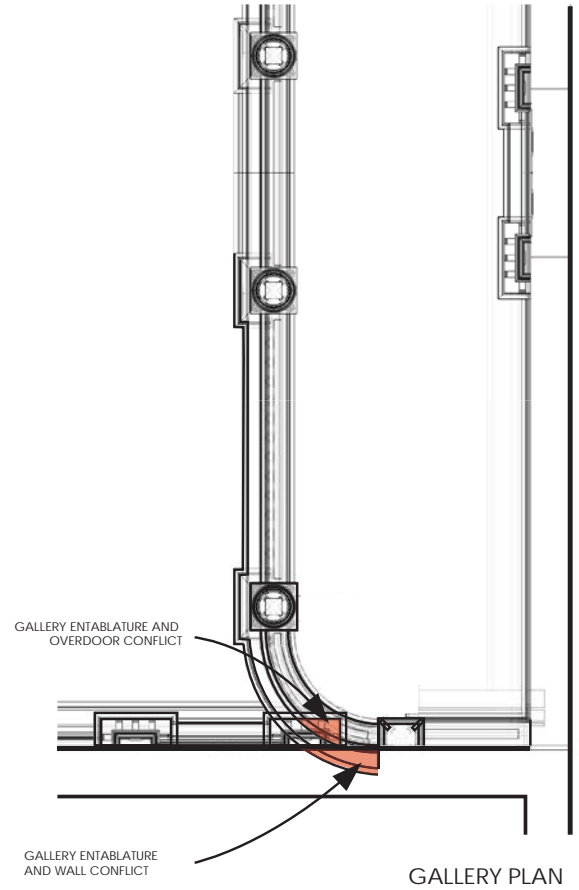
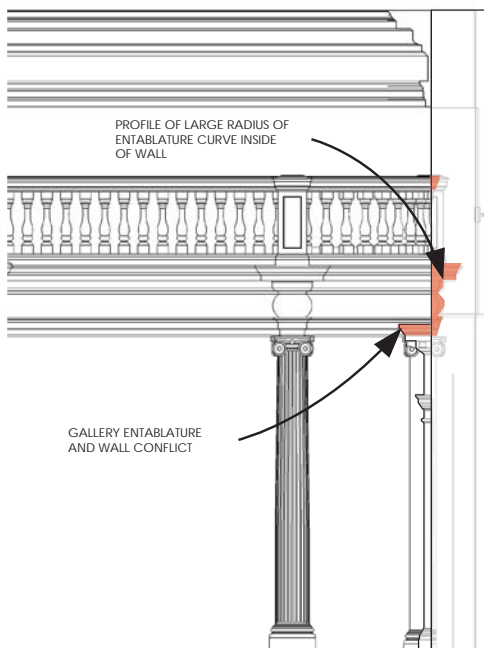
LARGE RADIUS CONVEX CURVE

The following pages graphically describe the “train wreck” that occurs when the gallery terminates with convex ends. If the entablature arcs directly into the pilaster, all of the projecting cornice buries itself into the wall, creating a very awkward overlap intersection with the overdoor.

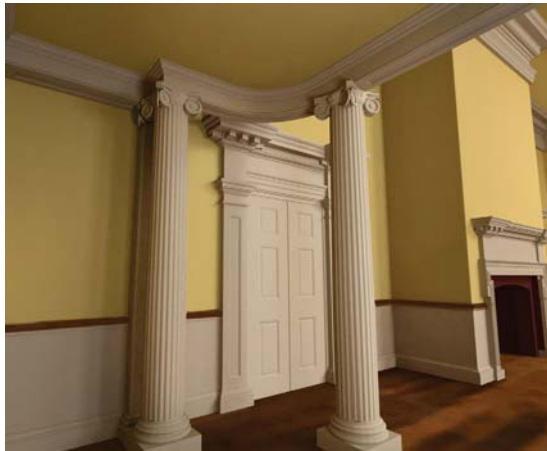
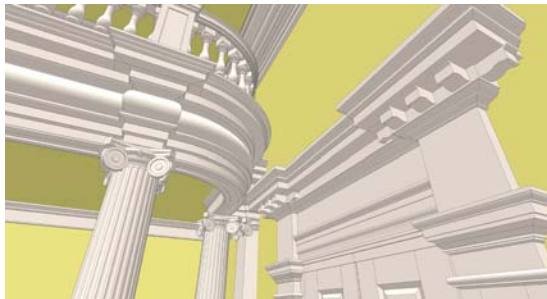
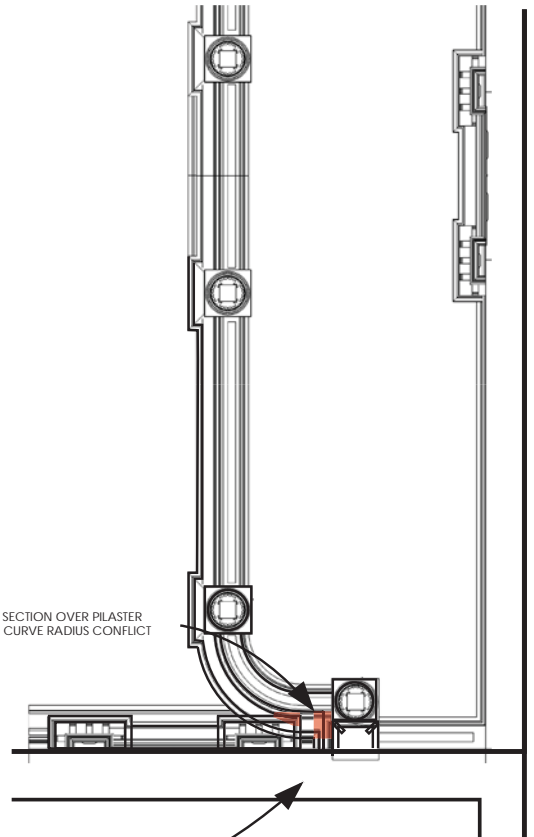
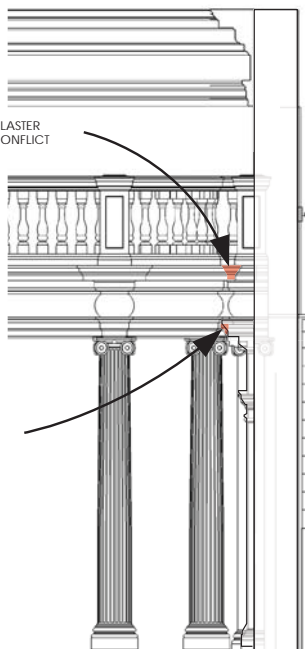
SMALL RADIUS CONVEX CURVE WITH DOG-LEG AND COLUMN

If the entablature arcs in a tight curve that misses the wall, it must then turn 90 degrees to enter the wall directly above the pilaster. This still conflicts with the overdoor although in a much less drastic manner. The result is an unsupported corner for the entablature beam. Since most classical architecture is based on stone construction, this unsupported corner would create a dilemma. While this feature can physically be constructed in wood and plaster, construction in stone would require a support. Therefore most 18th c. designers would place a column there abutting the pilaster. A lot of extra work for a solution that still does not solve the conflict.

ENTABLATURE SECTION OVER PILASTER
CAPITAL AND CURVE RADIUS CONFLICT

GALLERY ENTABLATURE
AND WALL CONFLICT
