# VIOLET BANK CEMETERY

STONE WALL CONSERVATION

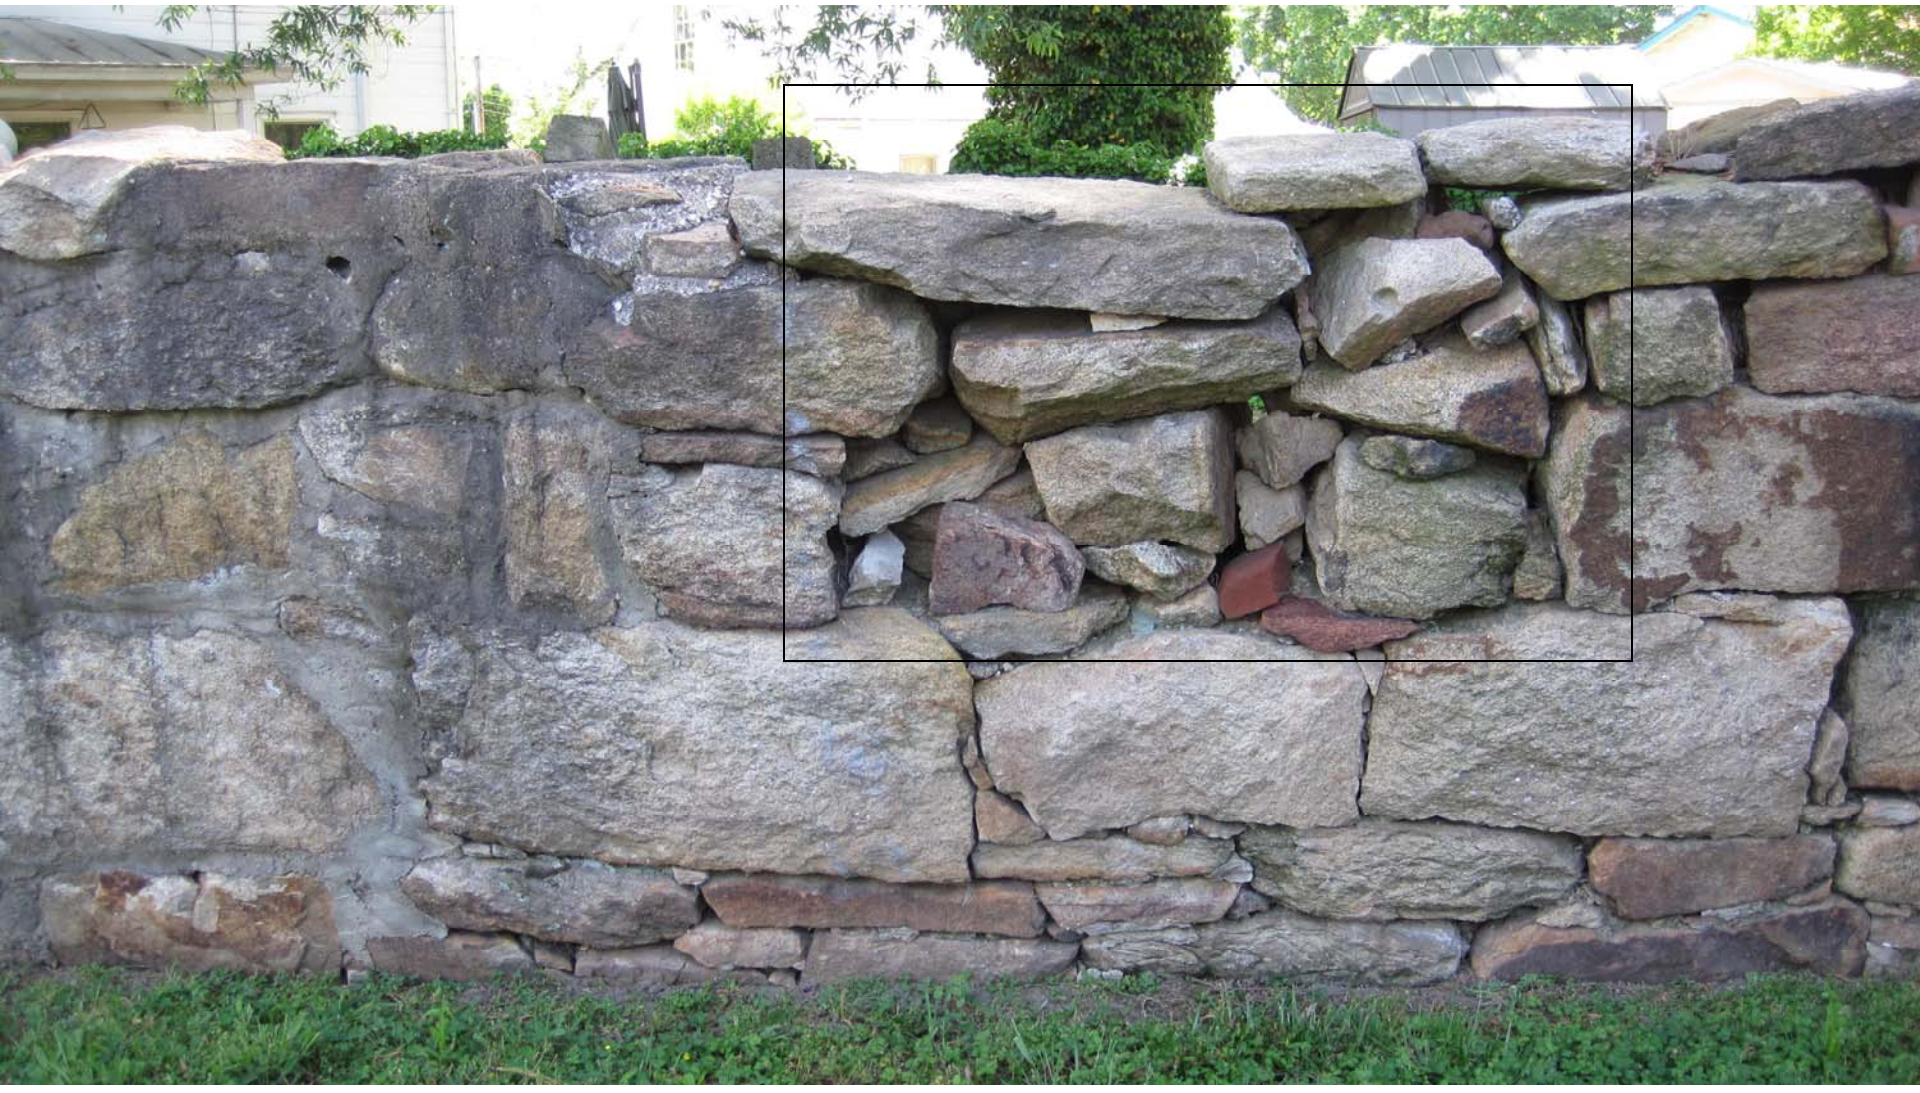
# VIEWED FROM OUTSIDE

PRIOR COLLAPSE  
UNSTABLY LAYED AS A LEANING  
JUMBLE OF STONE

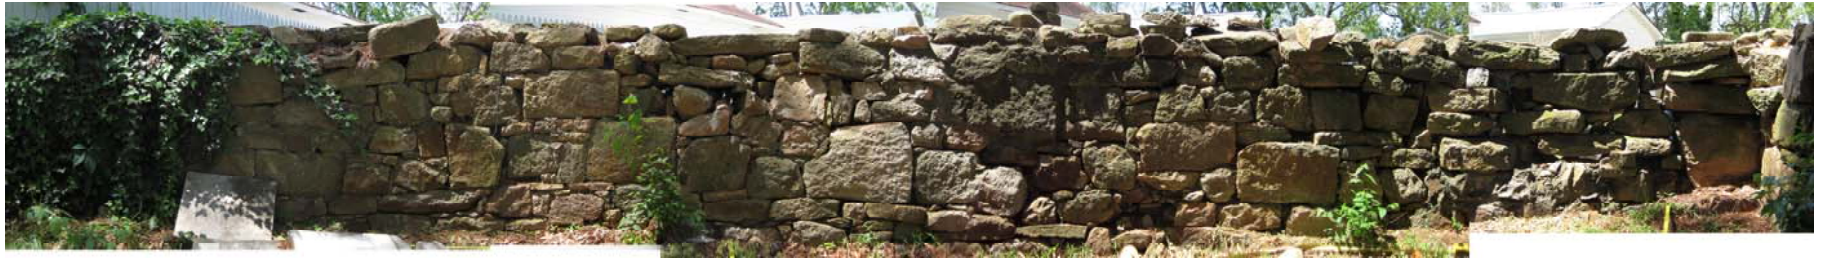
WALL VIEWED FROM INSIDE THE CEMETERY

THE WEST WALL IS ALSO  
LEANING AND

APPEARS TO HAVE COLLAPSED  
IN TWO PLACES THAT HAVE BEEN  
POORLY REBUILT

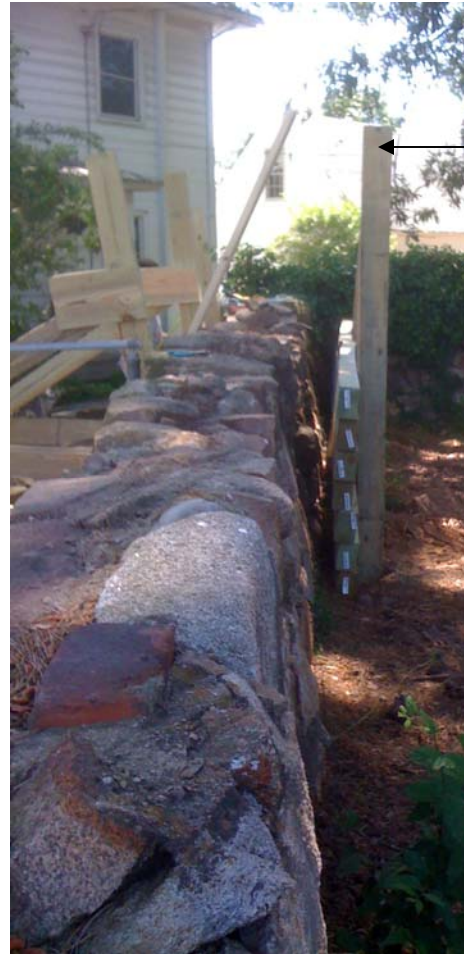
# STRAIGHTENING THE NORTH WALL

THESE POSTS ARE VERY CLOSE TO VERTICAL.

THE CRIBBING IS TEMPORARILY SHIMMED OVER TO THE WALL FOR SUPPORT AND CONTROL.

AS THE WALL IS STRAIGHTENED THE SHIMS ARE REMOVED UNTIL IT IS VERTICAL.

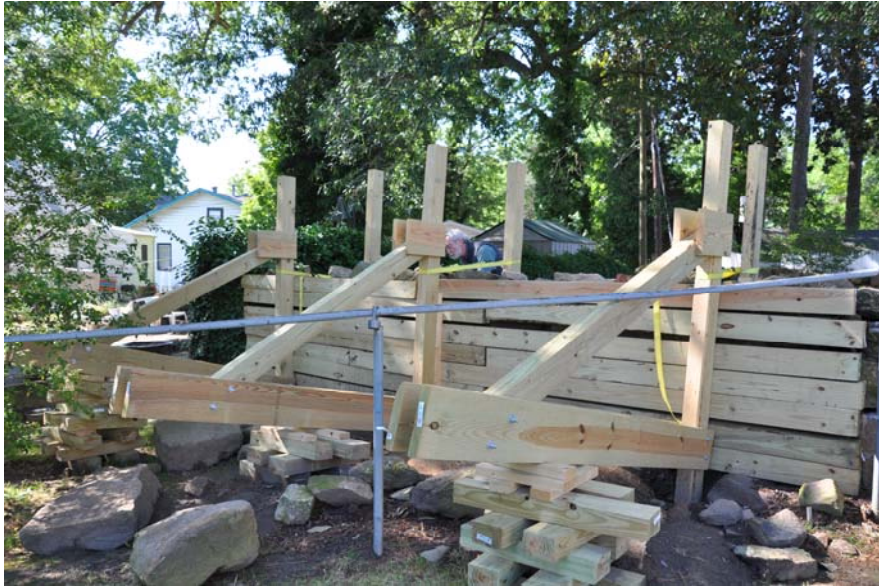
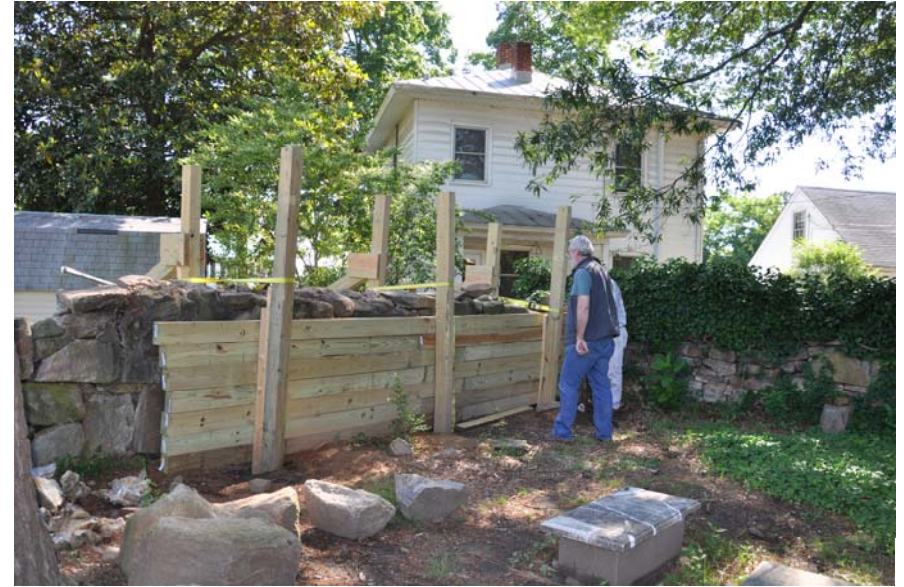
# POSTS ARE NOW PARALLEL AND VERTICAL

WITH THE WALL SANDWICHED IN BETWEEN

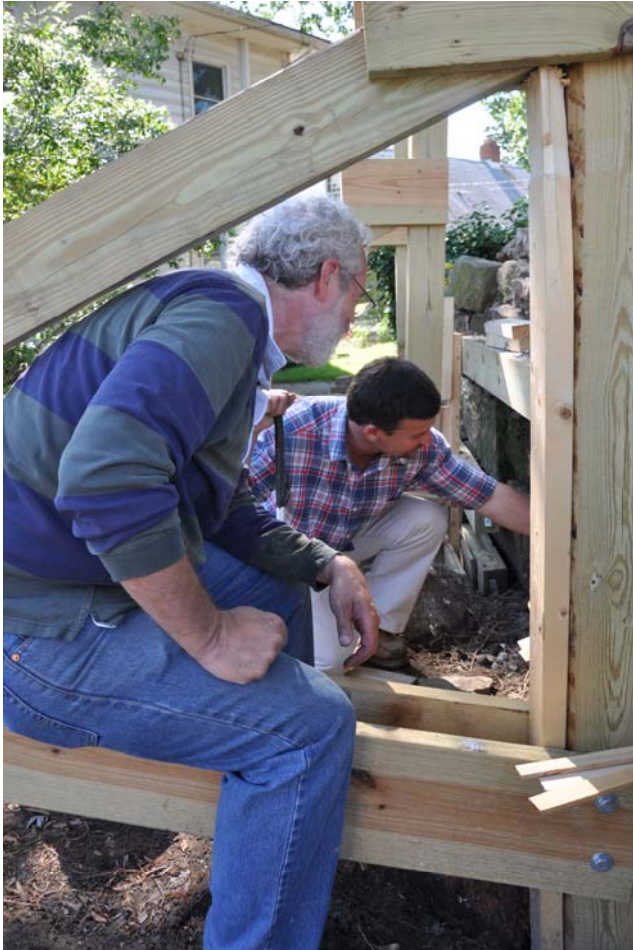
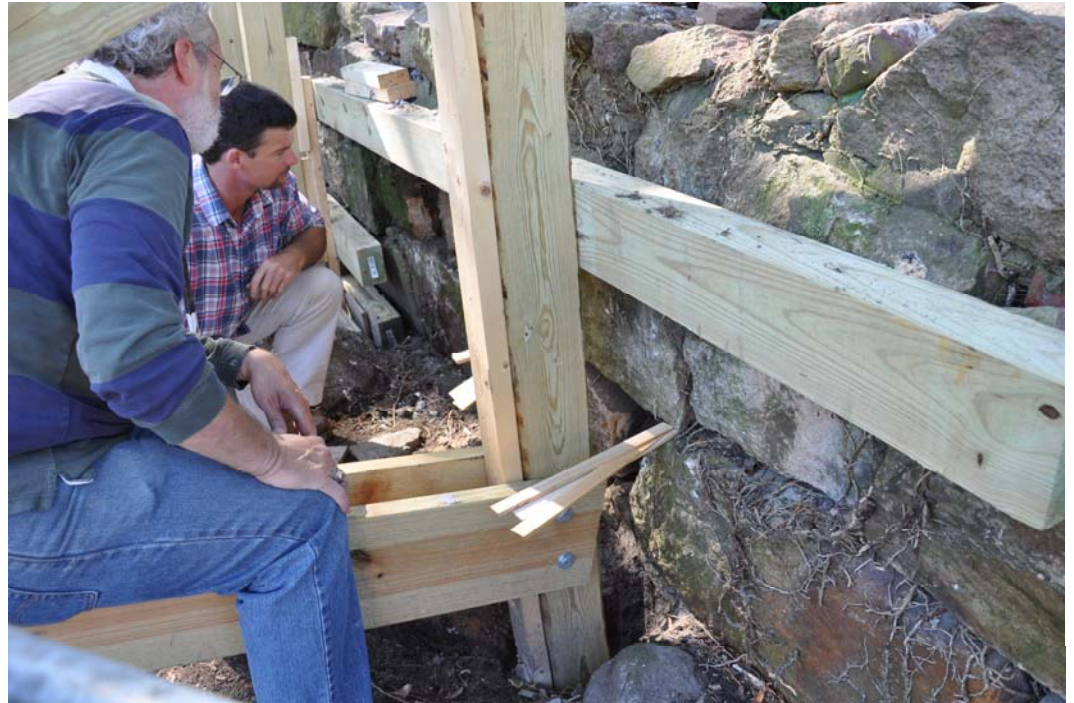
# SOMETIMES IT JUST WILL NOT BUDGE

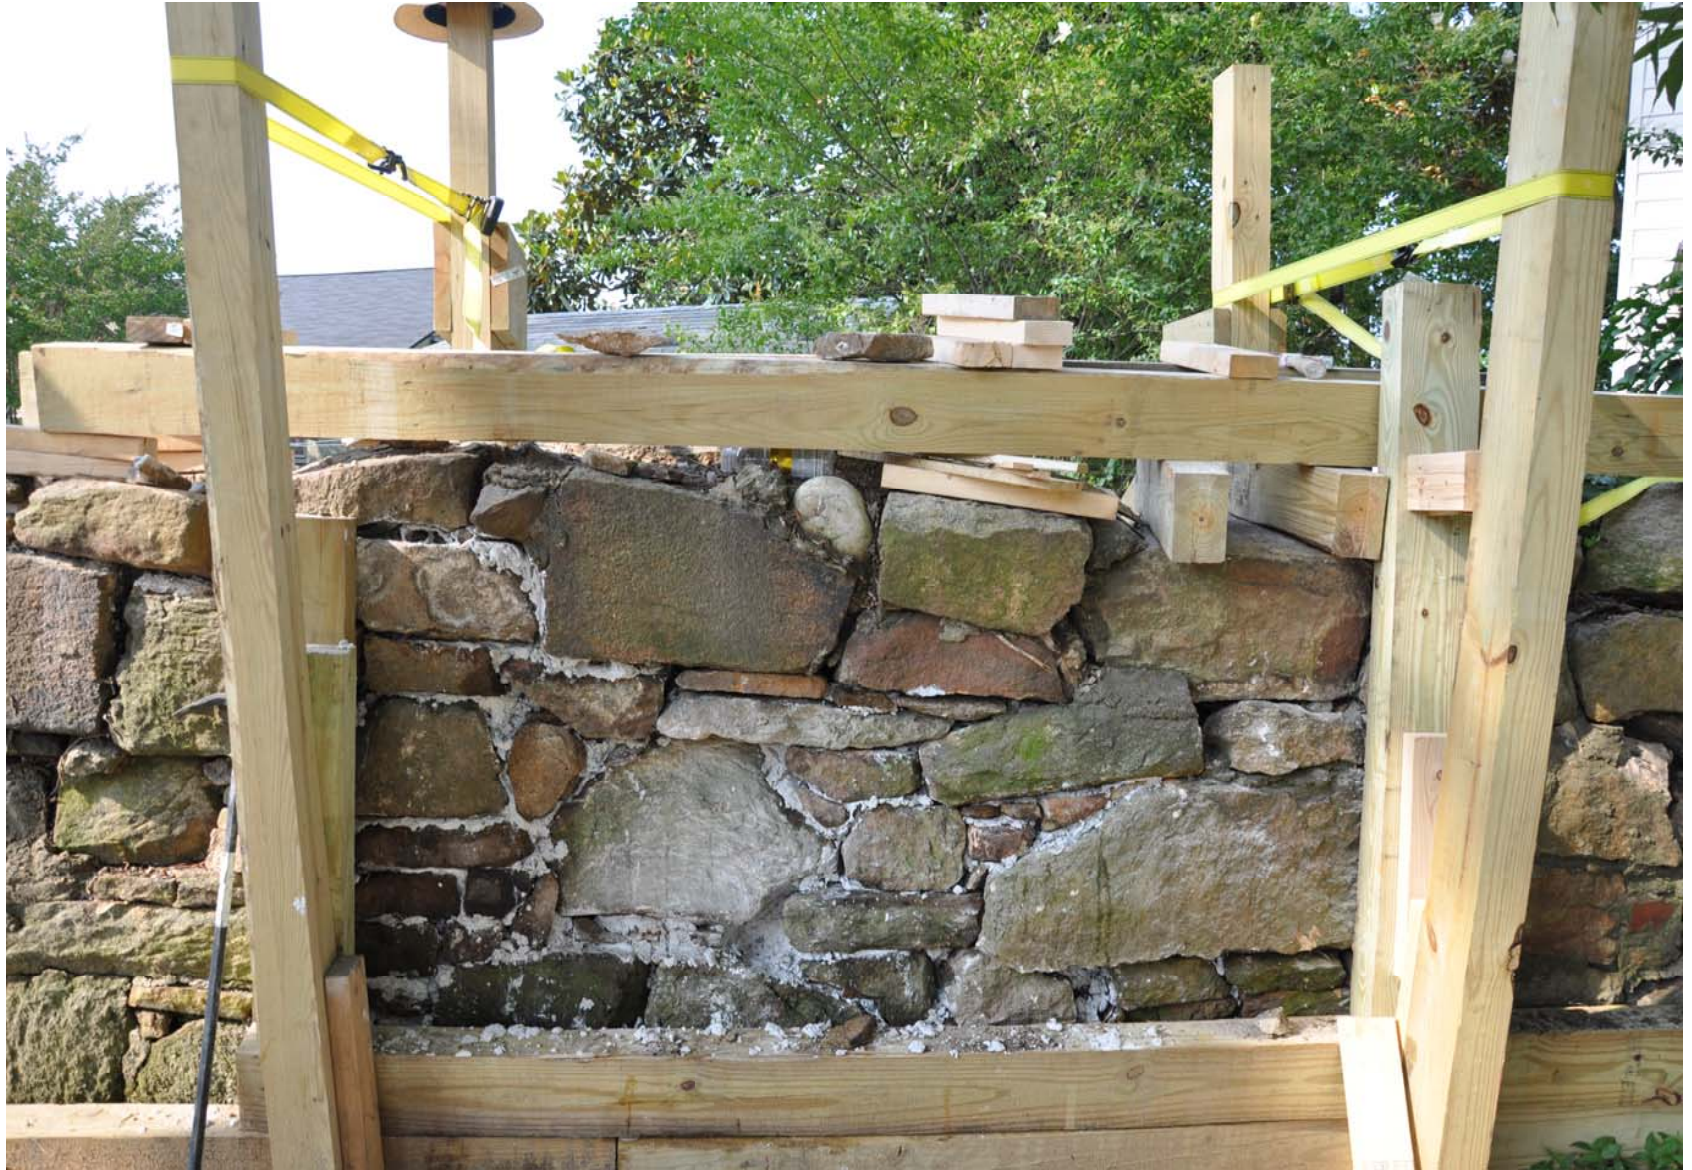
HAPPILY THIS IS THE SPOT THAT  
HAD COLLAPSED ON THE INSIDE  
AS WELL

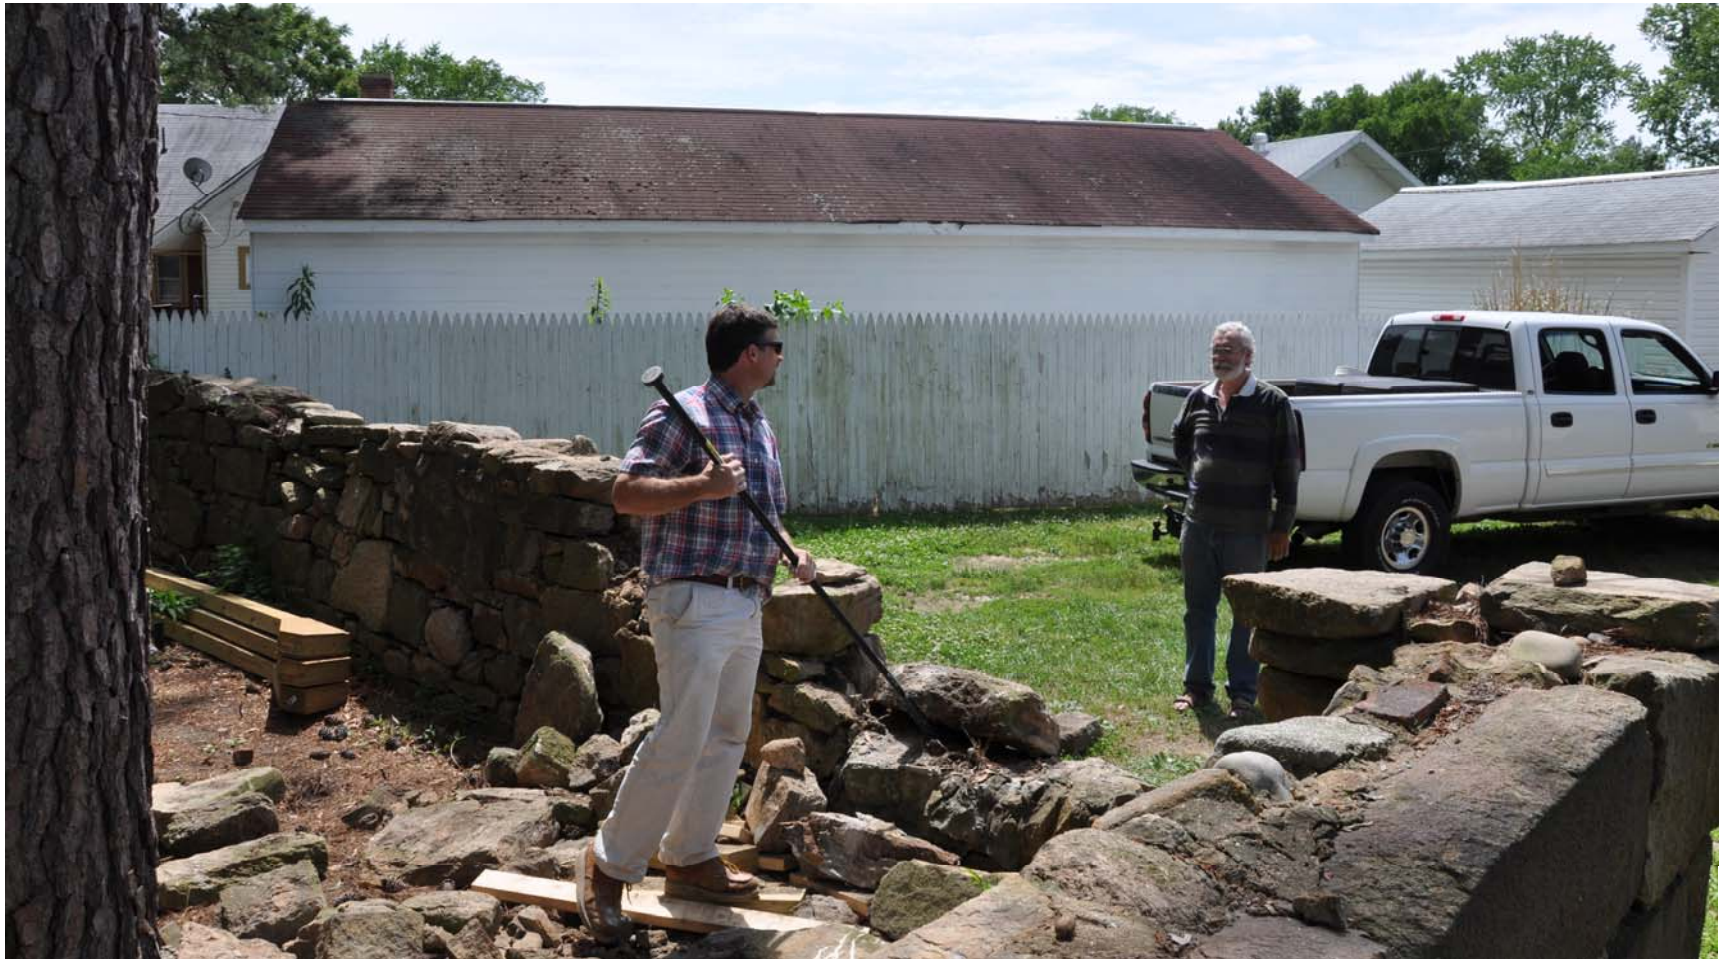
# CHUCK FUNK WORKING ON THE MASS OF PORTLAND CEMENT AT THE BOTTOM OF THE RUBBLE

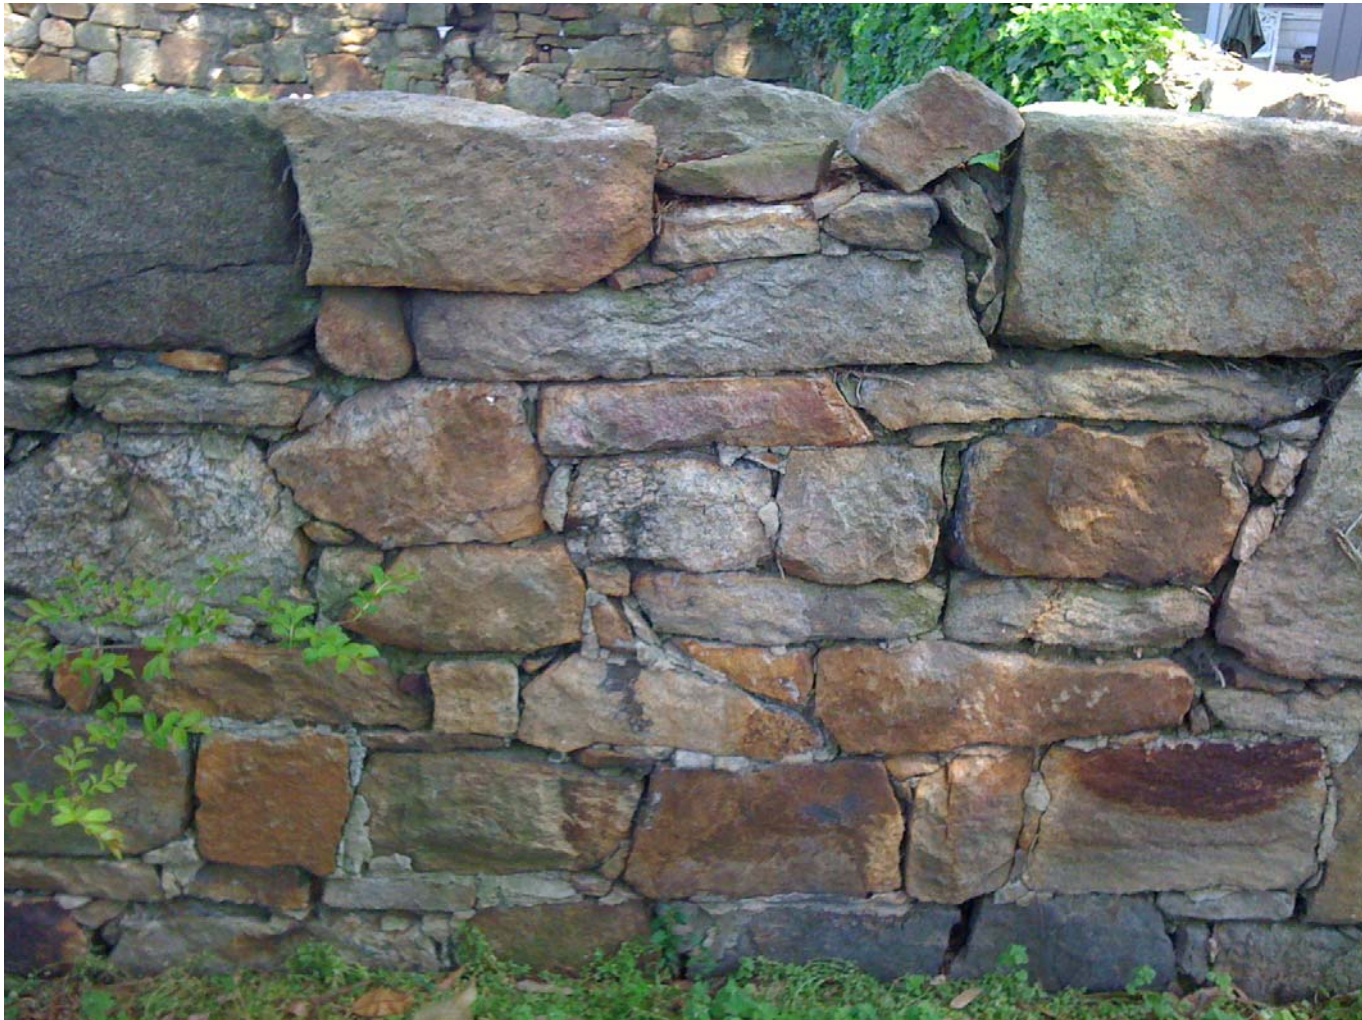
MAJOR FACE STONES RUN  
IN HORIZONTAL BANDS MAINTAINING  
THROUGH MORTAR JOINTS

# TAKING OUR CUES FROM THE GOOD PORTIONS OF THE ORIGINAL WALL

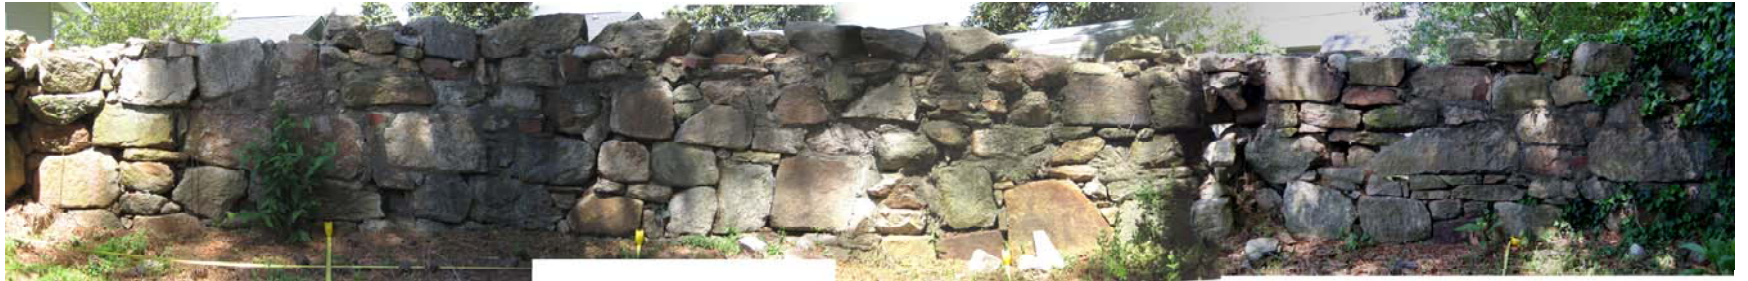
BEFORE

IN ADDITION TO THE WALL  
LEANING 8 INCHES,

THE BASE STONES ARE  
ROTATING, BUCKLING THE  
WALL AND DUMPING OUT  
MAJOR STONES

## NORTH WALL VIEWED FROM INSIDE

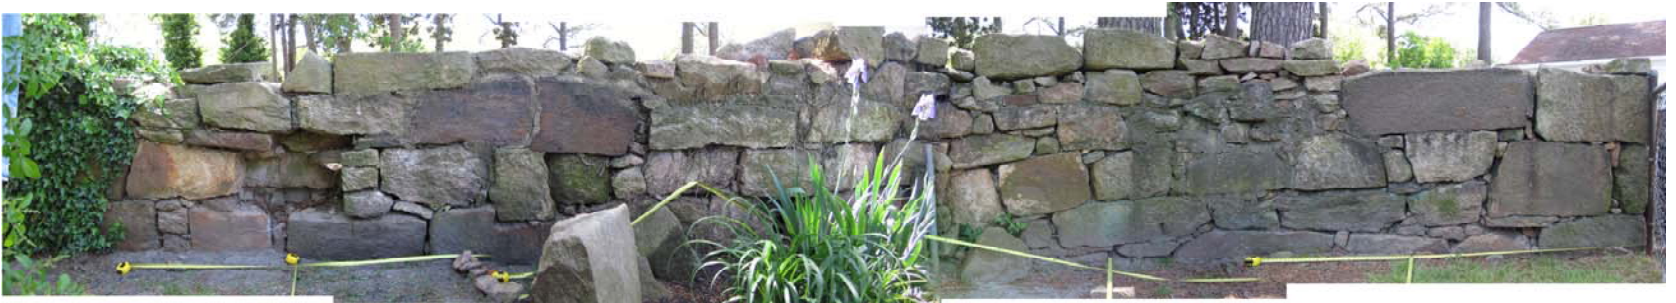
BEFORE

## NORTH WALL VIEWED FROM OUTSIDE

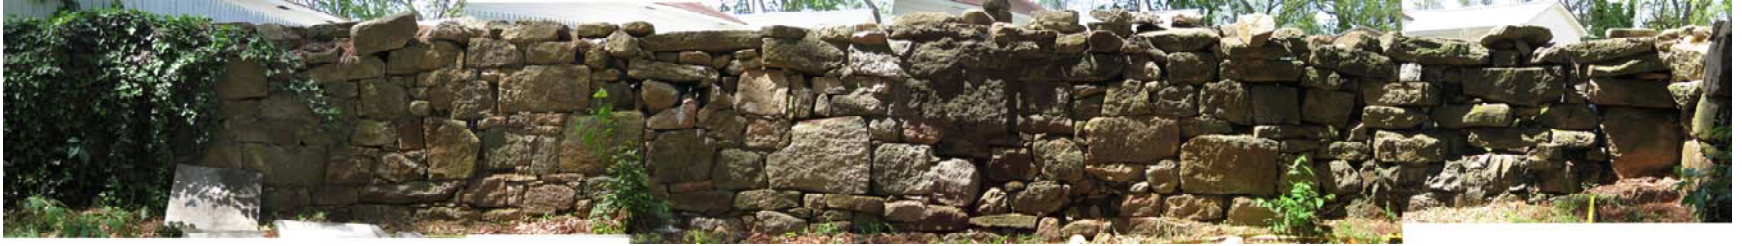
ANOTHER SIGNIFICANT AREA IS  
BOUND UP IN PORTLAND  
CEMENT

# BEFORE AND AFTER WEST WALL VIEWED FROM INSIDE

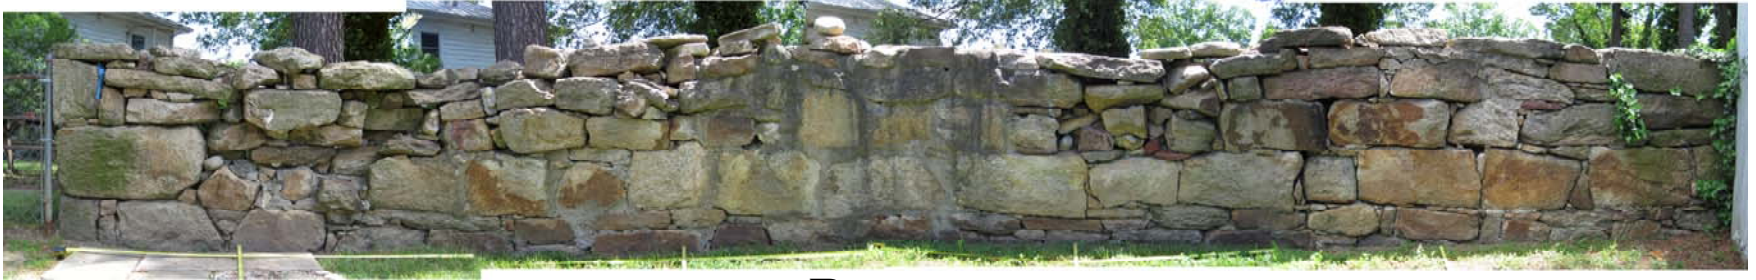
BEFORE

## WEST WALL VIEWED FROM OUTSIDE
